CCHRC Product Testing Laboratory

Safe and Effective Exterior Insulation Retrofits

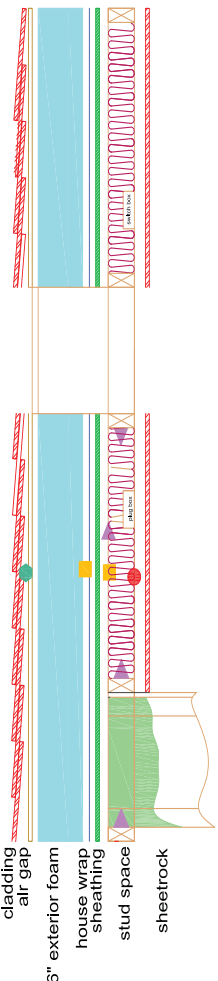
A wall section diagram.

All nine test walls were built using typical building practices. Each test wall has a different ratio of insulation in the wall cavity (fiberglass batts) to the insulation on the exterior of the wall (rigid or spray-on foam). Also, some walls have no interior vapor barriers.

Each wall in the MTL has 15 sensors embedded in it. They will record temperature, wood moisture content, relative humidity, and heat flux through the wall.
