COLD CLIMATE HOUSING RESEARCH CENTER

# Laboratory Study of Integrating an Air Source Heat Pump into a Combined Heating and Ventilation System for Cold Climates

Robbin Garber-Slaght, P.E.

March 29, 2019

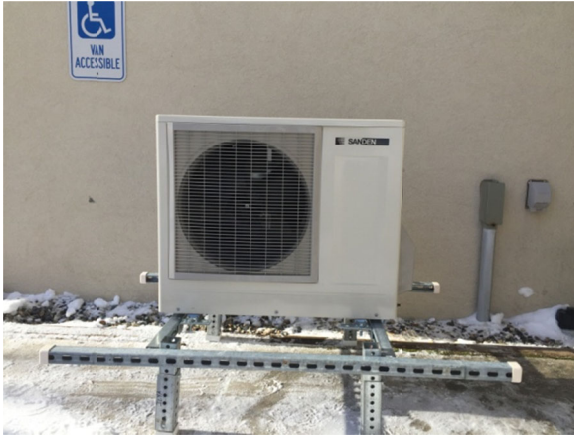
Figure 3. The Sanden GS3-45HPA heat pump. The ice removal tray is not pictured.

The Sanden GS3-45HPA was selected as it met these requirements at a reasonable cost and in addition uses CO<sub>2</sub>, a HFC free refrigerant.

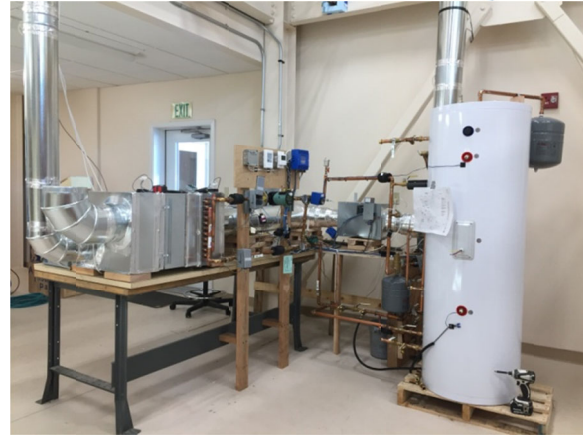
Figure 4. Completed installation of combined heating and ventilation system with integrated boiler and air-source heat pump.

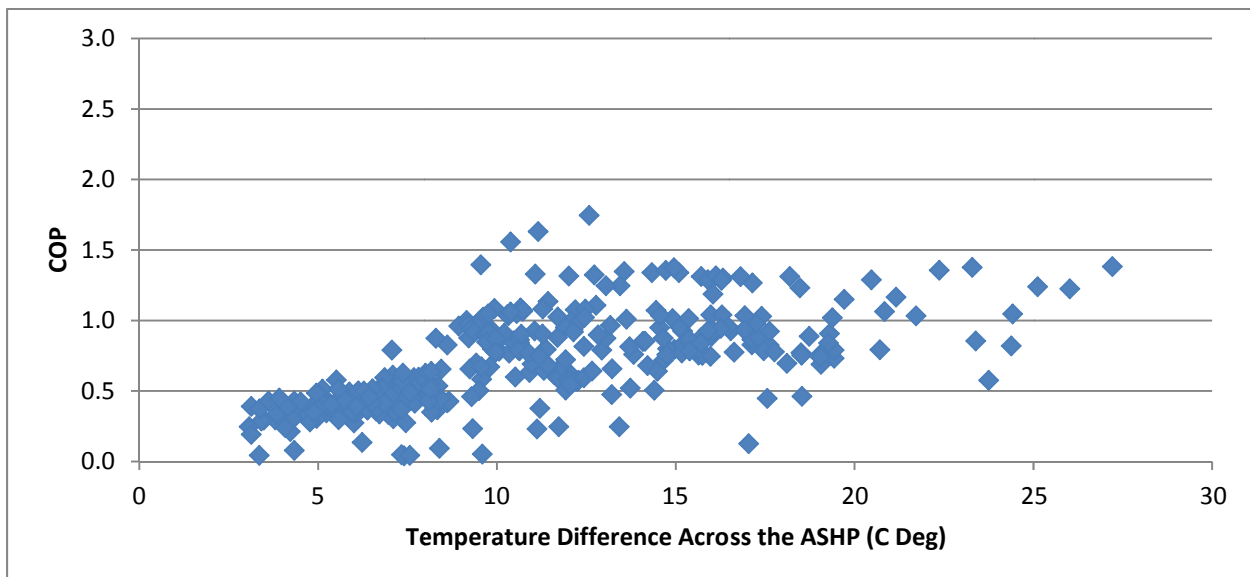
**Figure 8. COP and temperature difference across the heat pump. The heat pump is designed to have a high temperature difference; these low differences most likely caused the poor performance of the heat pump.**

There are other factors affecting the COP of the Sanden besides the outside and delivery temperature. Since it is designed to heat domestic hot water directly, it requires a high temperature difference in the fluid across the heat pump. The COP does track with the temperature difference better than with the outside temperature. Temperature differences above 20 °C give a higher COP (see Figure 8). It is expected that as the unit approaches the delta T it is designed for (around 55°C) it could approach the COP in its specifications.

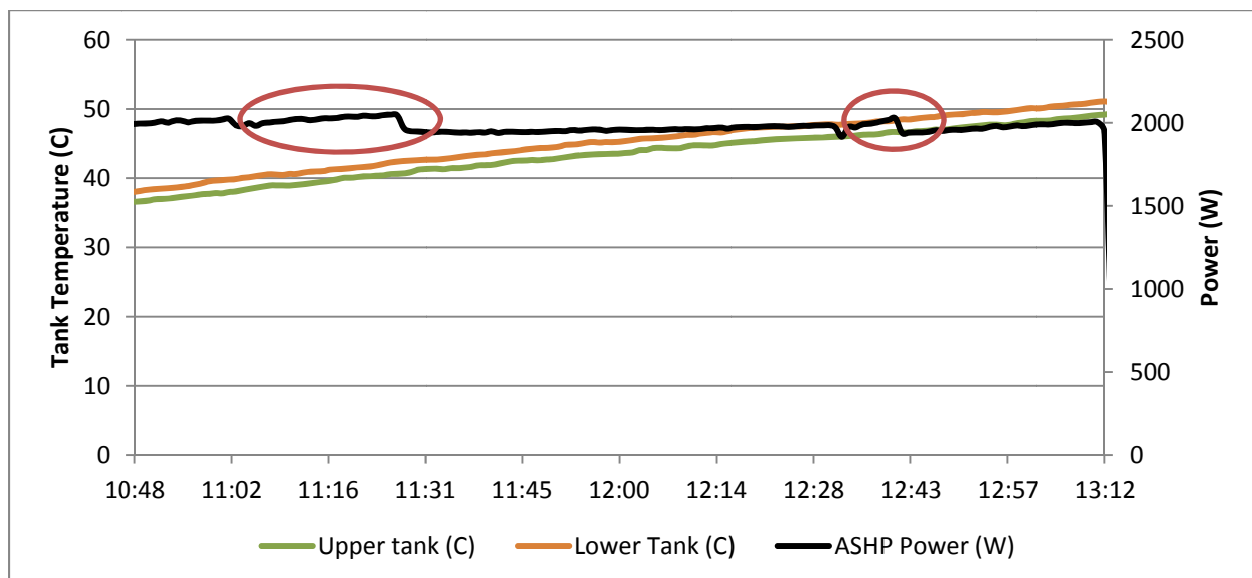
Figure 14. Defrost cycles from Figure 13 called out. The first defrost cycle ran 20 minutes the second was shorter only running about 6 minutes.

The ASHP also has a defrost cycle that runs to remove any ice buildup from the outdoor coils. The Sanden documentation says that the unit calculates when it needs to defrost based on outdoor conditions. If the ASHP is running for at least 12 minutes and the outdoor condition sensor determines it needs to defrost, the compressor speed increases and the expansion valve opens fully, allowing hot gas into the evaporator coil to melt any frost. The defrost ends when the defrost sensor reaches a certain temperature or once it has been engaged for 20 minutes. You can see this defrost cycle in the data in Figure 13 at 11:30 and 12:30 on 2/12 (among several times) when power to the compressor jumps up for a few minutes and then drops back to its heating mode. Figure 14 shows a zoomed in version of the two most visible defrost cycles.

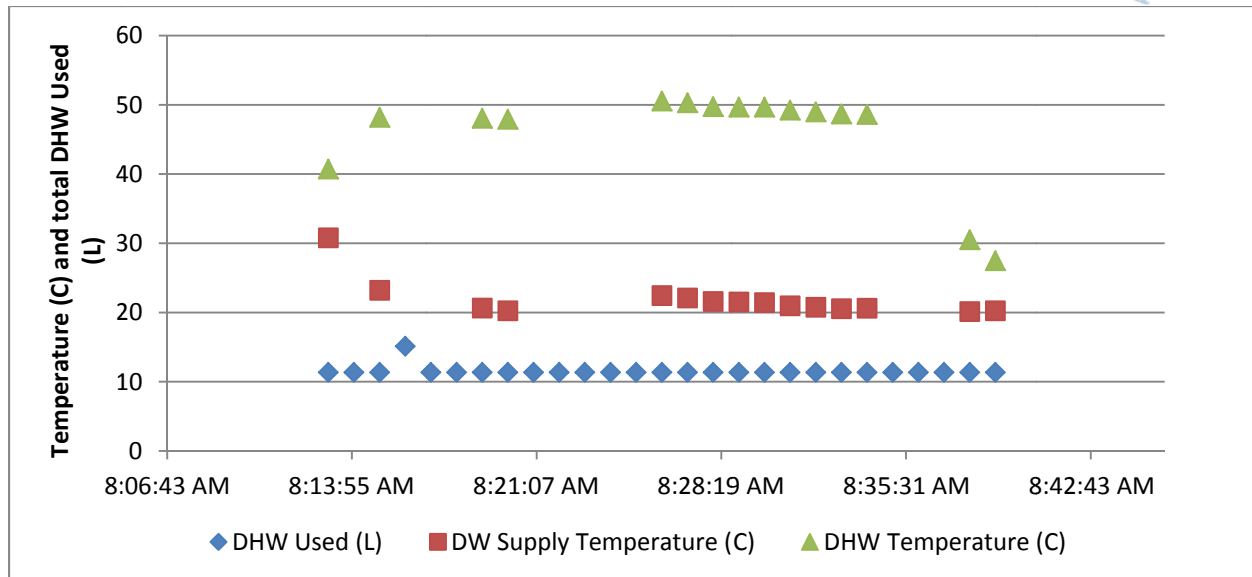
Figure 15. Removing all the hot water in the DHW tank. Holes in the data have to do with faulty data collection equipment.

A simulated domestic hot water draw was run over the course of 4 different weeks in the second winter. Generally, the metered DHW use did not have much effect on the temperature in the buffer tank if there was no call for heat. In an effort to analyze the recovery time of the buffer tank using the ASHP, the hot water was removed from the tank and replaced with new water (the domestic incoming water was around 21°C). Figure 15 shows the DHW temperature and incoming water temperature as the hot water was used.

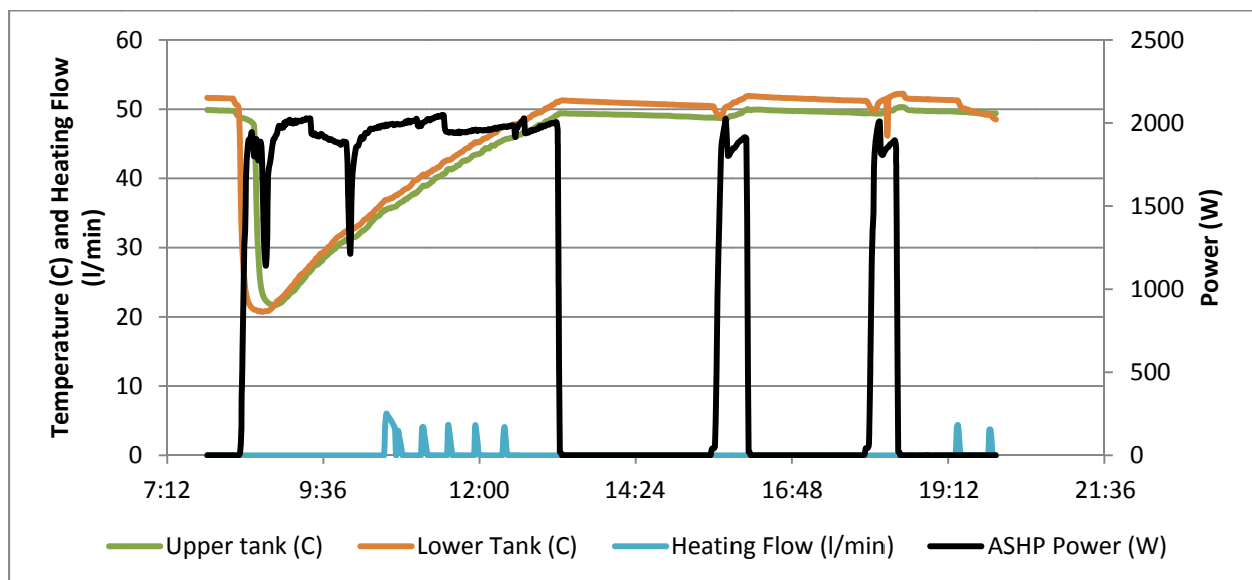
Figure 16. Recovery time for the full tank of DHW (February 12, 2019). The calls for heat shown by the blue line slowed the recovery of the tank down.

Figure 16 shows the recovery in the tank temperature from the heat pump. The tank took more than 5 hours to recover its original temperature with only the heat pump operating. There were several calls for heat from the buffer tank at that time, which is probably the reason the tank took so long to recover.

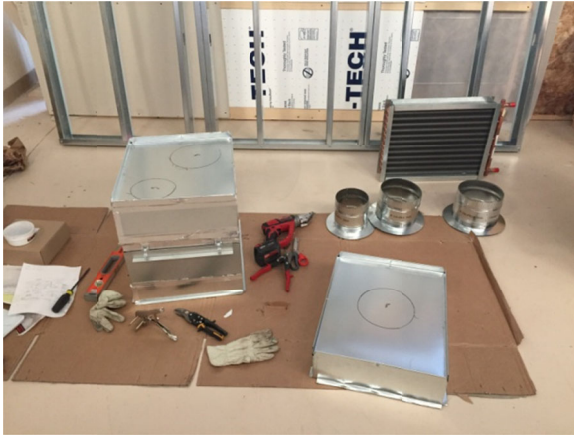
**Figure A 1** BrHEAThe filter and coil box assembly with off-the-shelf ducting components

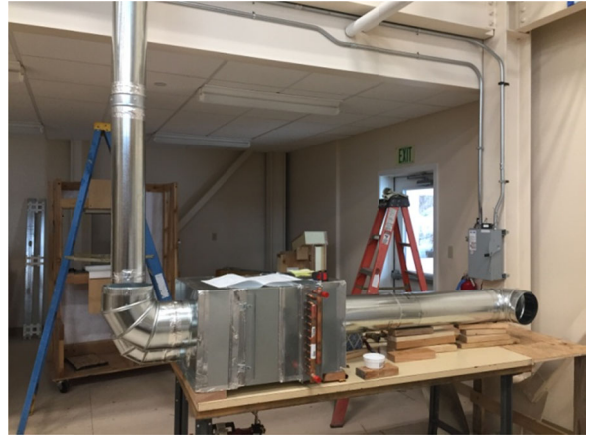
**Figure A 2** Assembled BrHEAThe coil box tied into CCHRC's HRV

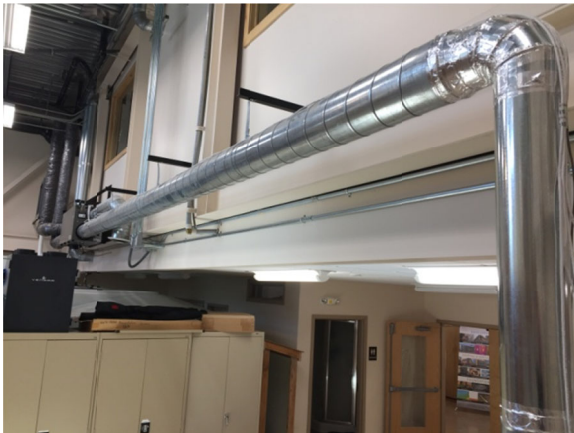
**Figure A 3** CCHRC HRV connection to the filter and coil box

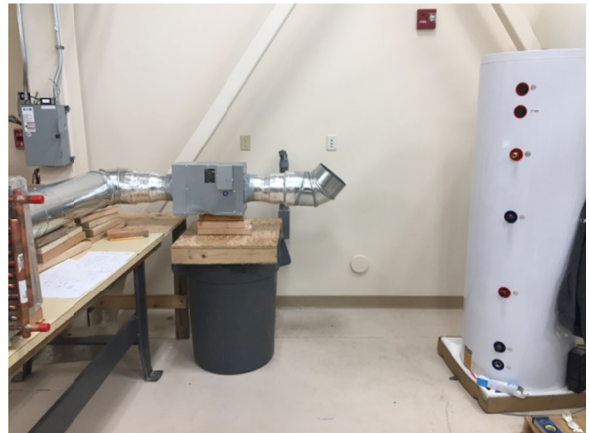
**Figure A 4** Inline fan added to filter and coil box

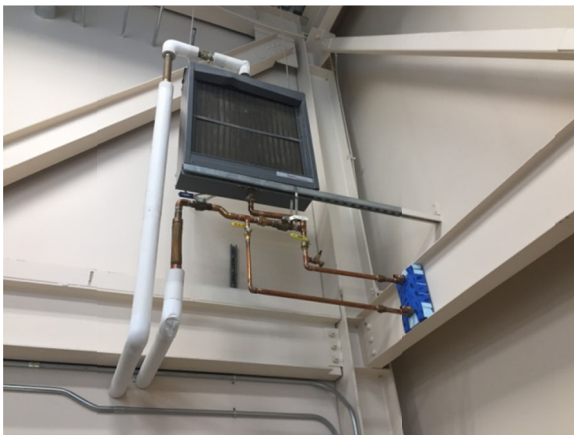
**Figure A 5** CCHRC boiler tied into the system

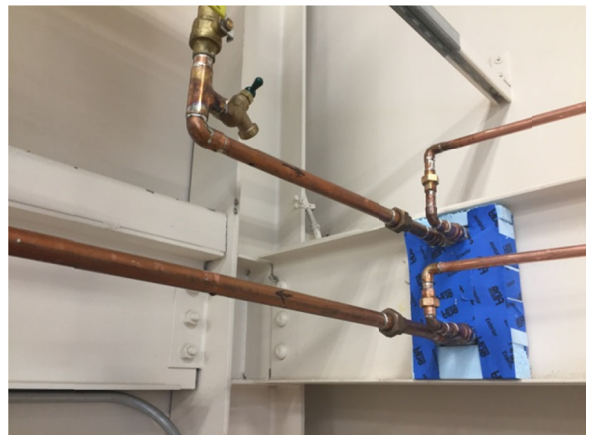
**Figure A 6** Heat exchanger between the boiler and the system

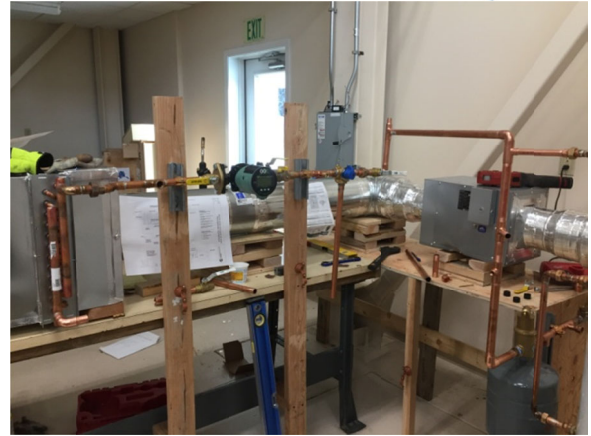
**Figure A 8** Plumbing BrHEAThe coil to the tank with variable speed circulator

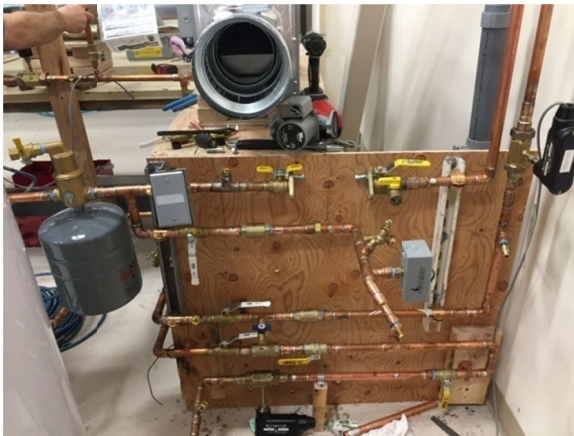
**Figure A 9** Plumbing from the boiler, tank, and BrHEAThe coil including temperature and flow sensors

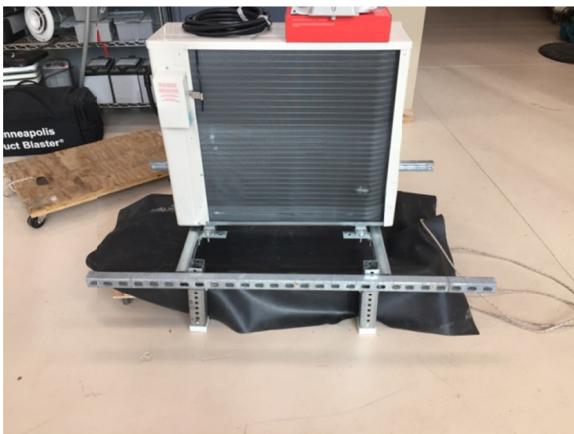
**Figure A 11** ASHP with site-built stand to allow for any condensate or snow melt to be cleared from the unit

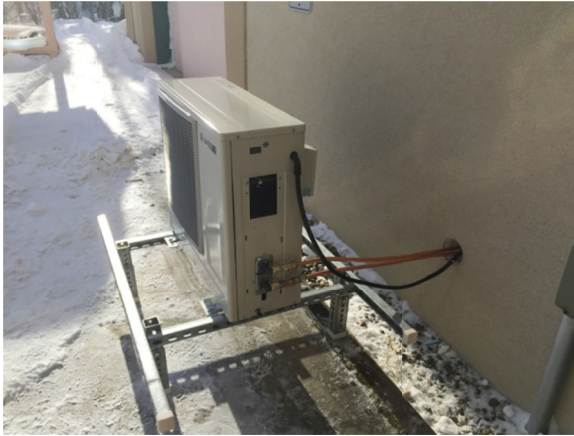
**Figure A 13** ASHP plumbed through exterior wall of South Laboratory

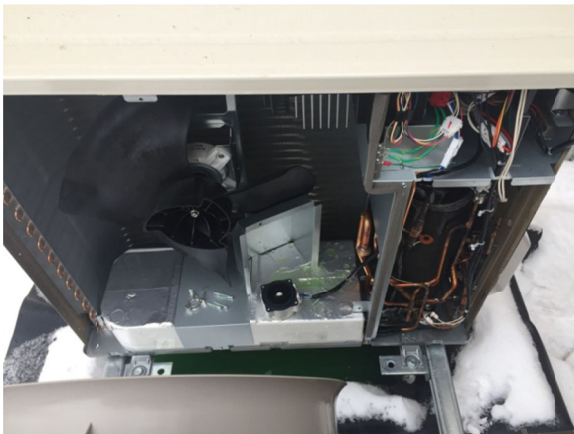
**Figure A 17** ASHP disassembly after cracked ASHP pump casing leaked glycol

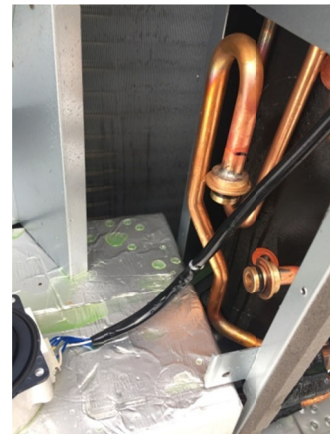
**Figure A 18** ASHP copper to plastic connections with rubber o-rings.

- b. Plastic components proved to be an issue due to their susceptibility to breaking. This is especially an issue if any maintenance needs to occur outside during below-freezing temperatures
  - c. The ASHP seems to be very susceptible to Fairbanks' imperfect electrical service. The main circuit board had to be replaced once and just as the study was ending the ASHP was starting to see error codes that were unrelated.
- 2. The controls
  - a. The Tekmar controls were not flexible enough for this application
  - b. More robust programmable controls will need to be found for future installs
- 3. The buffer tank
  - a. The heat coils in the buffer tank were too restrictive for the tank to reach the high temperature necessary for the BrHEAThe heating coil

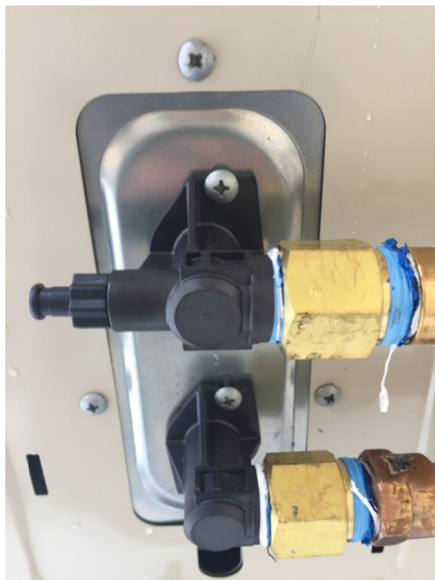
**Figure A 23** ASHP plastic plumbing connections

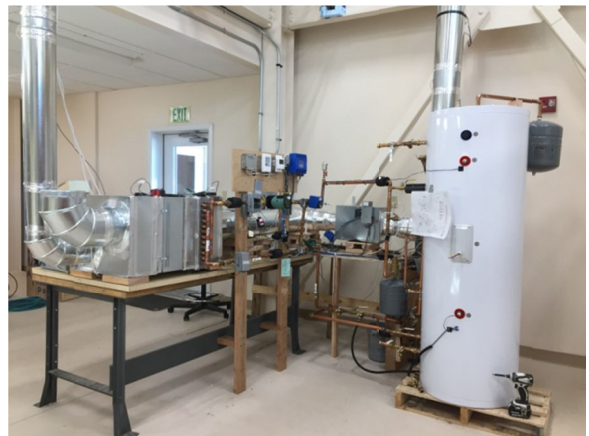
**Figure A 24** Completed installation of combined heating and ventilation system with integrated boiler and air-source heat pump
