A White Paper on Energy Use in Alaska's Public Facilities

Published 11/7/2012 | Version 1

White Paper on Energy Use in Alaska's Public Facilities

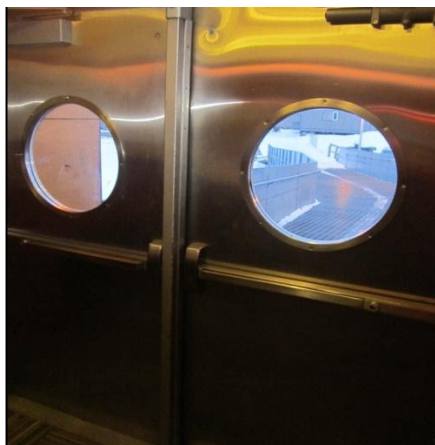
School A

- 7.25" Rigid Insulation
- Hot, sealed roof
- Well insulated metal doors with small windows.
- Arctic Entry

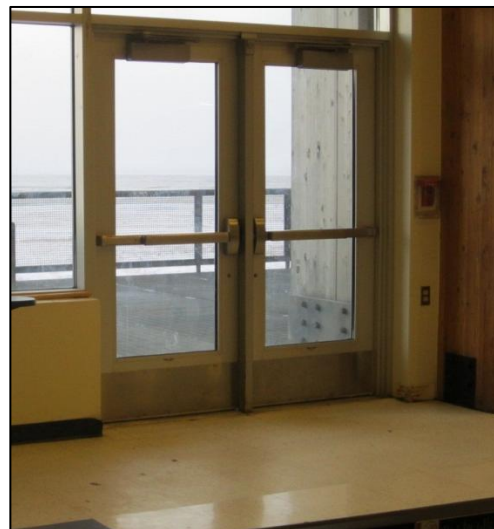
School B

- 5.5" rigid insulation
- Cold, vented roof
- Full glass metal doors
- No arctic entry

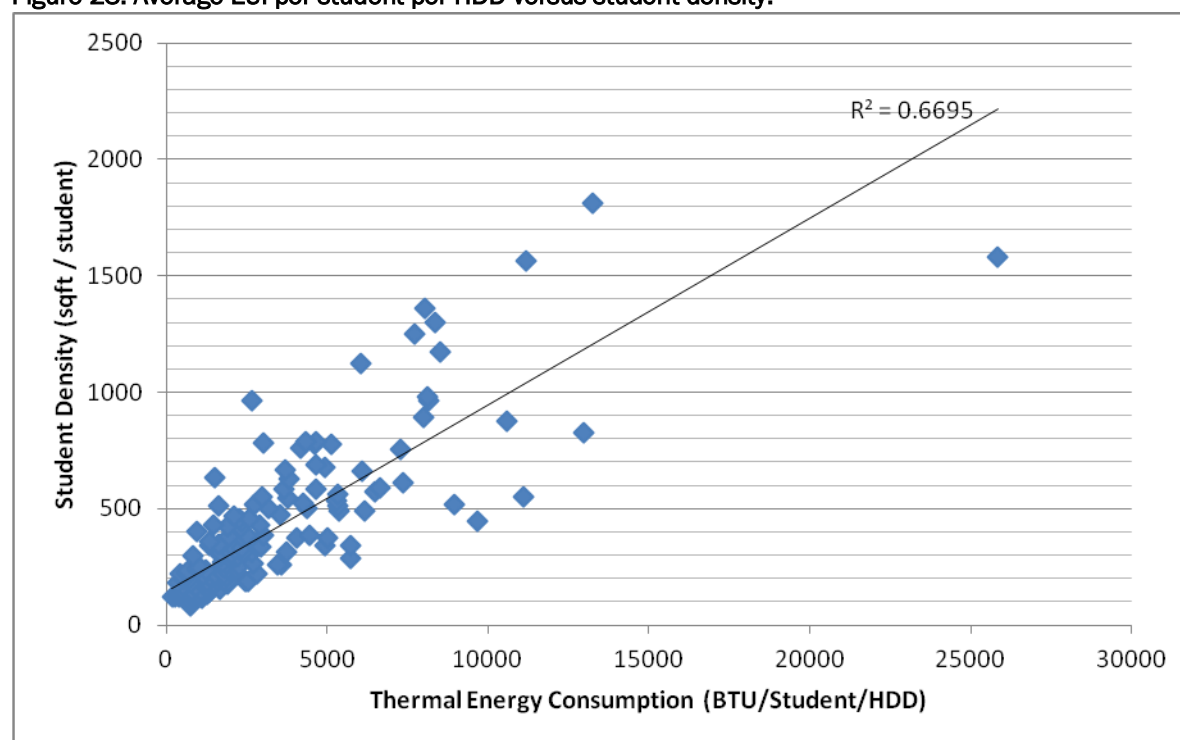
Figure 23: Average EUI per student per HDD versus student density.

Each data point represents one school. Upper bound outlier audit data points have been thoroughly reviewed and validated.
