## Ground Source Heat Pump Demonstration in Fairbanks, Alaska – 2020 update

By Robbin Garber-Slaght  
September 1, 2020

# Ground Source Heat Pump Demonstration in Fairbanks, Alaska

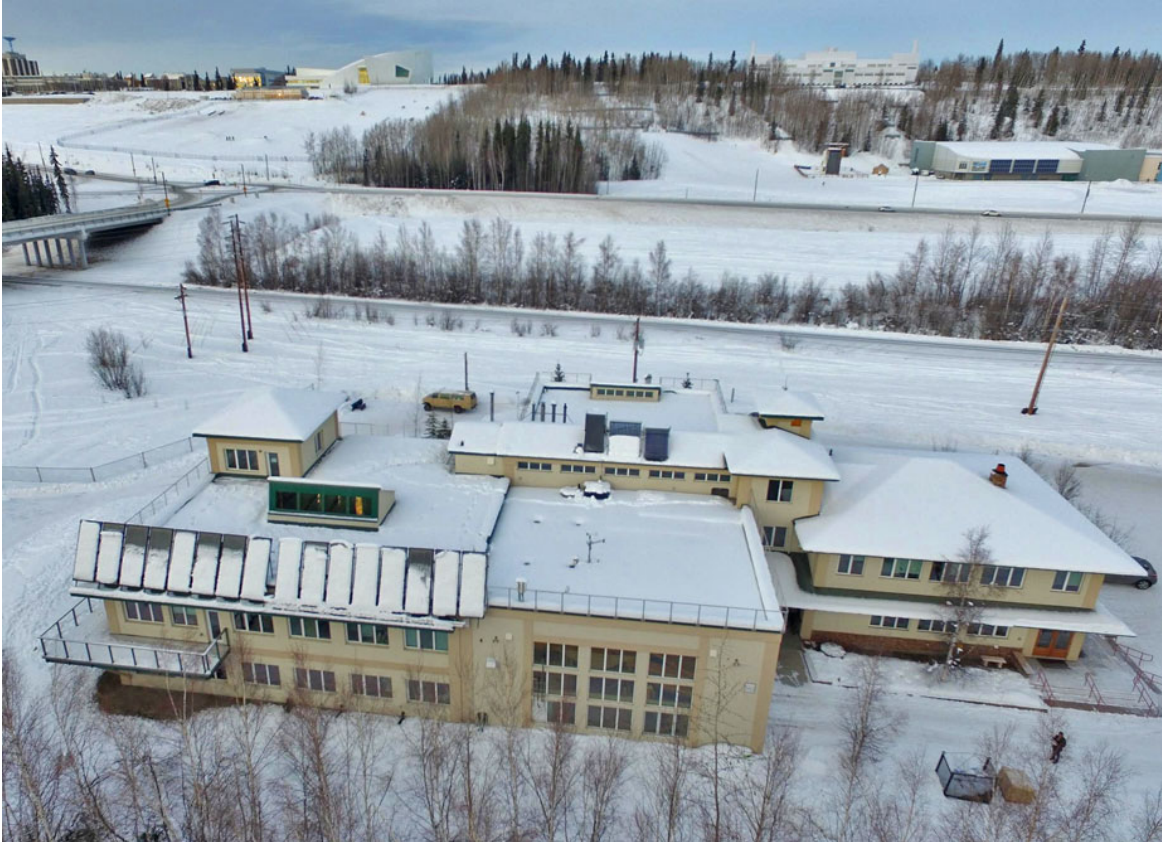
Figure 1. CCHRC's Research and Testing Facility. The original building (the right side of the photo) was built in 2006; the addition on the left was completed in 2012. The heat pump heats the section on the far-right end of the photo.

CCHRC's Research and Testing Facility (RTF) is located on the campus of the University of Alaska Fairbanks (UAF) (Figure 1). Fairbanks has 7,509°C heating degree-days<sub>18</sub> (13,517 °F HDD<sub>65</sub>) and 40°C cooling degree-days<sub>18</sub> (72°F CDD<sub>65</sub>); the 99.6% design temperature is -41.9°C (-43.5°F) (ASHRAE, 2013). The area surrounding the RTF is an open field cleared of native vegetation more than 60 years ago and is made up of moist silt (Shannon & Wilson, Inc., 2002).

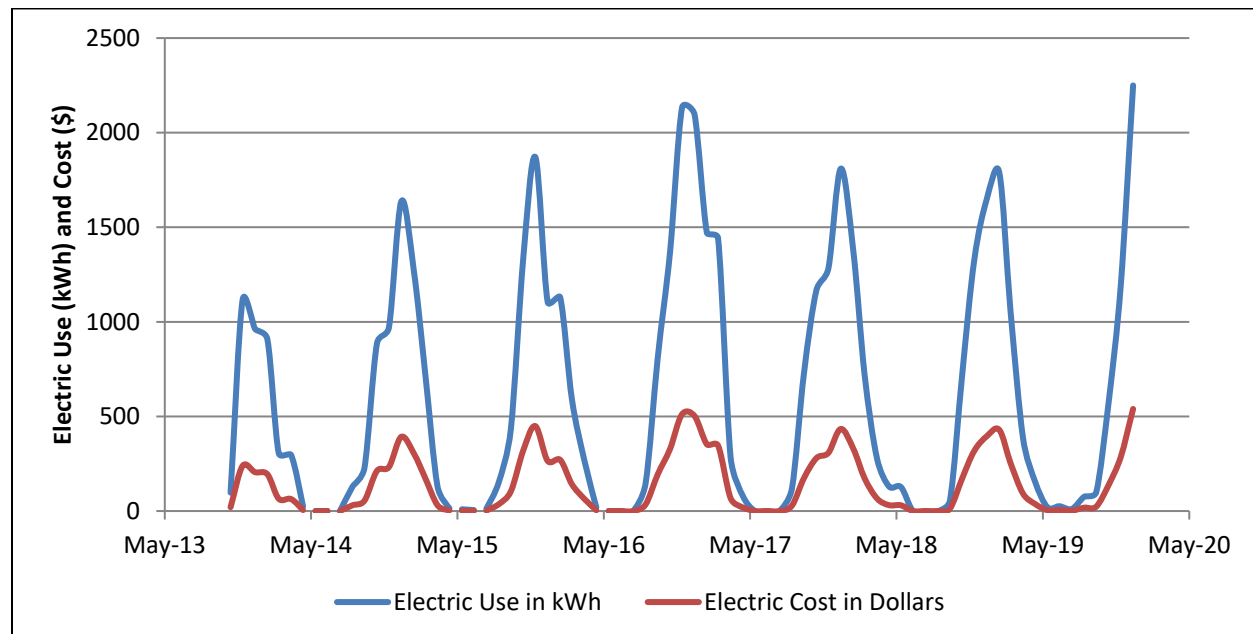
Figure 4. Electrical use of the heat pump system. Year 7 stops in January as the heat pump stopped working then.

Over the course of the study thus far, the system has used 48,303 kWh of electricity. This amounts to \$11,592 in heating costs at a constant \$0.24 per kWh (the actual rate CCHRC paid). Figure 4 shows the electrical cost trends by year.

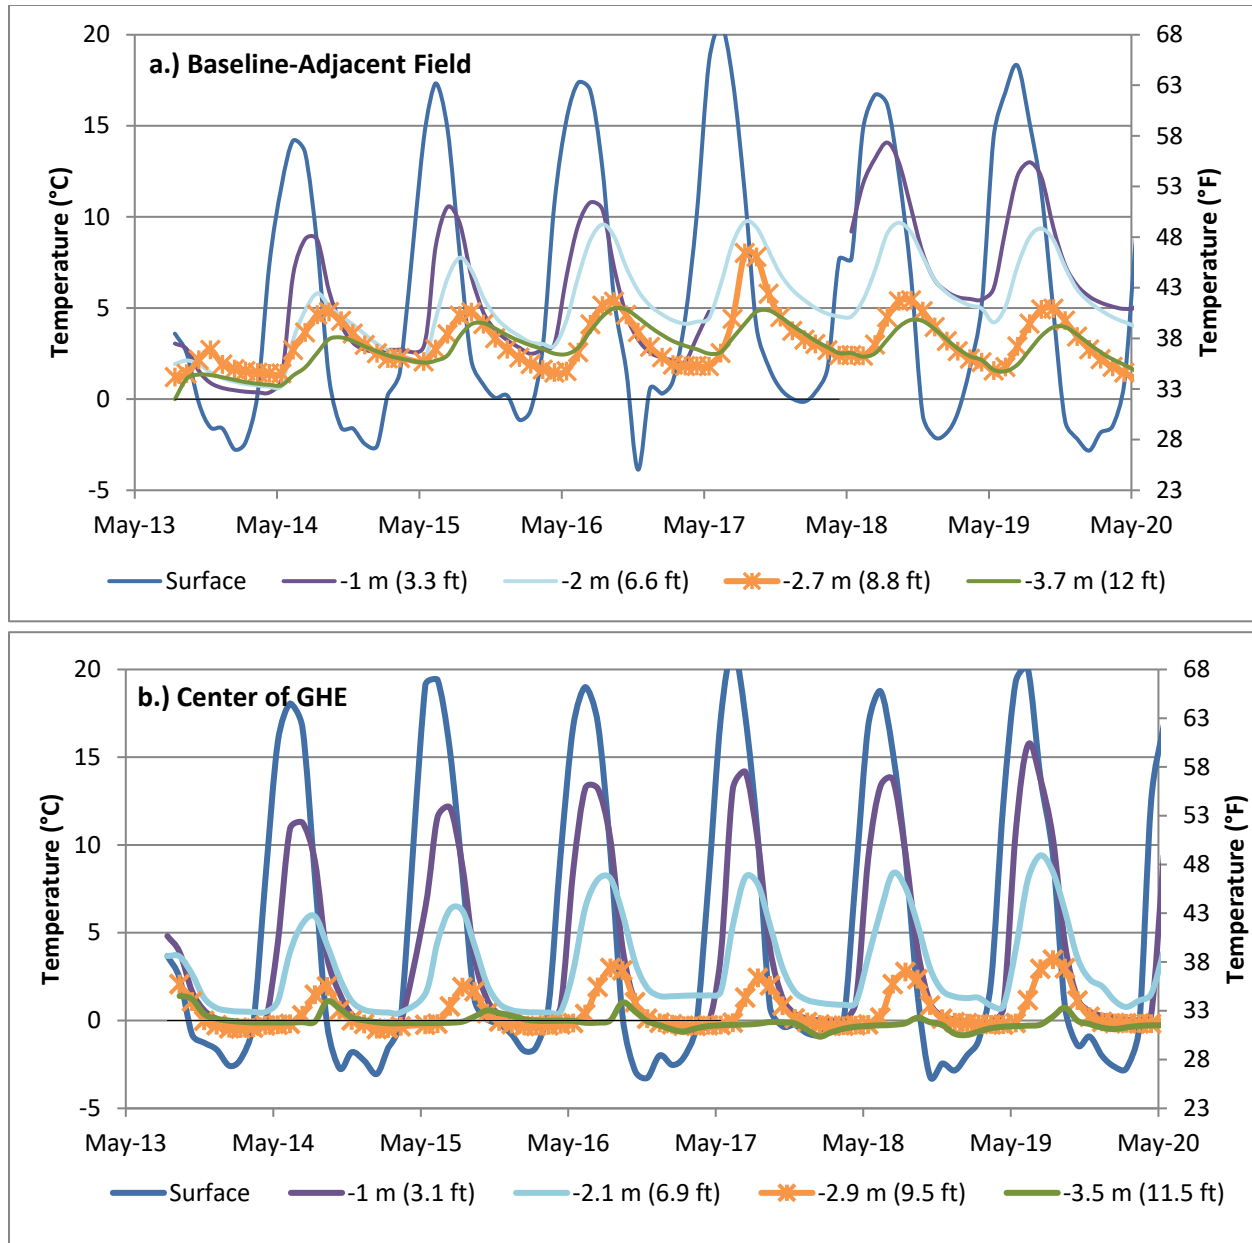
Figure 5. In-ground temperatures over time, a.) temperatures outside of the influence of the GHE, b.) temperatures in the center of the GHE. The orange starred line is nearest to the ground heat extraction coils. Temperatures are cooler in the GHE than in the field next to the GHE.

Temperatures recorded in and underneath the GHE show colder soils (Figure 5b) over the 7 years the heat pump has been in use when compared to the baseline data (Figure 5a). The temperatures in the vicinity of the heat extraction coils are lower than the baseline temperatures in the adjacent field. The temperature at the depth of the coils shows 0°C (32°F) most of the winter; the baseline temperatures are 3 to 4°C (5.4 to 7.2°F) higher.
