COLD CLIMATE
HOUSING RESEARCH CENTER

Ground Source Heat Pump Demonstration in Fairbanks, Alaska – 2021 update 8th year of operation

By Robbin Garber-Slaght
September 1, 2021

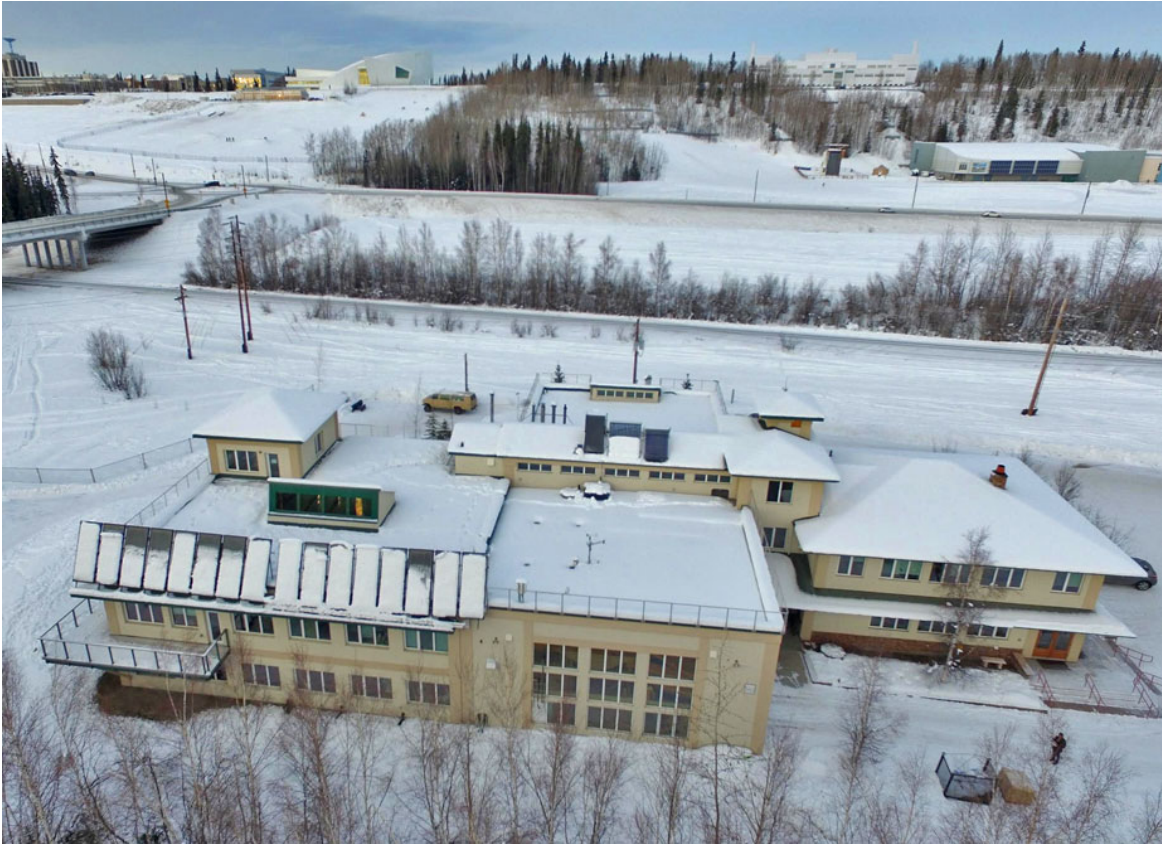
Figure 1. CCHRC's Research and Testing Facility. The original building (the right (east) side of the photo) was built in 2006; the addition on the left was completed in 2012. The heat pump heats the section on the far-right end of the photo.

CCHRC's Research and Testing Facility (RTF) is located on the campus of the University of Alaska Fairbanks (UAF) (Figure 1). Fairbanks has 7,509°C heating degree-days₁₈ (13,517 °F HDD₆₅) and 40°C cooling degree-days₁₈ (72°F CDD₆₅); the 99.6% design temperature is -41.9°C (-43.5°F) (ASHRAE, 2013). The area surrounding the RTF is an open field cleared of native vegetation more than 60 years ago and is made up of moist silt (Shannon & Wilson, Inc., 2002).

The RTF is 2,044 m² (22,000 ft²) with 3 distinct heating sections. The heat pump was sized to heat the 464 m² (5,000 ft²) office space on the east side of the building with a design heat load of 17.6 KW (60,000 BTU/hr). Heat is distributed to the area via an in-floor hydronic tubing system embedded in concrete. The office space has 9 thermostatically controlled zone valves. The heat pump system replaced a 22.3 KW (76,000 BTU/hr) oil fired condensing boiler as the main source of heat for this portion of the building; a masonry wood stove is still used for supplemental space heating.
