# Kwigillingok

## Energy Action Plan

6/17/2019

Kwigillingok Energy Efficiency Project

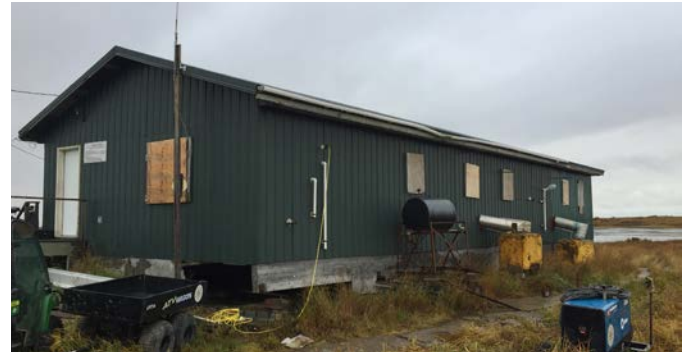
The bunkhouse is a single story, wood framed structure. It is not currently used and is in poor condition. It has several broken windows and its foundation has detached from the structure in multiple places.

The ANTHC bunkhouse is currently not in use due to its poor condition.

The energy audit recommends four important actions which should be addressed as soon as possible, regardless of the future use of the building:

2. The existing Toyo stove has a programmable thermostat for setting back space temperatures when the building is unoccupied.
3. The unsafe foundation should be repaired.
4. There are several wall, floor, and ceiling electrical penetrations that are unsafe and should be repaired.

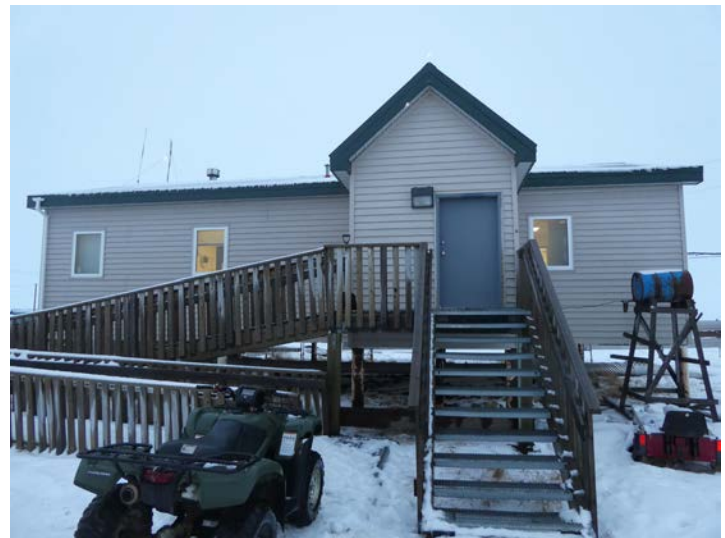
The clinic is in relatively good condition, and its four employees provide health services to the community on weekdays and during emergencies.

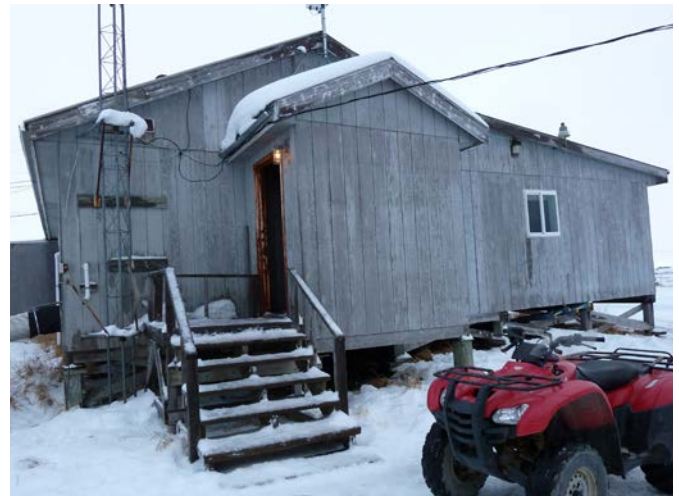
The I.R.A. office building is a 2,400 square-foot, single story, elevated pier foundation, wood framed, wood sided structure. The building shell is in poor condition. The windows on the west side of the building are in very poor condition and the building shows signs of deferred maintenance. Heating is provided by a Toyotomi Laser 73 and a Toyotomi Laser 72 stove with onboard thermostatic controls for programs. An oil-fired, forced air furnace previously distributed heat through the building but has since been removed. The ductwork penetrations through the attic still exist. There is no domestic hot water or other plumbing in the building, although, there is an RV-style, tankless flush toilet with a lavatory sink. Lighting consists of 48" linear fluorescent, 32 watt, 2-lamp, electronic ballast, T8 fixtures. There are no lighting controls in the building. Plug loads are high due to the high occupancy and use of the building as a tribal office.

The I.R.A. Council office is the central administrative hub of Kwigillingok, despite its poor condition. Its 14 employees help up to 20 visitors each day.

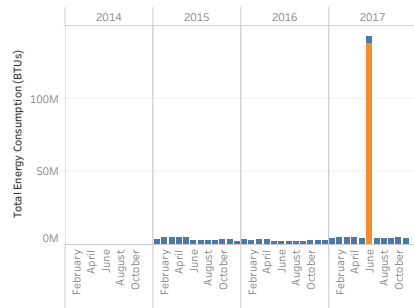
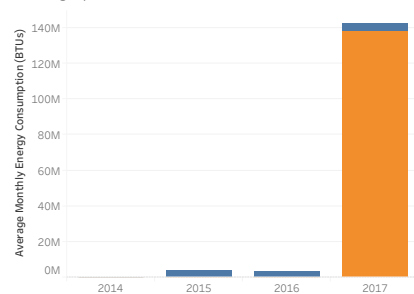
1

Clinic Total Energy Consumption

Clinic Monthly Energy Consumption  
Average per Year

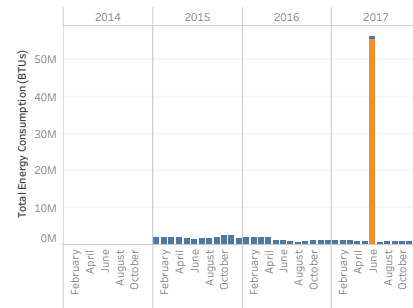
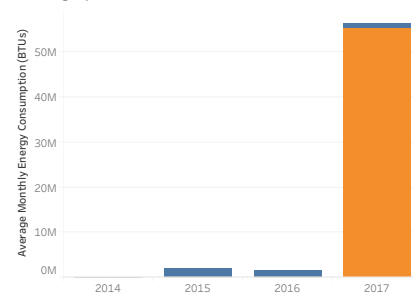
2

Post Office Total Energy Consumption

Post Office Monthly Energy Consumption  
Average per Year

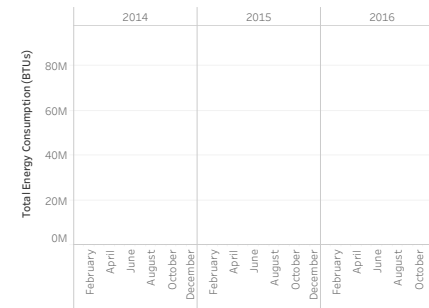
3

Bunkhouse Total Energy Consumption

Bunkhouse Monthly Energy Consumption Average

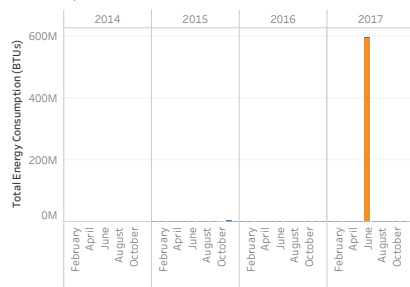
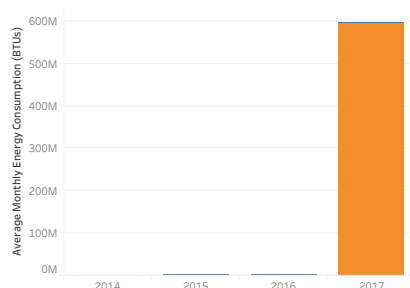
4

Fisheries Support Building Total Energy Consumption

Fisheries Support Building Monthly Energy Consumption Average per Year

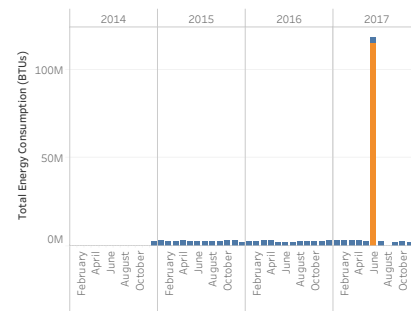
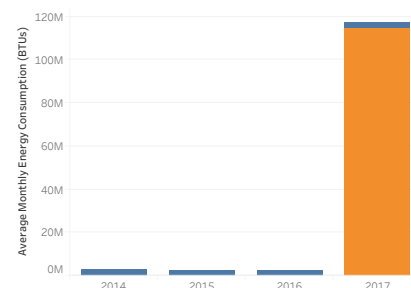
5

Office Total Energy Consumption

Office Monthly Energy Consumption Average per Year

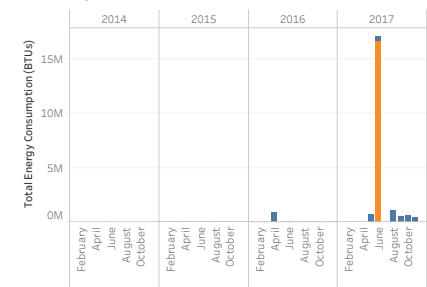
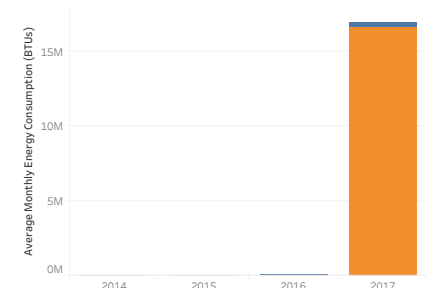
6

Tribal Police Department Total Energy Consumption

Tribal Police Department Monthly Energy Consumption Average per Year

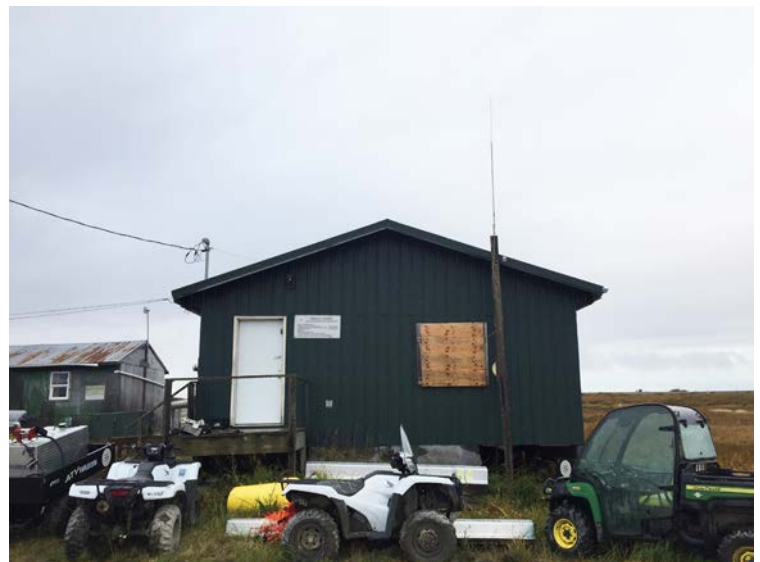
The ANTHC bunkhouse is a 1,536 square foot building constructed around 1980. The building is occupied intermittently by summer work crews. The tribal council is considering renovating the building for use as an office. The energy audit thus considers two scenarios – one where the building continues in its current use, and a second where it would be occupied by 3 people Monday-Friday from 8:30 AM to 3:00 PM. As housing for summer work crews, the annual energy cost is approximately \$3,700 per year, mainly due to electrical use. Should the building be converted into an office, annual energy use with no energy upgrades would be over \$10,000, over \$8,000 of which would be for electricity. The remaining would pay for fuel oil.

1. The zoning for space heating in the building is inadequate when doors are closed. This can be improved by installing a boiler and hydronic distribution system.

Other recommendations include replacing existing lighting with LED, replacing clothes washer at its end of life an Energy Star version, adding blown-in cellulose insulation to the attic, and installing occupancy sensors on the bathroom fans.

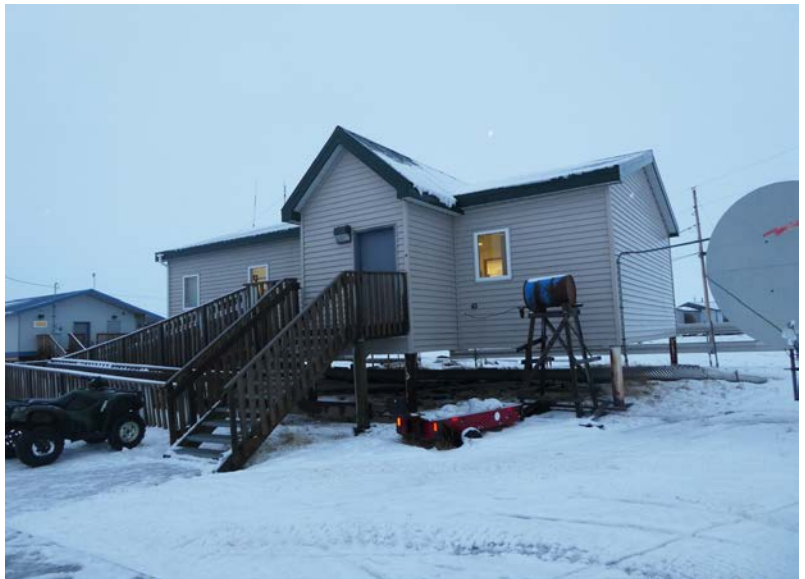
The energy use of the clinic could decrease by over \$3,000 per year if audit recommendations are implemented.

1. Remove the cardboard from the combustion intake vent in the furnace room allowing for unrestricted combustion air for proper operation. This is a serious safety issue.
2. Remove all combustible materials from the furnace room, particularly the cardboard boxes adjacent to the water heater burner. This is also a serious safety issue.
3. Install plug load management devices in exam rooms to manage computer power usage when the room is unoccupied.
4. Investigate erratic year-to-year electric consumption - consumption decreased 21% between 2015 and 2016 but increased 53% between 2016 and 2017.

Other recommendations include installing setback thermostats throughout the building and implementing a 63 degrees Fahrenheit unoccupied setback temperature, replacing existing lighting with LEDs, replacing the existing

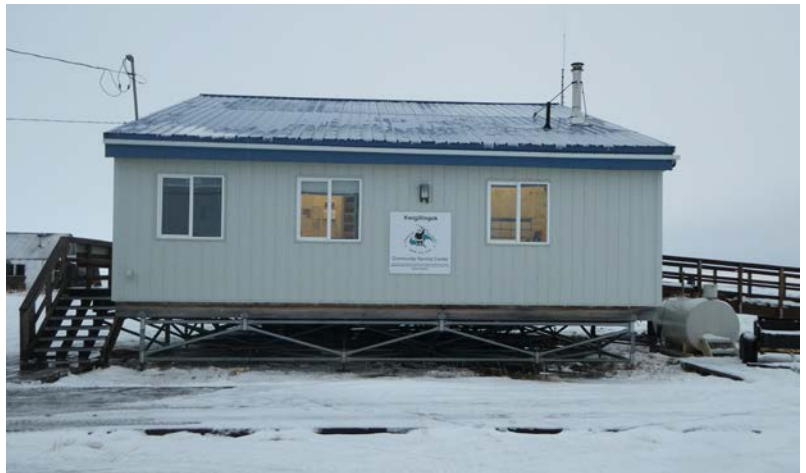
Recommendations for the fisheries building include using setback thermostats and upgrading lighting to LED bulbs.

1. Unset the programmable thermostat in the southwest office from *hold*, set the clock to the proper time, and program setback temperatures for unoccupied hours.
2. Program the Toyotomi stoves in the garage to set back the temperature during unoccupied hours, checking the settings after every power outage.

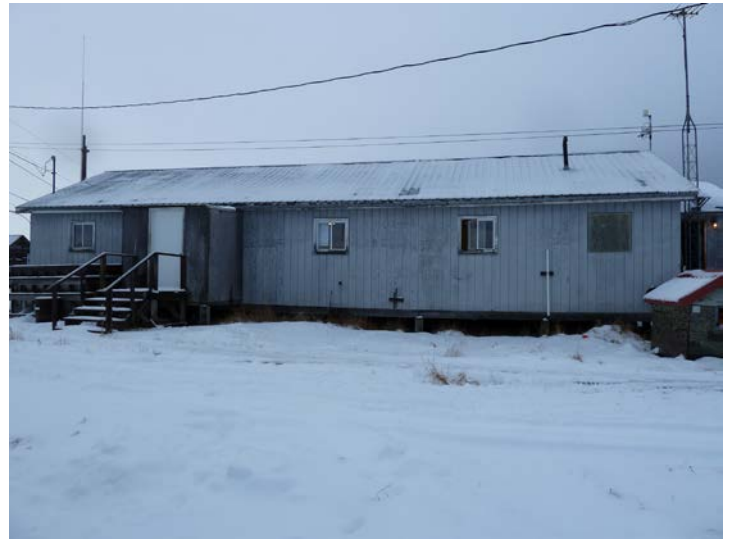
The office building could benefit from several retrofits, such as setback thermostats, occupancy sensors, and air-sealing of the building envelope.

5. Be sure to turn off the heat trace on the wastewater line during the warmer months.
6. Program the Toyotomi stoves to set back the temperature during unoccupied hours and checking the settings after every power outage.
7. Investigate and repair the Toyotomi stove indicating a fuel obstruction (error EE6) for optimal performance.
8. Remove the items stored in the attic and reinsulate with a minimum of R-42, store the items in a non-attic location.
9. Add switch mounted occupancy sensors to each office that is intermittently occupied.

Other recommendations include implementing a heating temperature unoccupied setback to 63° Fahrenheit throughout, replace existing lighting with LEDs, add an R-9 insulating blanket to the hot water heater, replace bathroom fans with models with occupancy and humidity sensors, perform air sealing to reduce leakage by 50%, replace the existing window with a U-0.22 vinyl window, and remove manual switching and add new timers or scheduled controls on the heat trace.

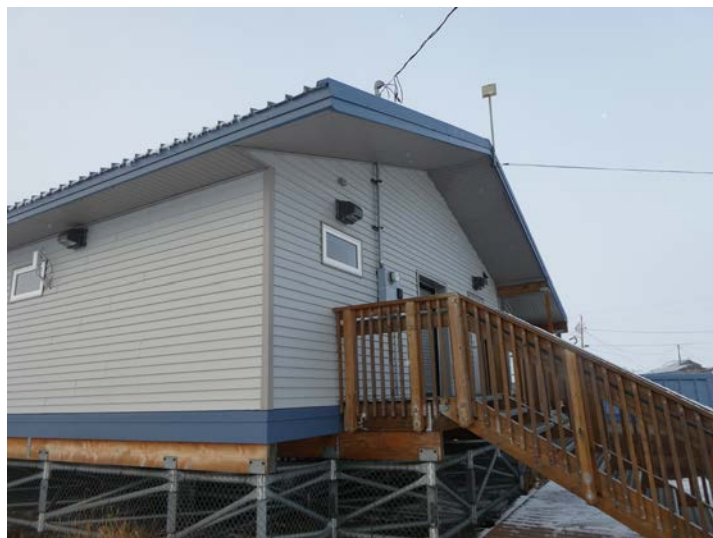
The primary recommendation for the post office is to program the heating appliance's temperature setback option.

If the Tribe is able to implement all recommendations, the annual energy use would decrease by 15.9 MBTU, resulting in an energy and maintenance savings of **\$1,995**. At an approximate installation cost of \$5,858, the simple payback of a retrofit project would be **2.97 years**.

The audit also includes suggestions for several ECMs, including ongoing energy monitoring, efficient building management, reducing air infiltration, turning off plug loads, and servicing HVAC equipment annually. Additionally, specific to the Post Office, the Tribe should be sure to maintain the air sealing on the envelope, use electronic timers for large electronic equipment, and keep heating coils and fans on the Toyotomi stoves clean.

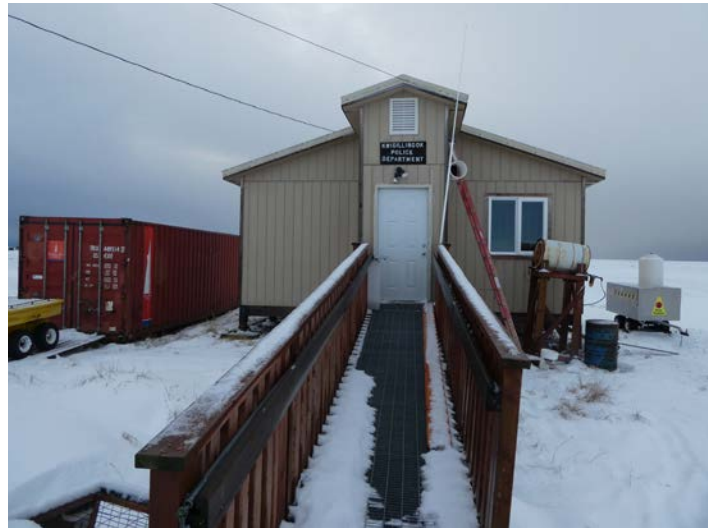
Energy retrofits for the small VPSO building would pay back in a little over a year.

1. Program the Toyotomi stove to set back the temperature during unoccupied hours and check the settings after every power outage.

Other recommendations include implementing a heating temperature unoccupied setback to 65° Fahrenheit throughout, add occupancy sensors to bathroom light, and replace existing lighting throughout with LEDs.

If the Tribe is able to implement all recommendations, the annual energy use would decrease by 3.3 MBTU, resulting in an energy and maintenance savings of **\$444**. At an approximate installation cost of \$540, the simple payback of a retrofit project would be **1.2 years**.

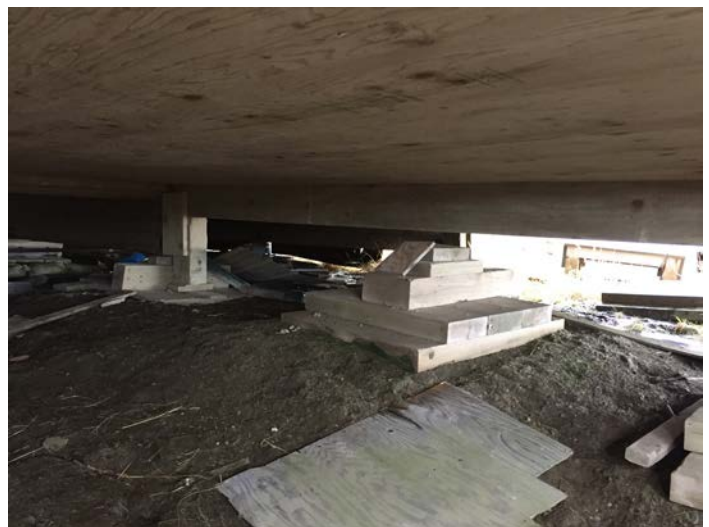
During the monthly walk around the exterior of the bunkhouse, be sure to note if there has been further movement of the foundation, which could exacerbate the current safety issues.

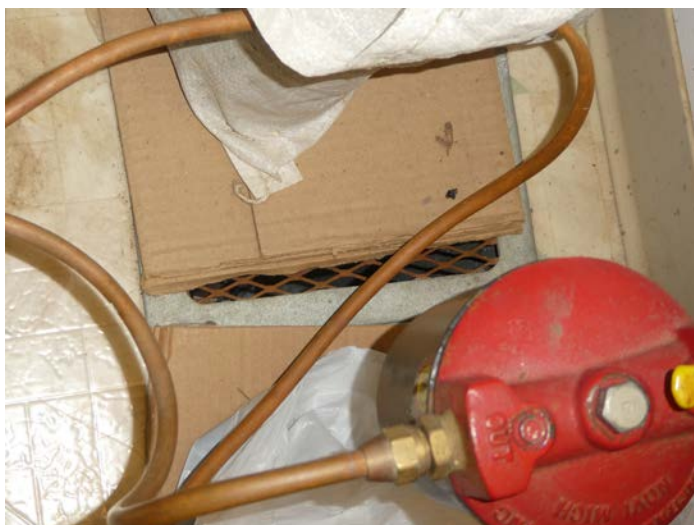
Check that the furnace is not running during the summer. Make sure the air intake for the furnace pictured above doesn't have anything blocking it.

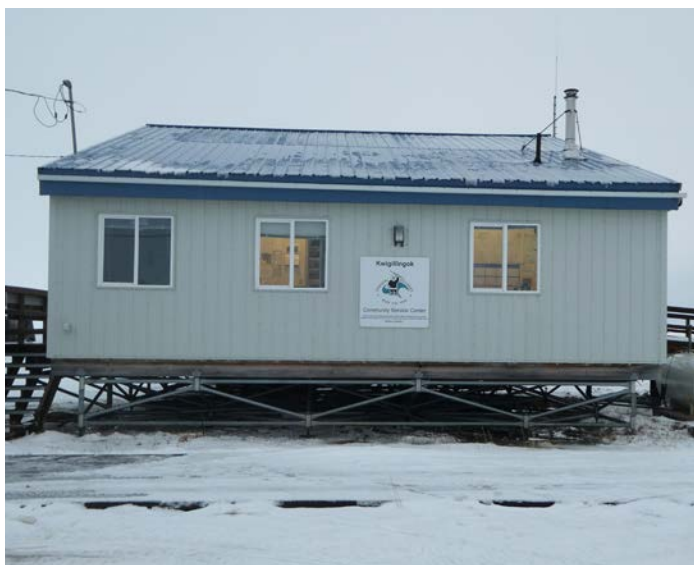
A visual inspection of the building exterior should be done to document any damage to the structure, such as damaged roofing or siding.

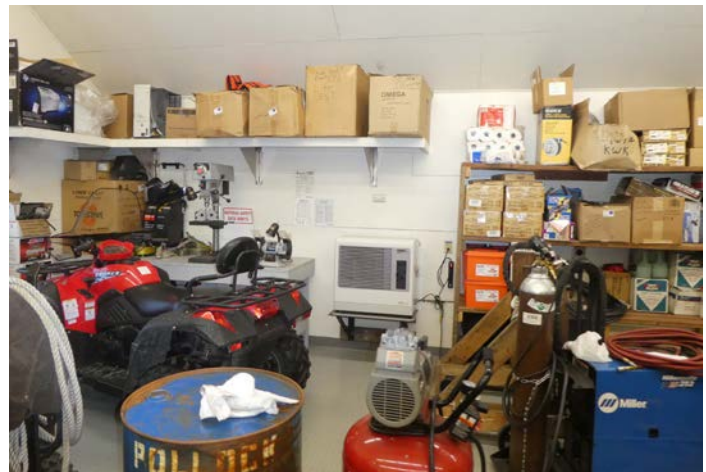
The Toyotomi stove should be checked periodically to ensure that the programmable thermostat is running correctly.

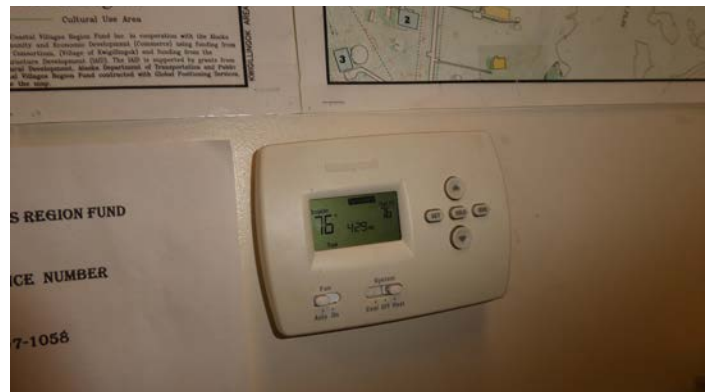
The American Standard's furnace should be checked periodically to ensure that the programmable thermostat is running correctly.

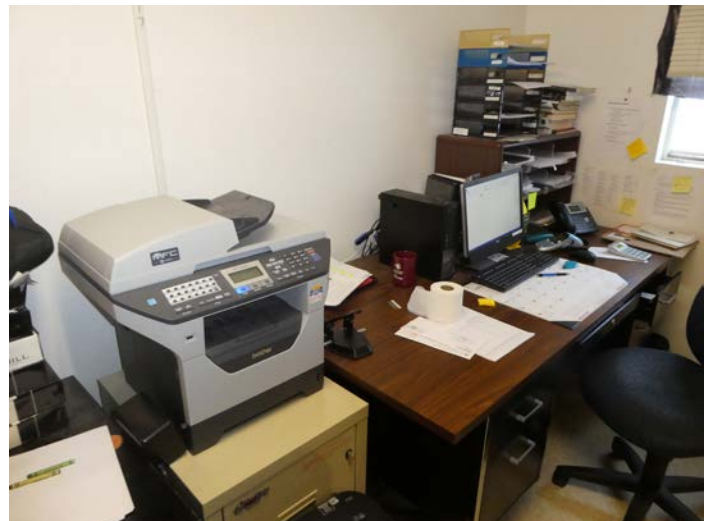
The office equipment should be set up with plug load management devices to ensure that the equipment isn't running while no one is at the office.

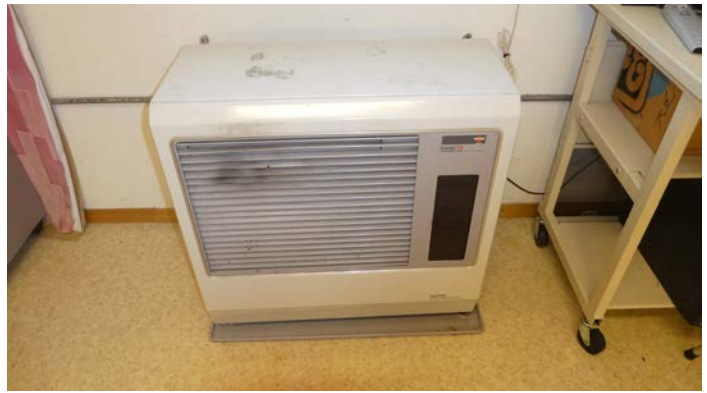
The Toyotomi stoves should be checked periodically to ensure that the programmable thermostats are running correctly.

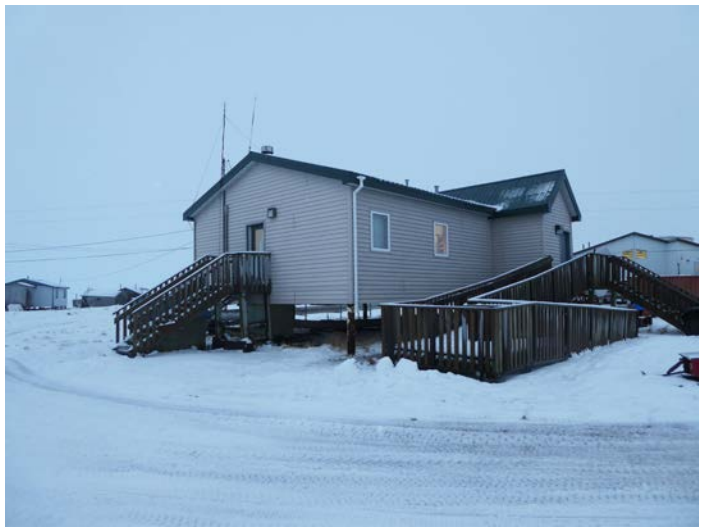
A visual inspection of the building exterior of the post office should be done monthly to document any damage to the structure, such as damaged roofing or siding.

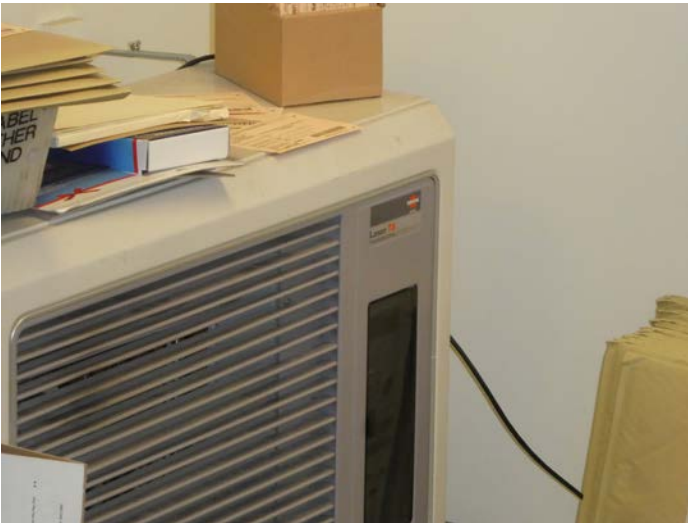
The Toyotomi stove should be checked periodically to ensure that the programable thermostat is running correctly, especially after a power outage.

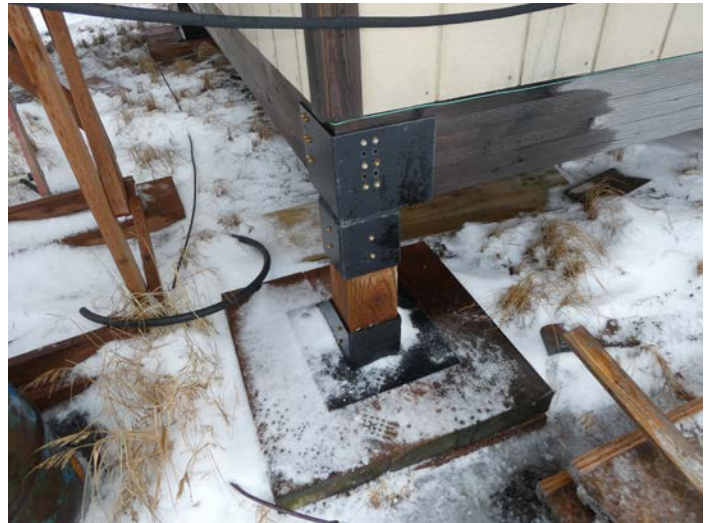
During the visual inspections of the building exterior, check the foundation.

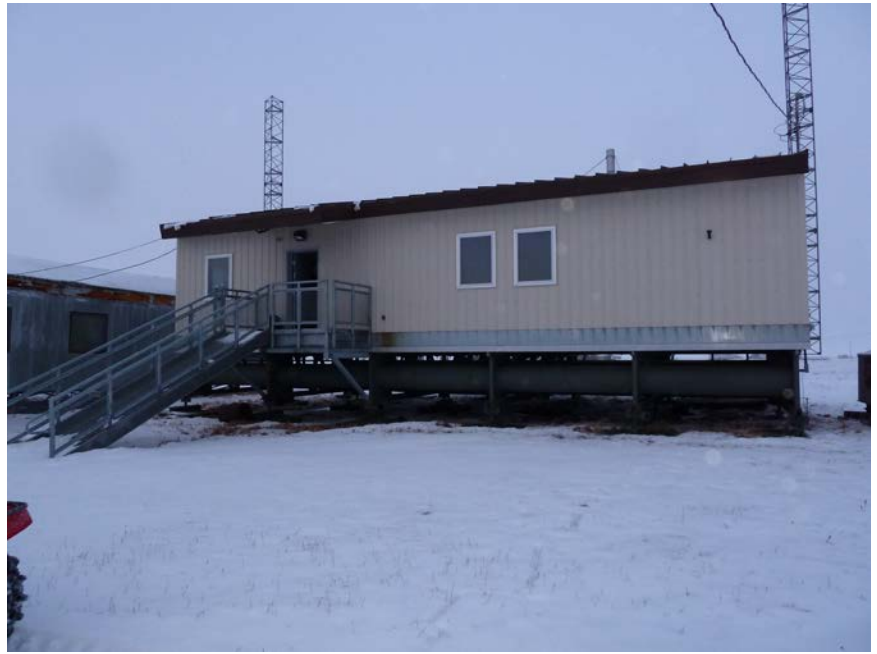
A comprehensive retrofit for the armory would reduce annual energy costs by over \$2000 and pay back in less than two years.

The energy audit includes a list of priorities that are cost-effective and have a fast payback period. Temperature control was one of the highest priority energy efficiency measures (EEMs). Implementing a heating temperature setback of 63 degrees Fahrenheit in the office and open space, during unoccupied hours, would cost \$300 to install and would save \$1,152 per year. This investment would pay off in just 0.3 years.

Improving the lighting is another simple upgrade. Since this building currently uses fluorescent lighting, converting to more efficient LED lighting can provide a significant increase in efficiency. For example, performing this change in the main room, two small rooms, toilet and storage, wall packs, exterior lighting, and INC-A-60W would cost about \$3,205 and save \$1,167 per year. This investment would take only 2.75 years to pay off.

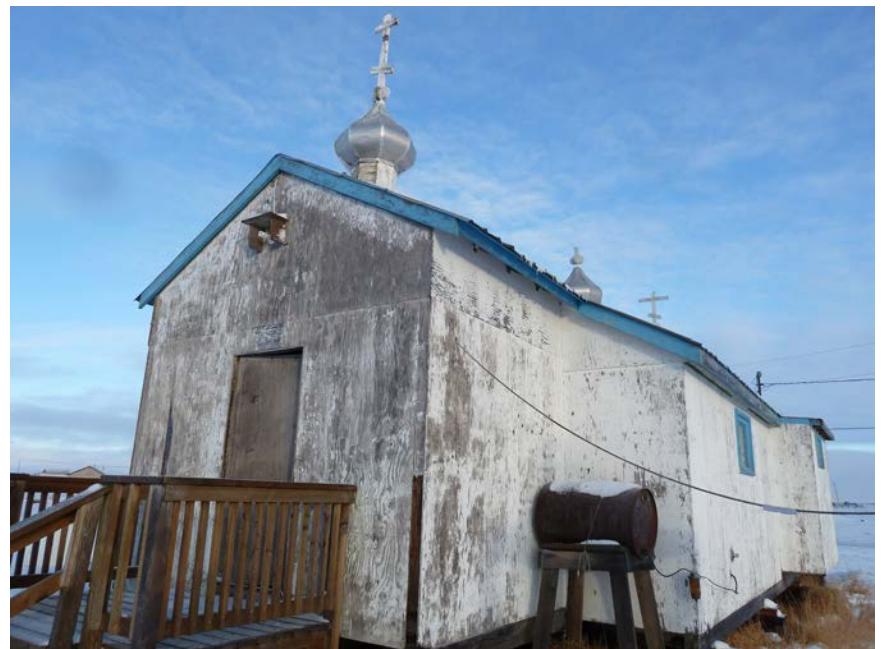
Due to its low occupancy, the only retrofit recommended for the church is a lighting upgrade.

Due to the very low occupancy and usage, the payback periods of improvements to this building are generally longer than their useful life. From a strict financial perspective, only one recommendation is justified.

This energy efficiency measure (EEM) is to replace the INC-A-60W light with an LED 8W Module StdElectronic light. Implementing this measure would cost \$5 and save \$1 annually, paying off after 3.7 years.

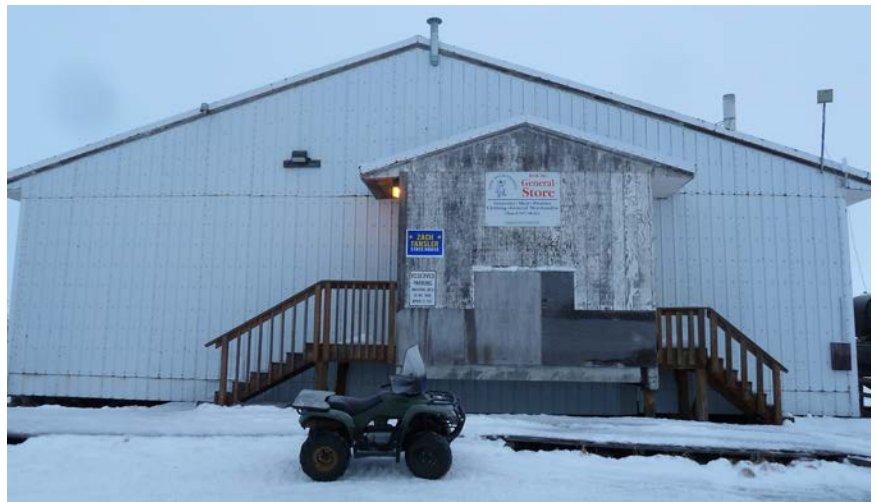
A lighting upgrade is the top recommendation for the store.

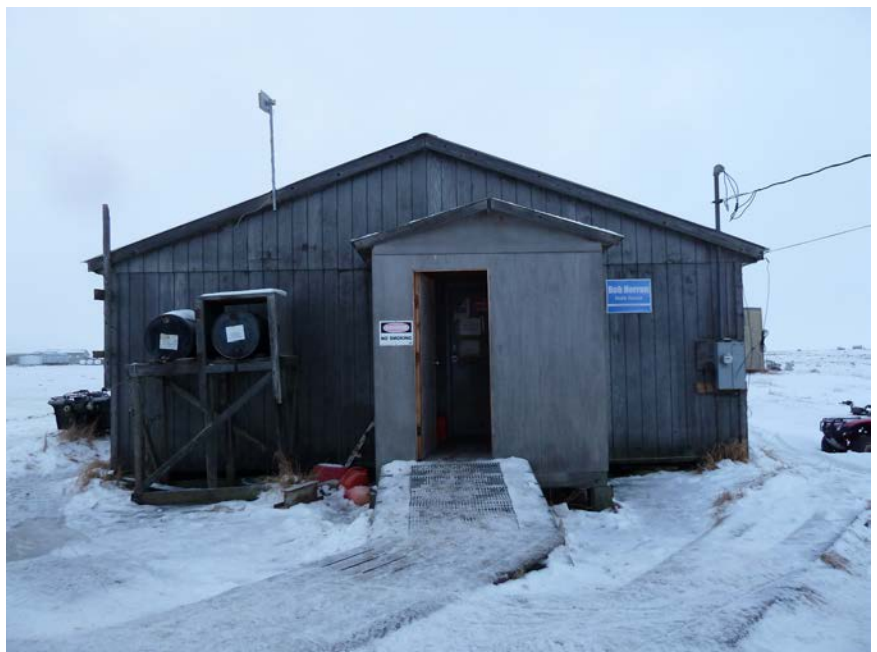
The Marina was constructed around 1995, with a normal occupancy of 2 staff members and 10-15 customers visiting daily. The building is in operation for 4.2 hours on average, every day of the week. The exterior walls of the Marina are constructed with 2"x6" studs and are presumed to have R-19 batt in their cavities. The building is heated by a Monitor 2400 and Norodyne furnace. At current rates, it costs approximately \$7,775

A lighting upgrade and attic insulation would reduce the energy use of the marina building.

Specific ECM recommendations for the Marina included purchasing electronic timers as power strips for large copy/scan/fax machines or other appliances with a sleep cycle. Another recommendation is to Sub-meter, or closely monitor the electric consumption in the shop (and for the entire building) to identify the excessive electric load.

If all of the cost-effective Energy Efficiency Measures recommended in the audit are completed, the annual costs can be reduced by \$1,337. These measures are estimated to cost \$6,251 for an overall simple payback of 4.7 years.
