Improving Indoor Air Quality for Small Alaska Homes

June 2019

Prepared by the Cold Climate Housing Research Center

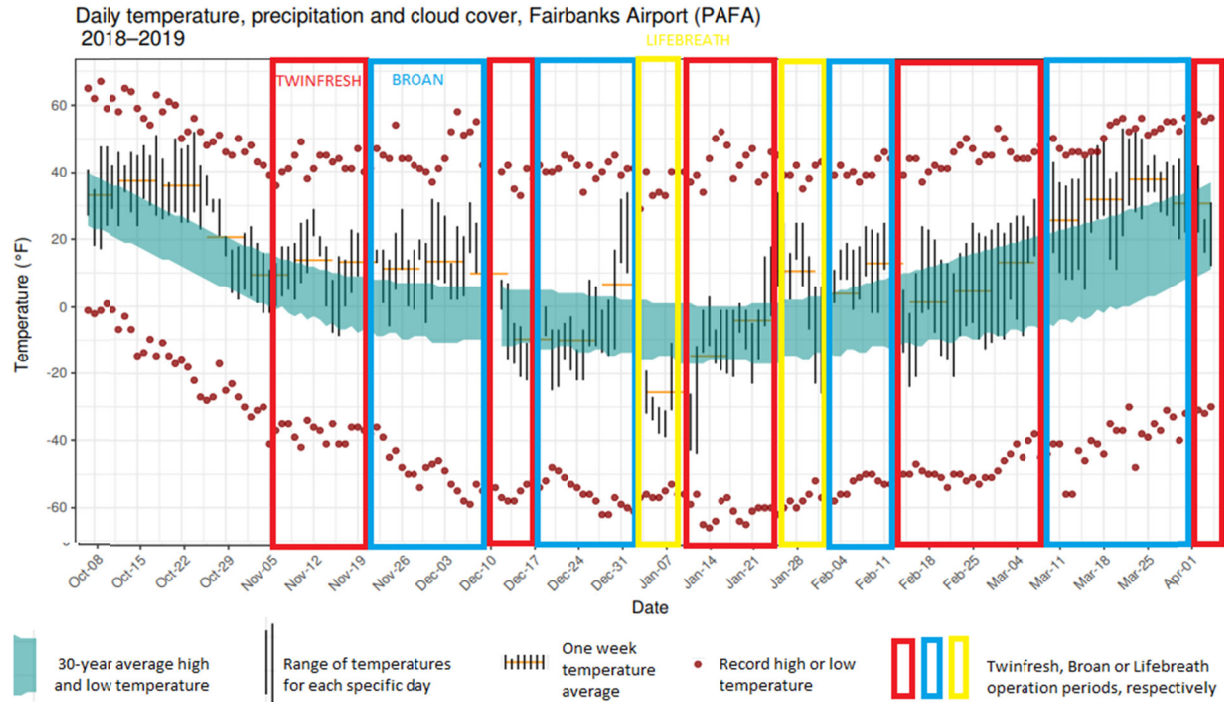
Figure 1. The MTL study period. The Lifebreath unit was running at the coldest outside temperatures and encountered power outages. Adapted with permission from C. S. Swingley. (2019).

All MTL units had the same controlled interior conditions, except for several power outages in January. They ran in the MTL at different times, as shown in Figure 1. Figure 1 also shows the daily outside temperature range during the study.

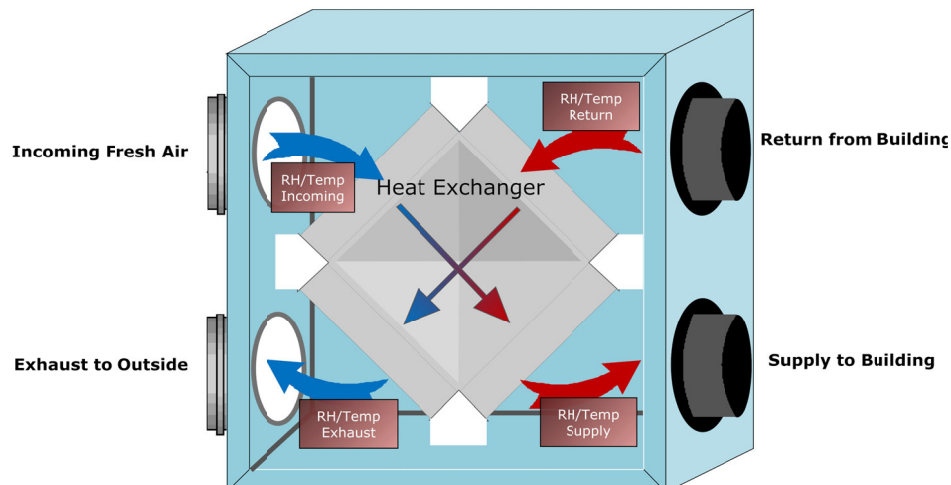
Figure 2. HRV schematic with sensor locations. This naming is repeated in the charts for the MTL HRVs.

The two HRVs in the MTL had the same sensor naming system. Figure 2 presents a diagram of an HRV with the location of sensors.

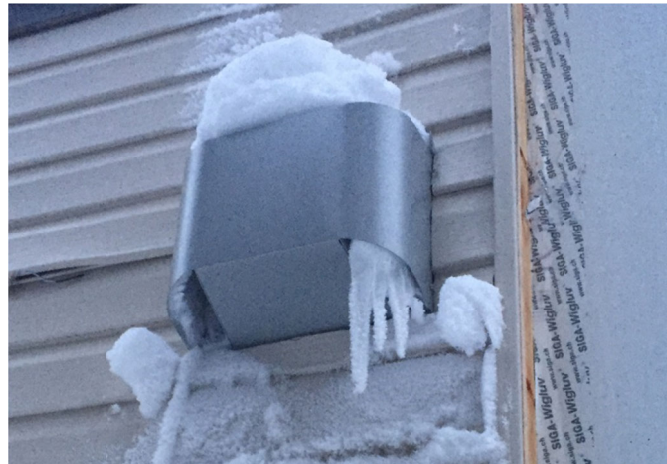
Figure 3. The TwinFresh outside hood. The hood was filled with ice, completely preventing airflow.

The period from November 5-14, 2018 illustrates the normal working conditions of the TwinFresh around the critical temperatures over a period of 10 days. Note that while the core of the unit did not freeze, moisture condensate accumulated in the hood, especially in conditions at or below the crucial zone of exterior temperatures (about 20°F) (Figure 3).

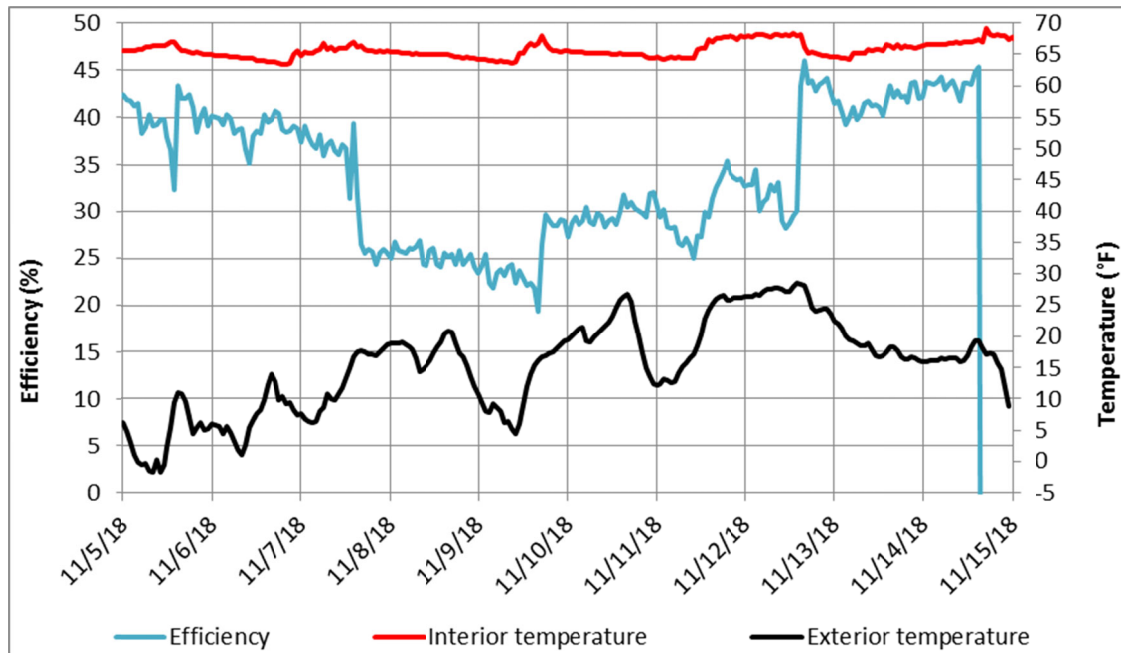
Figure 4. TwinFresh efficiency and surrounding conditions. The drop in efficiency at colder temperatures is an indication of ice blocking air movement.

Figure 4 shows the calculated efficiency with the interior and exterior temperatures. When it was colder than 20°F, icing started to occur inside the exhaust hood. On November 7, the icing passed a critical threshold and began impeding system efficiency. A period where the temperature exceeded 25°F for approximately 24 hours on November 11-12 de-iced the exhaust hood and restored normal airflow. Following November 14, 2018, the temperature fell below 20°F for an extended period and the exhaust hood became fully frozen, blocking airflow; this can be seen in Figure 4 when the efficiency drops suddenly below zero.

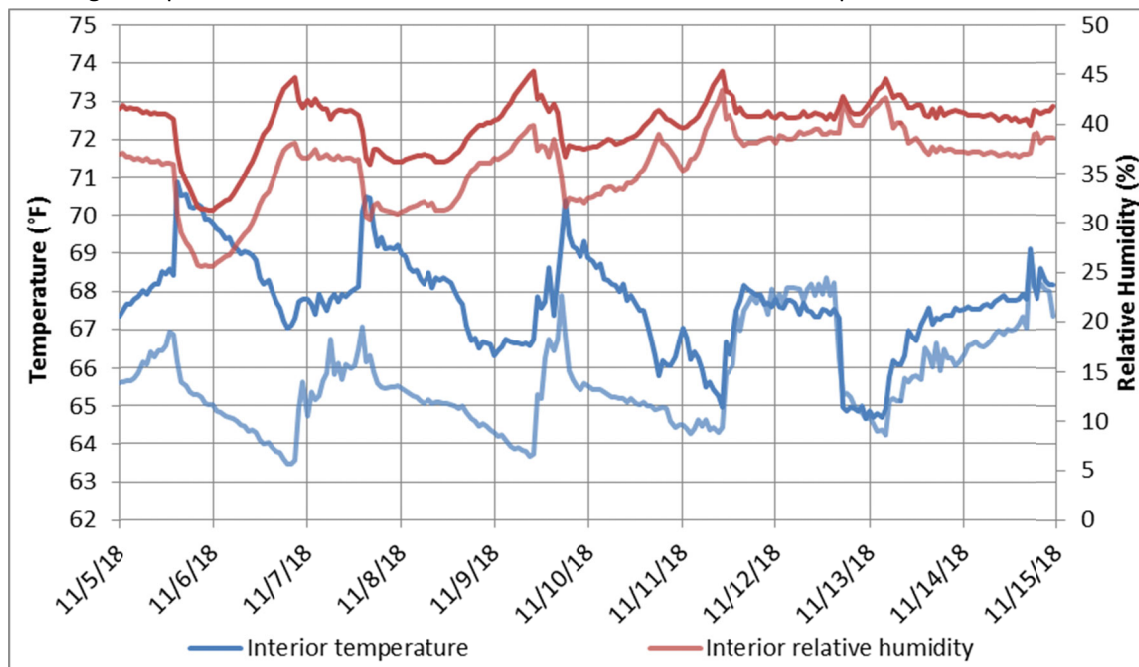
Figure 5. MTL interior conditions. Note the inside temperature stability on November 11 and 12 corresponding to the period when the outside temperature was above 25°F. The two shades of temperature and relative humidity show the variation between the interior sensors, mostly due to placement within the room.

Figure 5 provides a closer view of interior conditions over the same period.

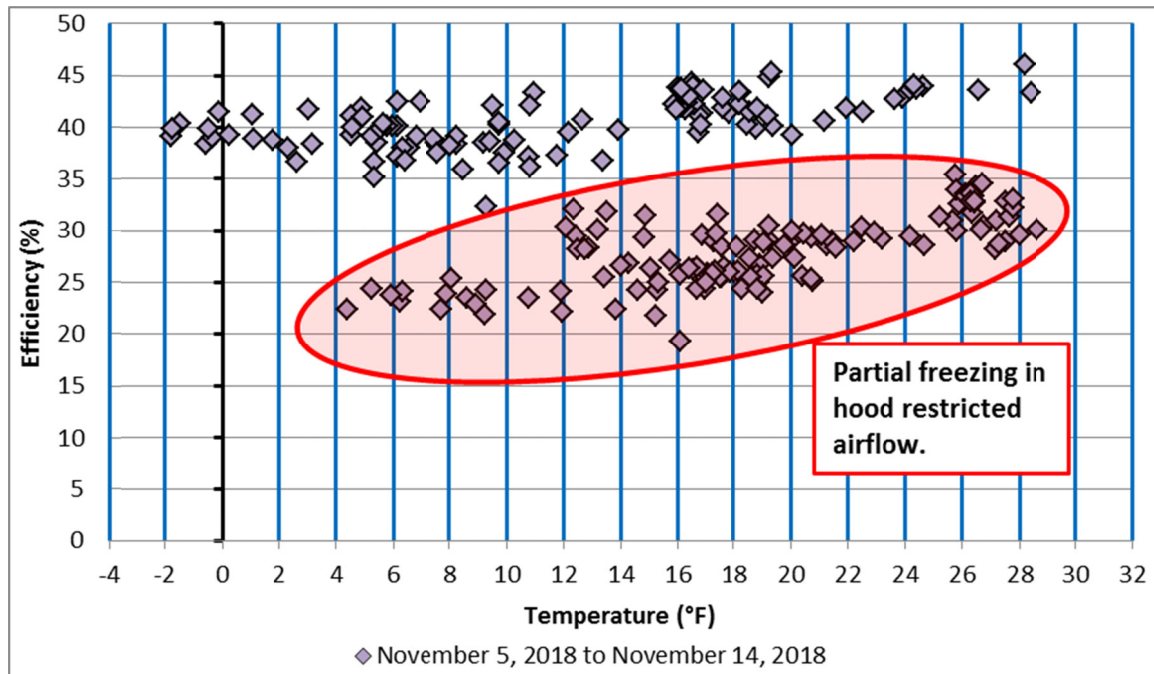
Figure 6. TwinFresh efficiency vs. outside temperature. When the TwinFresh was running as designed, it had a relatively stable efficiency around 40%, much lower than the 82-97% in the specifications.

Figure 6 illustrates data from the period in a different way. By plotting efficiency vs. temperature, two distinct clouds of data emerge. The points of lower efficiency correspond to the period where partial icing of the exhaust hood was identified.

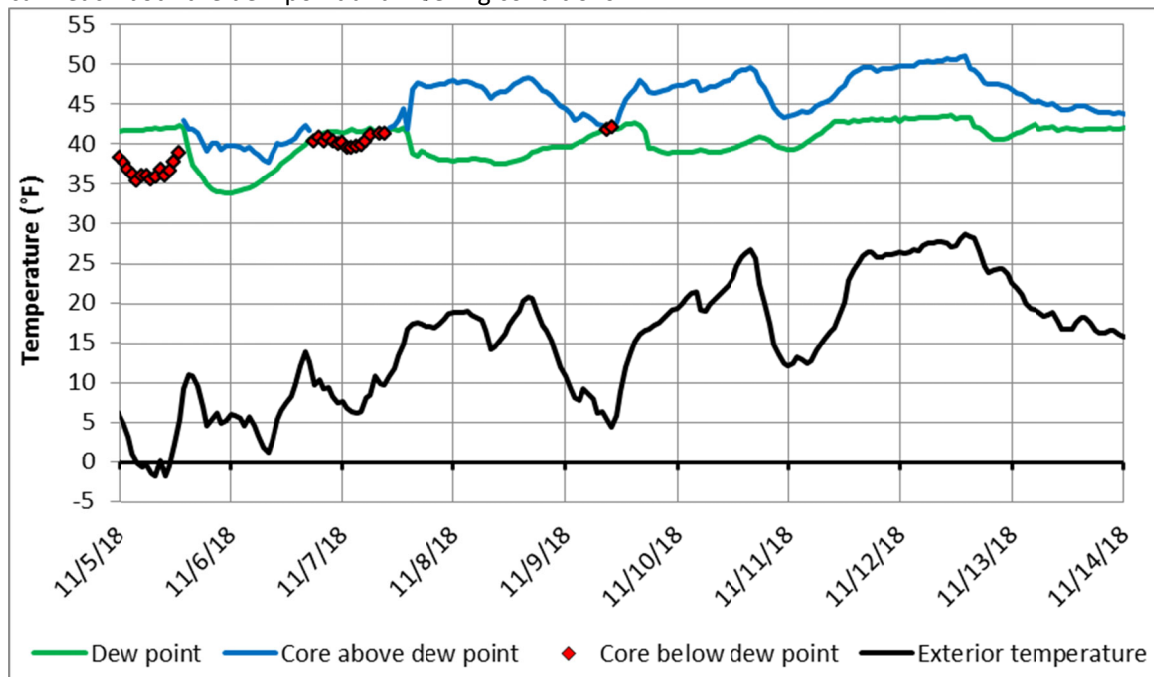
Figure 7. TwinFresh dew point in the core. The core temperature is an estimate based on the average of the inner and outer temperatures around the core.

Figure 7 identifies the periods where the temperature in the TwinFresh core was below the calculated dew point for the interior conditions. Based on the findings, the primary issue with the TwinFresh's performance is the hood design. The hood will ice up and impede airflow before the temperature in the core can reach both the dew point and freezing conditions.

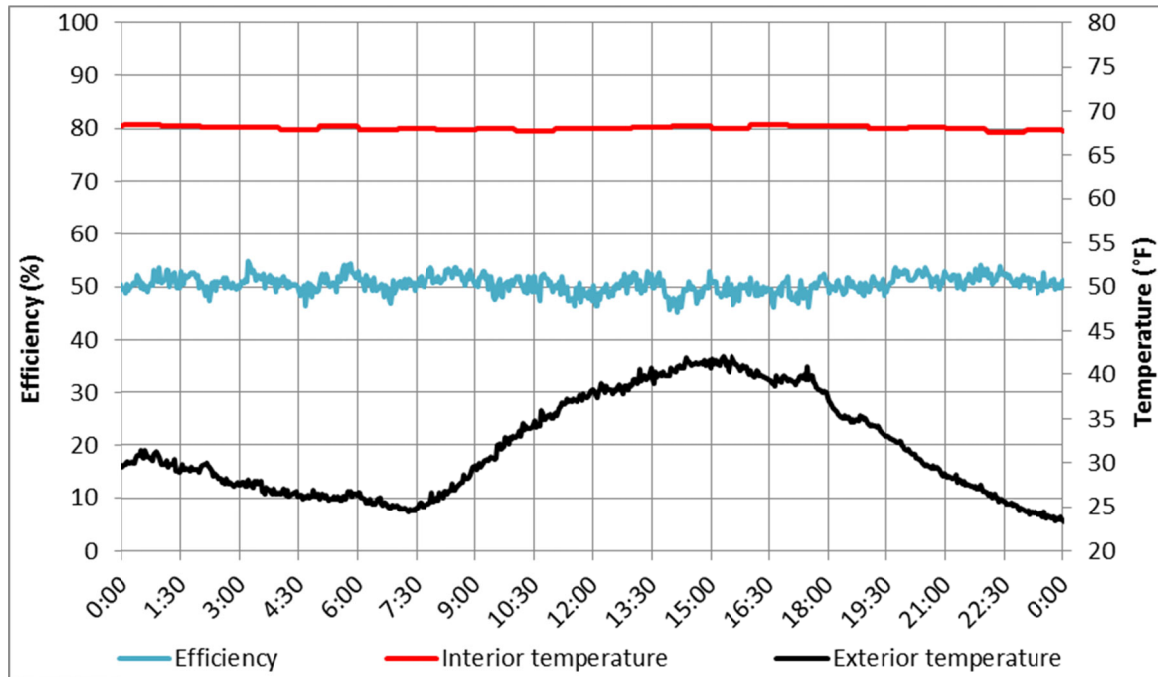
Figure 8. TwinFresh efficiency at warmer temperature. The heat transfer efficiency was constant at 50%, not near the expected 82-97%.

The period on April 2, 2019 shown in Figure 8 illustrates the normal working conditions of the TwinFresh

in ideal temperature conditions. Figure 8 also shows the calculated efficiency with interior and exterior temperatures.

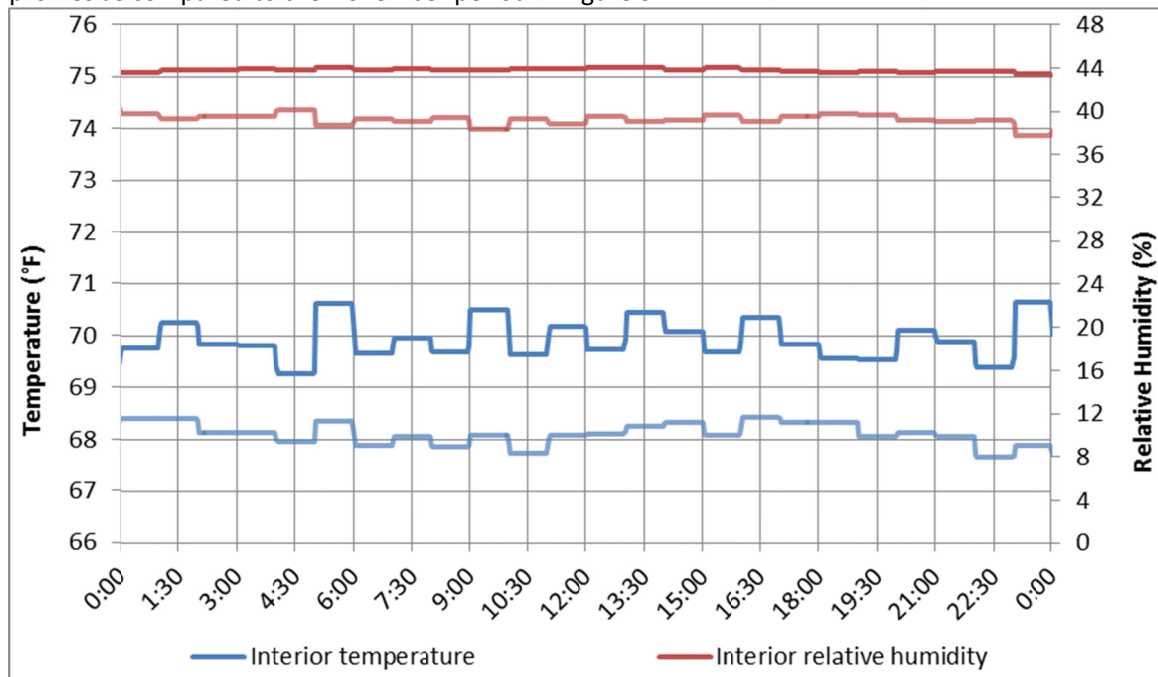
Figure 9. MTL interior conditions on April 2, 2019. The two lines come from different sensors, the variation in readings show less-than-perfect air mixing.

Figure 9 is a closer view of the interior conditions and shows much more stable temperature and RH profiles as compared to the November period in Figure 5.

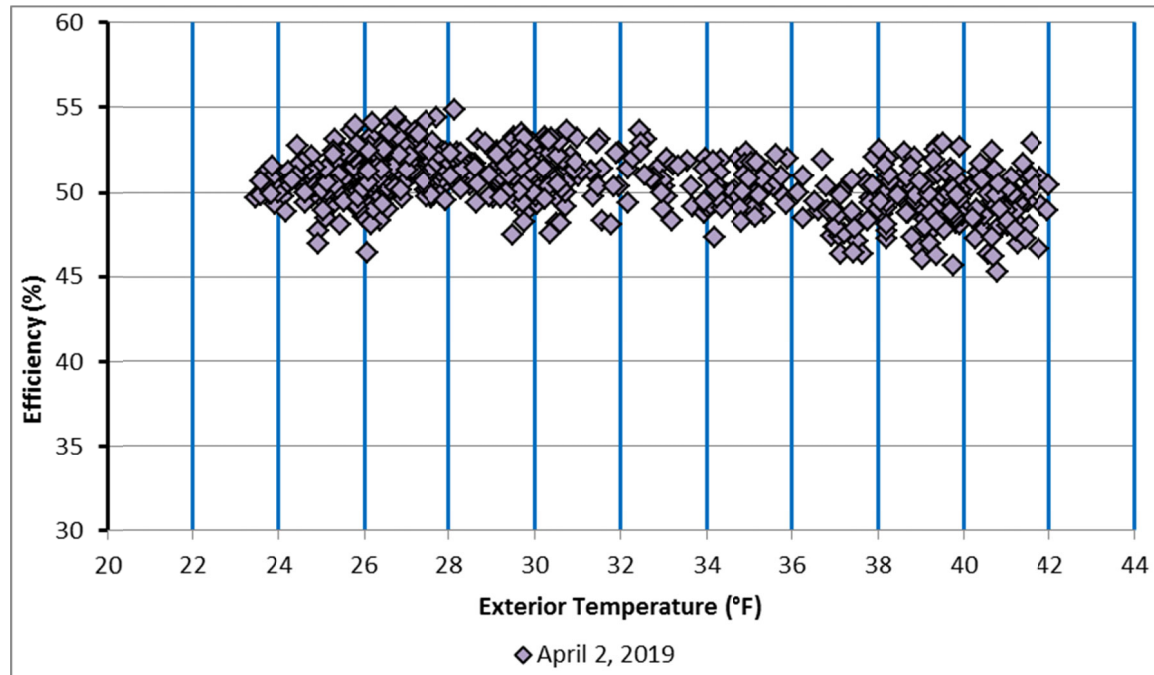
Figure 10. TwinFresh efficiency versus outdoor temperature. The efficiency is consistently around 50% from 24 to 42°F.

Figure 10 shows a single data cloud and a fairly consistent efficiency range. This indicates that abnormal conditions were not affecting the TwinFresh, such as the partial icing observed in the November period.

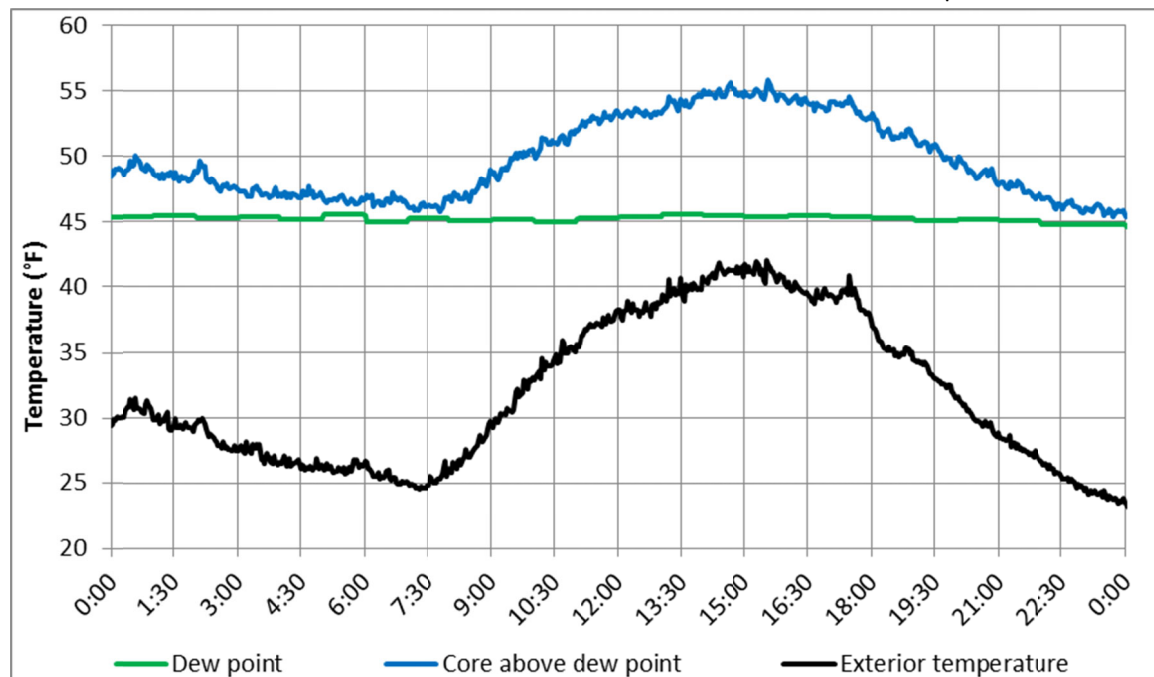
Figure 11. TwinFresh core temperature and dew point comparison for April. The core temperature is an estimate based on the average of the inner and outer temperatures around the core.

Figure 11 shows that the core temperature never fell below the calculated dew point, so no condensation occurred in the core. This is a difference from the colder November period.

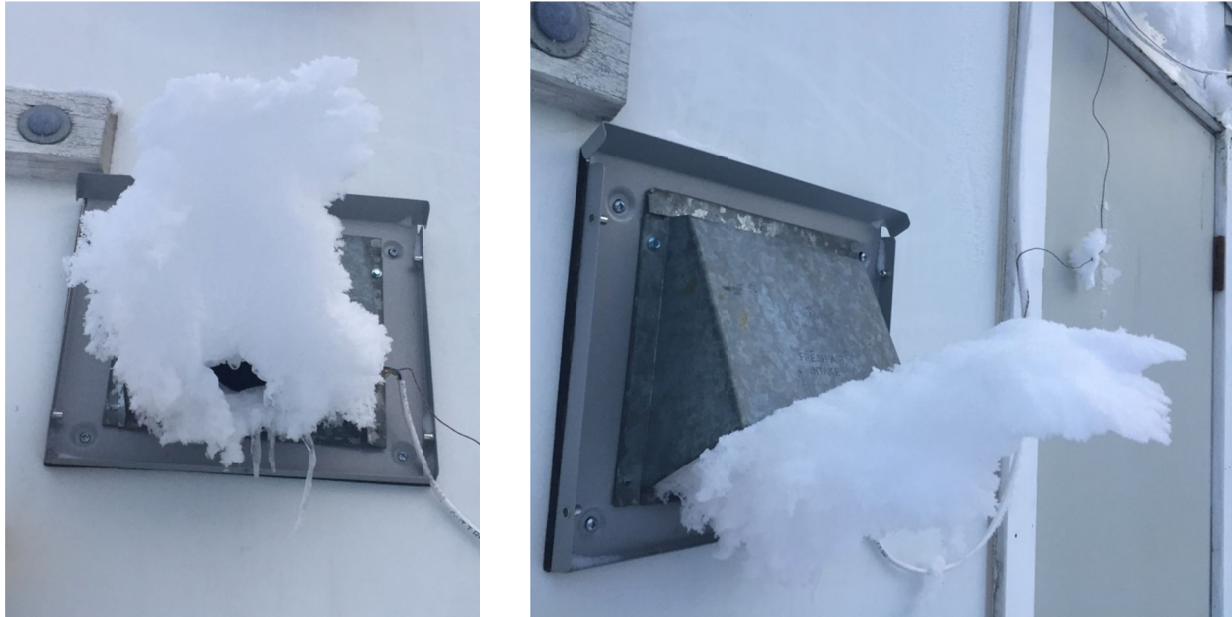
Figure 12. Ice around modified TwinFresh hood. This ice developed over the course of 10 days in January, when the outside temperature averaged -7°F .

Since the manufacturer's exterior hoods froze closed but the cores remained ice-free, different outside hood configurations were implemented. The manufacturer's hood was removed from the north-side unit and left open. The fans and the core developed ice that rendered the unit inoperable within a week. The south side hood was replaced with a typical 6-inch exhaust hood with no damper. The hood did not freeze closed but ice developed around it (Figure 12).

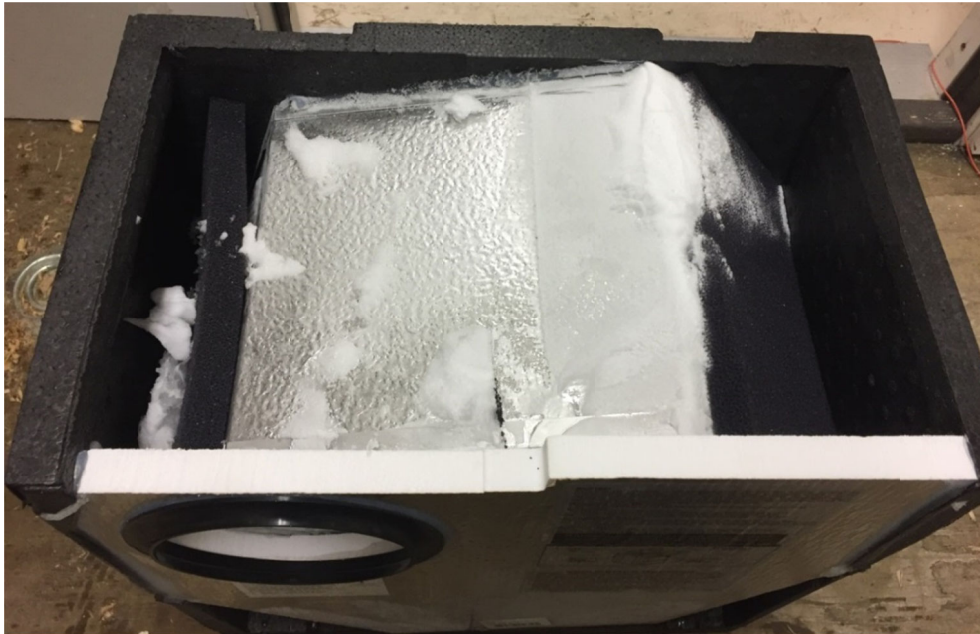
Figure 13. Ice on the top of the Lifebreath core. The black filter visible to the left is frozen to the core and blocks the view of the core.

The Lifebreath RNC4-TPD was installed into the ducted system in the MTL. The unit ran on low speed throughout most of the testing portion of the study. The unit was tested from January 4-9, when it failed. A visual inspection determined there was ice build-up in the unit cabinet and core. CCHRC research staff confirmed with Lifebreath's technical support service that the unit was configured properly for defrost mode to occur automatically. The RNC4-TPD's condensate drain outlets were installed incorrectly, which inhibited the release of condensate before the condensate froze. This exacerbated the freezing problems of the unit. Unfortunately, this was not corrected prior to the second test run. The ice from the unit was melted and measured at 0.75 liters. Figure 13 shows the ice on the top of the HRV core.

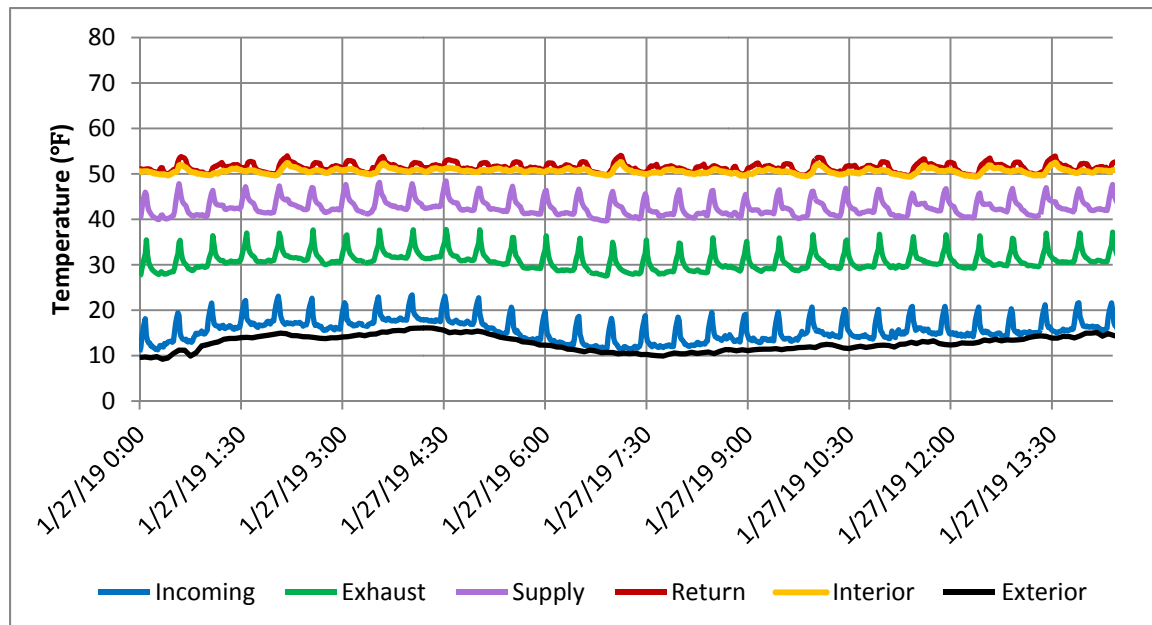
Figure 14. Temperatures in the Lifebreath air streams and MTL conditions. The location names correspond with Figure 2.

Figure 14 and 15 show the temperatures and relative humidity entering the Lifebreath core from all four sides compared to the MTL inside and outside temperatures. The defrost cycles can be observed as spikes in the data for the supply air, exhaust air, and incoming air; they occur roughly every 15 minutes. Exterior temperatures averaged 21.1°F during this test period.

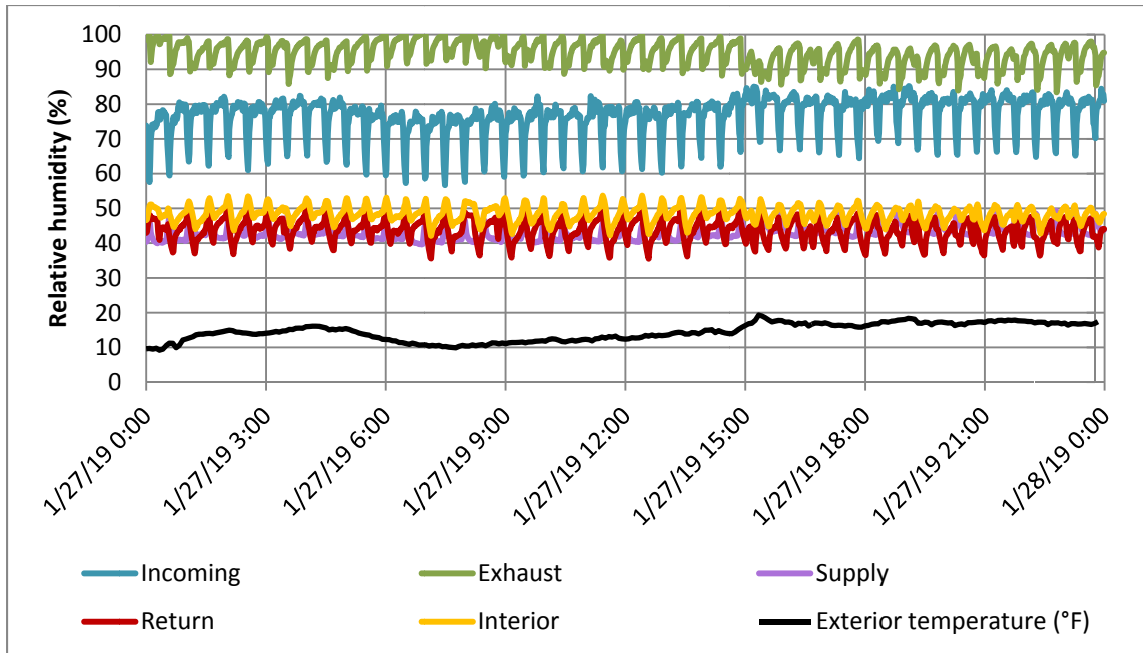
Figure 15. Relative humidity in the Lifebreath air streams and MTL conditions. The location names correspond with Figure 2.

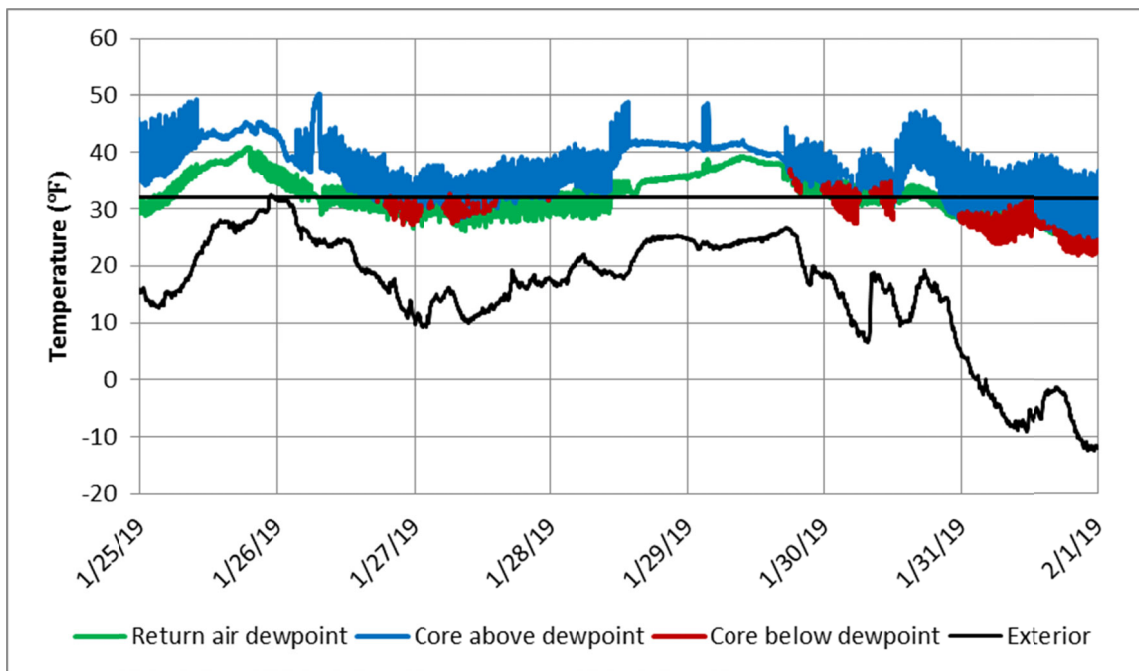
Figure 16. Lifebreath exhaust and return air temperatures. This demonstrates periods when the HRV core was above or below the dew point with respect to the exhaust air stream. The instances of condensate freezing potential increased from January 30 until the HRV ultimately ceased operation on February 1.

Figure 16 shows when the temperature in the core was in danger of condensing and freezing. The 40% humidity inside the MTL created the worst-case scenario for condensation in the HRV. The dew point line is based on the interior conditions and is higher than typical because of the high humidity. Ice developed in the core where the red dots occurred below the freezing line. Toward the end of this period, the defrost cycles were not keeping up with the ice formation and the HRV failed.

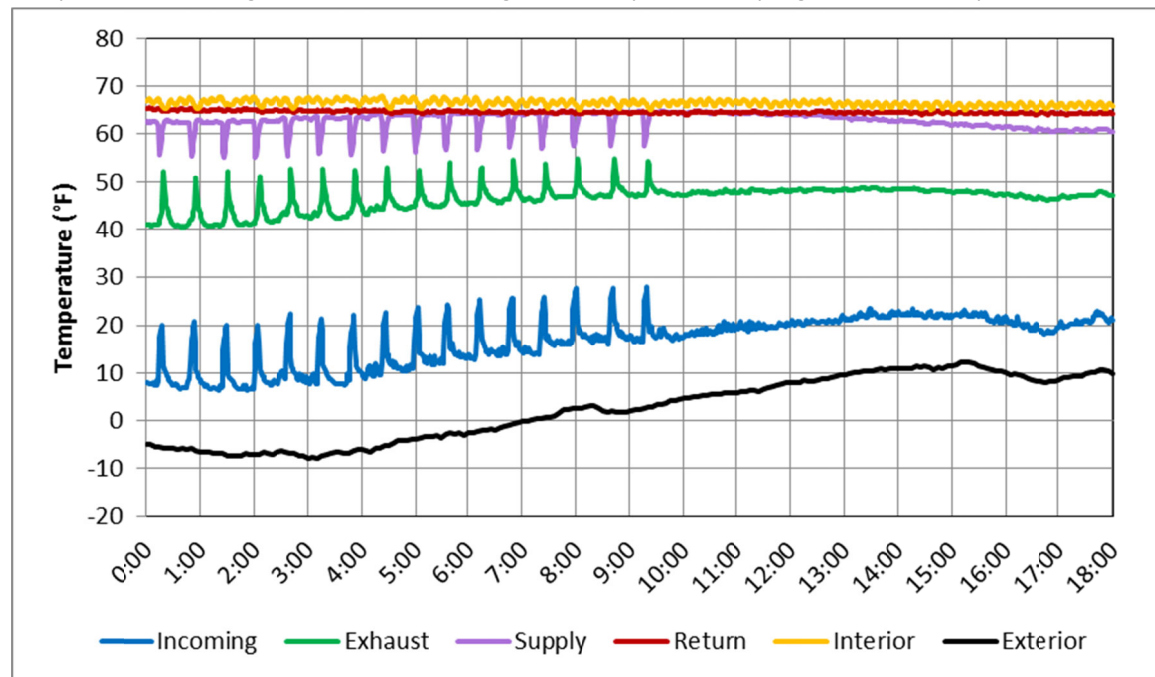
Figure 17. Temperatures in the Broan system on 12/30/2018. The incoming air from the outside (blue) is warmed in the duct slightly before reaching the Broan unit. There, the heat exchange from the return air warms that stream further, so the supply air into the room (purple line) is not too different from room temperature. The heat being removed from the room (return, in red) is room temperature; however it transfers some of its heat to the incoming air so that by the time it is exhausted outside (in green) it is cooler than room temperature. The location names correspond with Figure 2.

December 30, 2018 data for the Broan is shown in Figure 17. The figure shows the temperatures in the four air streams by the Broan unit together with the outside temperature and room temperature. The defrost cycles can be seen as spikes in the data until the outside temperature rose above 0°F. The data shows that the Broan successfully defrosts. The exhaust temperature is warm when compared to the exterior temperature showing that the heat exchange efficiency is not very high for this time period.

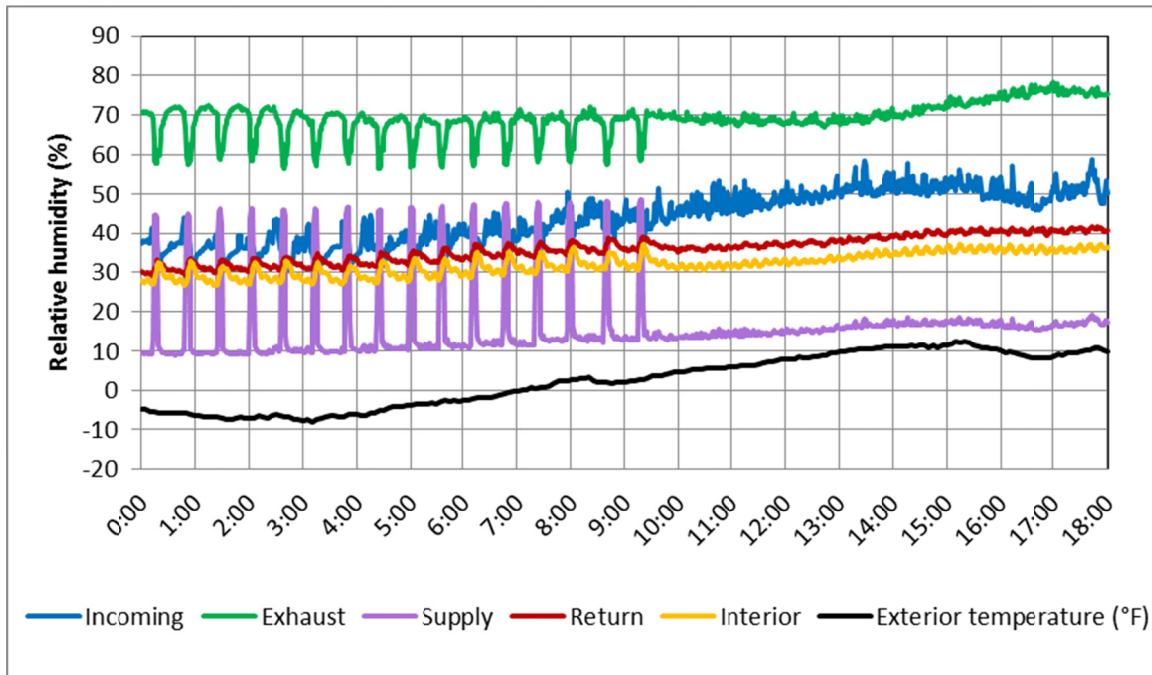
Figure 18. Broan system relative humidity on 12/30/2018. The location names correspond with Figure 2.

The relative humidity in the four air streams as well as the room is shown in Figure 18. The HRV does not recover moisture, which is apparent in the low humidity in the supply air to the building. Most of the moisture in the 30-40% humidity room air is exhausted outside in the exhaust air stream (70-80% humidity when not in defrost mode). An energy recovery ventilator (ERV), which can recover some moisture, would

alter this graph slightly.

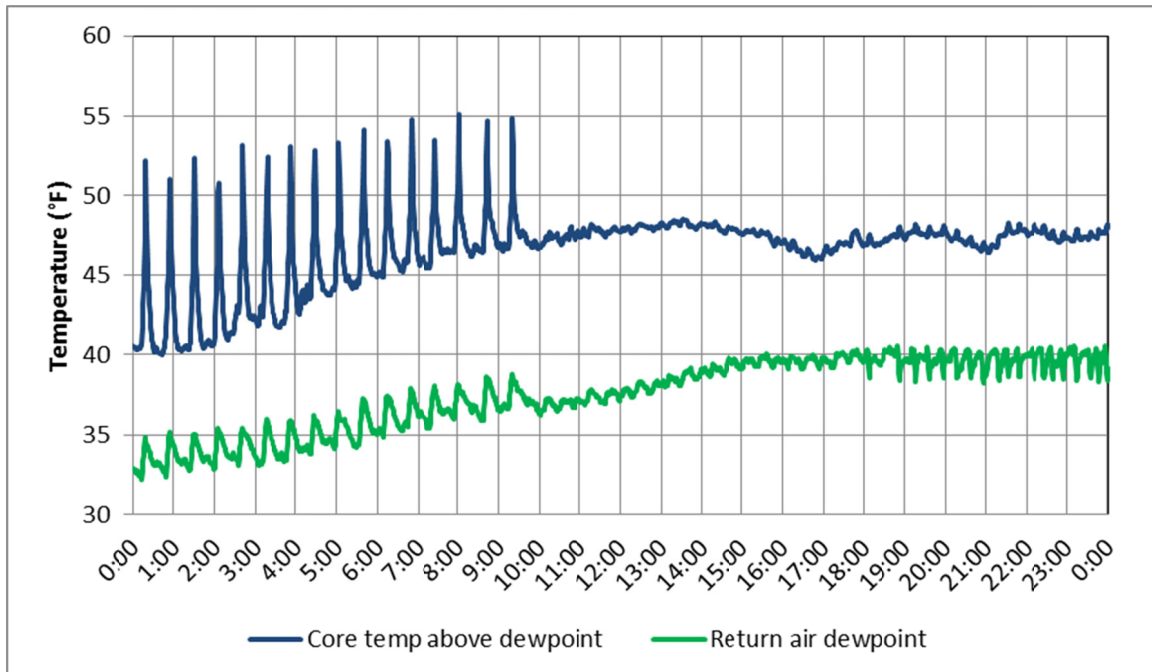
Figure 19. Temperatures in the Broan for December 30, 2018. The calculated dew point of the return air is shown, as well as the temperature of the exhaust (core).

For the same time period, the dew point of the return air is shown in Figure 19, together with the core temperature (which is actually the exhaust temperature, the coldest part of the exhaust stream). During this period, the HRV core temperature remains well above the calculated dew point, indicating that the air in the core is not likely to condense.

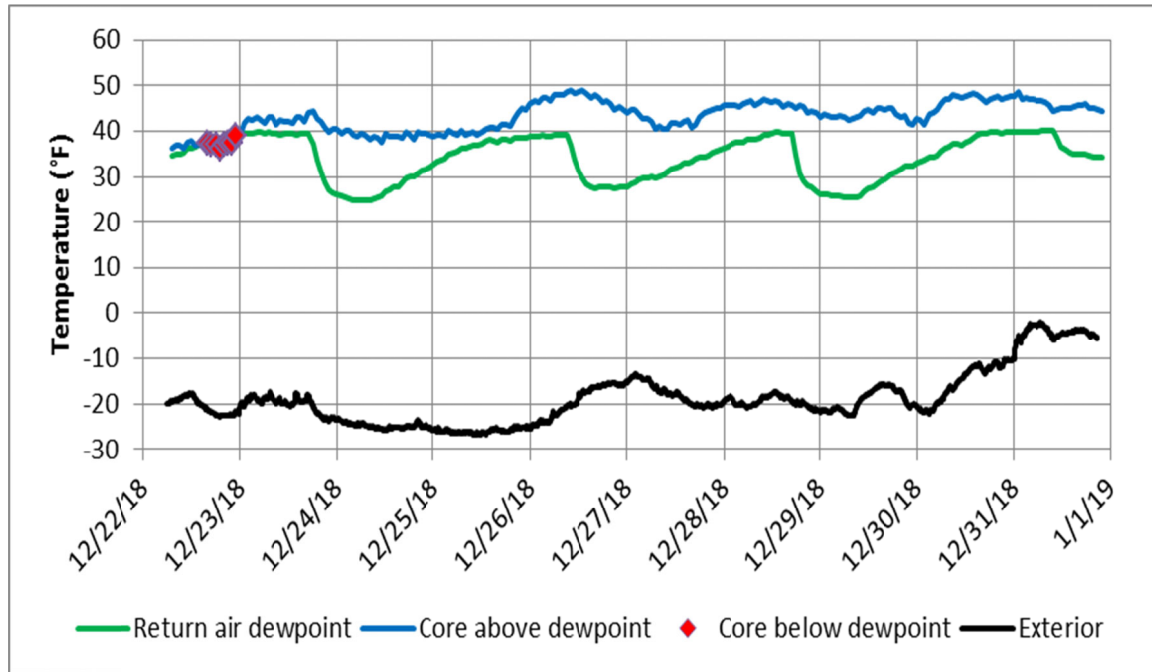
Figure 20. The freezing potential for the Broan HRV core. Even though the exhaust (core) temperature dipped below the dew point a few times, the exhaust (core) temperature was always above freezing in this period so there was no freezing potential.

A somewhat different picture emerges from the same data taken approximately a week earlier, shown in Figure 20. During that time, the exhaust (core) temperature dropped below the calculated dew point at certain points.

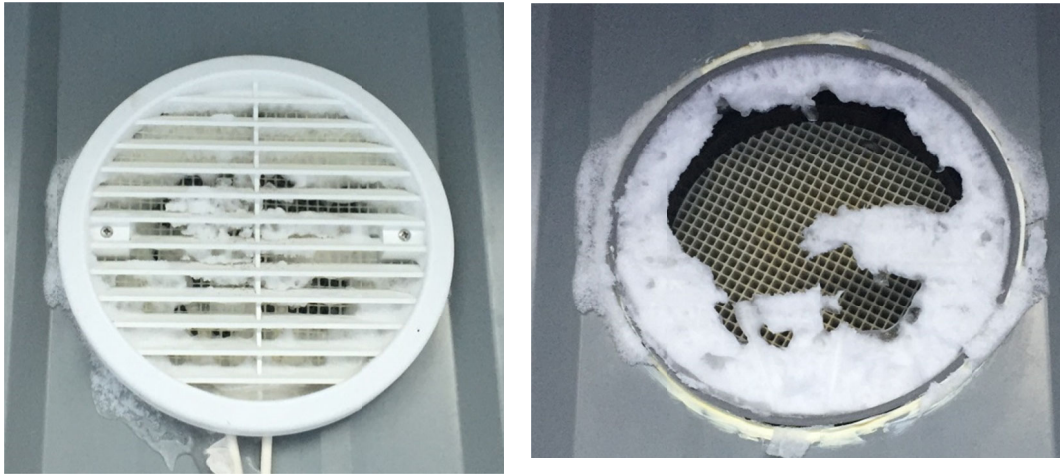
Figure 21. Lunos E2 exterior hood. Ice developed around the outer vent, but it did not extend to the core and did not cut off air supply.

This unit did not freeze closed during this study. However, the exterior vent did collect significant ice (Figure 21). Some of this could be explained by the temperature sensor installed against the grill, which may have been blocking some of the flow.

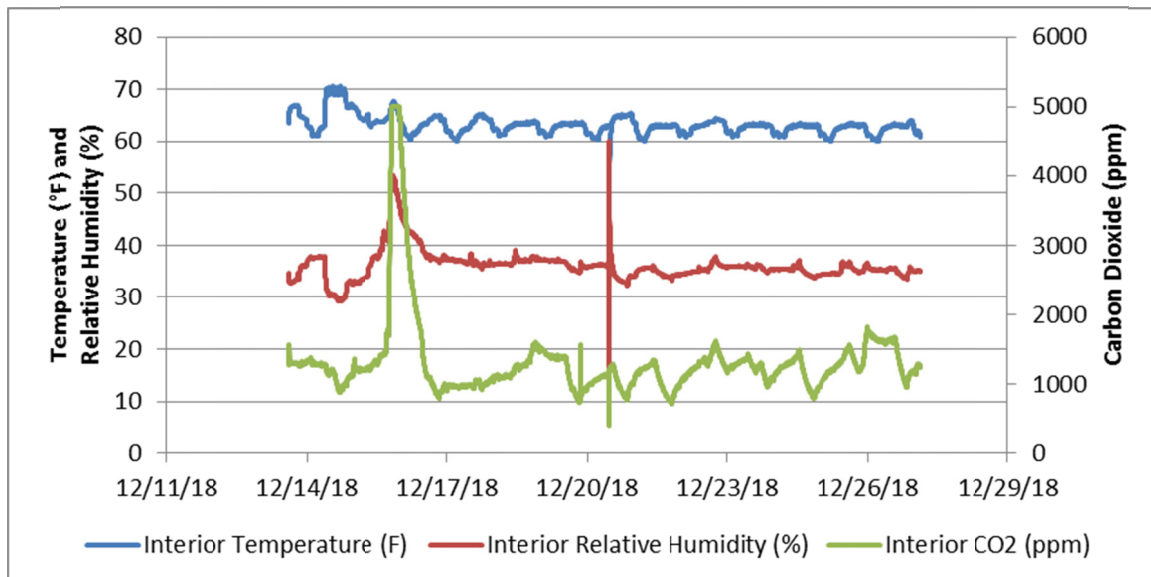
Figure 22. Lunos E2 interior conditions over a 2-week time period. Note that the spike in relative humidity on December 20th is an error.

Figure 22 displays the interior conditions for the E2 home. The interior temperature appears to remain constant around an average temperature of 67°F during the tested time period. A healthy range in relative humidity, but lower than 40%, is achieved by the Lunos E2 with the exception of the readings on December 15. Both relative humidity and interior CO₂ experienced an increase during this time as a result of the homeowner hosting a party. It is unknown how many guests were in the home, but it was enough to produce the maximum level of carbon dioxide (5000 ppm) that the data logger could read. Shortly after the party, it did not take long for the ventilation system to correct for the high levels in relative humidity and carbon dioxide.

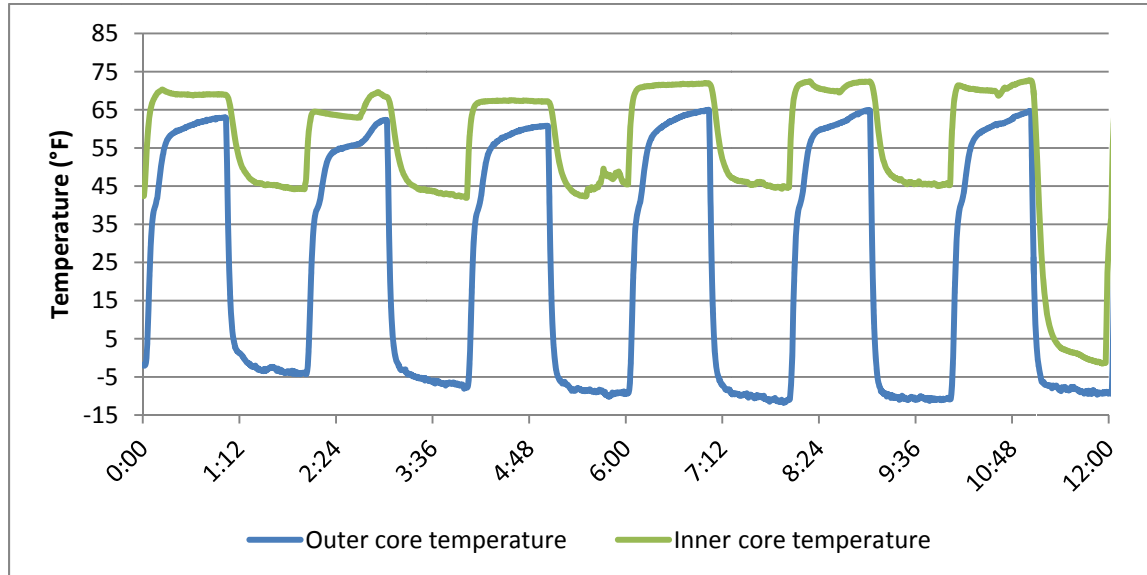
Figure 23. Downstairs E2 conditions on 12/17/2018. The alternating supply and exhaust cycles are readily apparent.

Figure 23 shows the inner and outer temperatures for the downstairs E2 unit. The 70-second cycles are apparent in the changes in temperature. There is a certain amount of heat recovery visible in the inner core temperature; it does not drop much below 45°F when the outside air (at 0°F or colder) is entering the space.

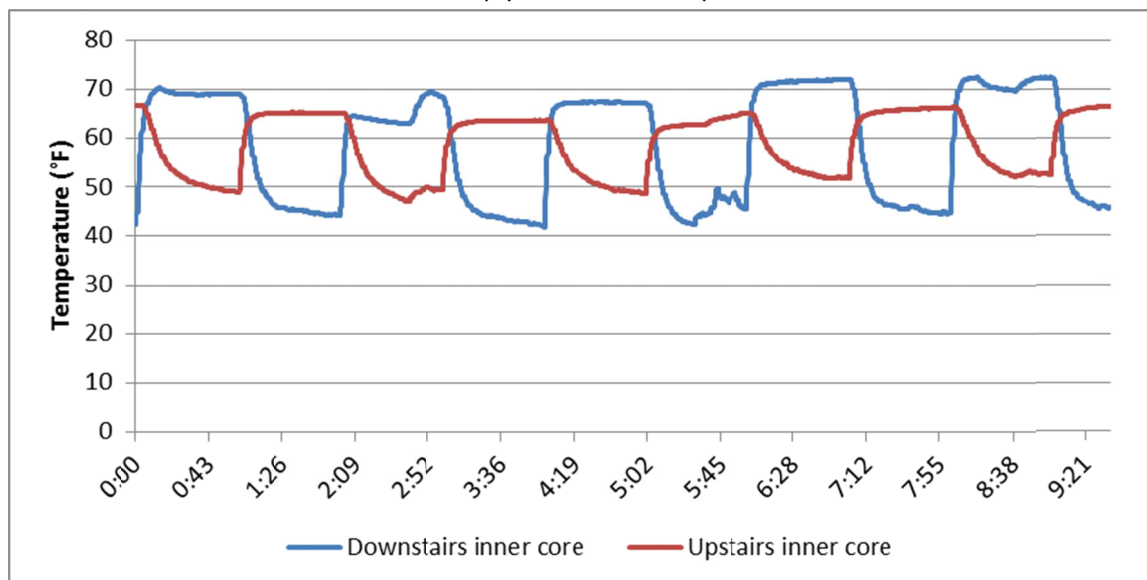
Figure 24. Both E2 units cycling on 12/17/2018. There is very little difference in the lowest and highest temperatures in each unit (about 6°F).

Figure 24 shows the inner core temperature for the upstairs and downstairs E2 units. They are well synced in their exhaust and supply cycles. The downstairs unit is warmer than the upstairs unit, which could be due to variation in airflow or could simply be in a warmer part of the house.

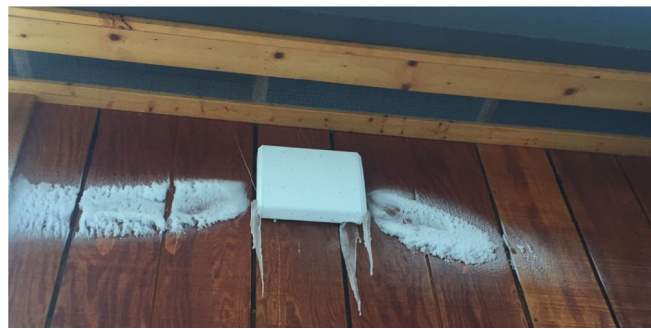
Figure 25. The Lunos Ego exhaust hood at the end of the data collection period. This hood remained free of ice during the data collection period mainly due to warmer-than-typical temperatures.

While this unit did not freeze during the test, the homeowners reported frequent freezing during the previous winter. Based on the tests of the TwinFresh in the MTL, it is likely that the exhaust hood on this unit freezes and the core remains mostly free of ice (Figure 25).

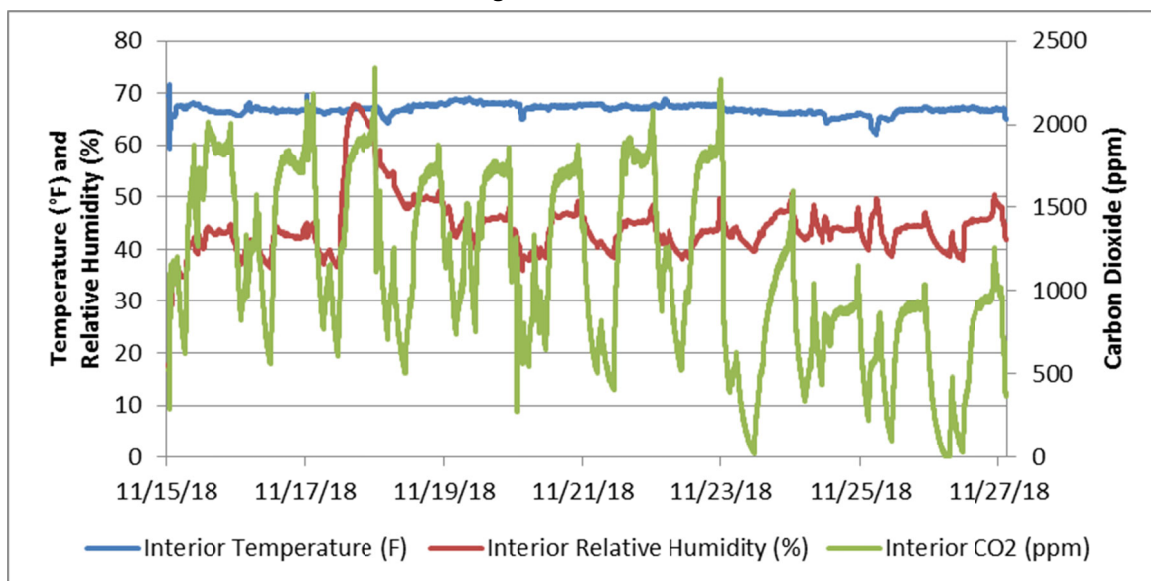
Figure 26. Lunos Ego interior conditions. The spike in relative humidity on 11/18/2018 is unexplained but is probably the result of occupant behavior.

Figure 26 shows the interior conditions during the Lunos Ego study period. The CO₂ is elevated when the building is occupied. The CO₂ should ideally be below 1200 ppm. In this house the CO₂ is consistently above 1200 ppm, indicating the house is not getting enough ventilation. The relative humidity is also higher than a typical Fairbanks house (around 20%), averaging 45% most of the time. There is limited data on the ventilator performance due to the restrictions on collecting data outside of this home.

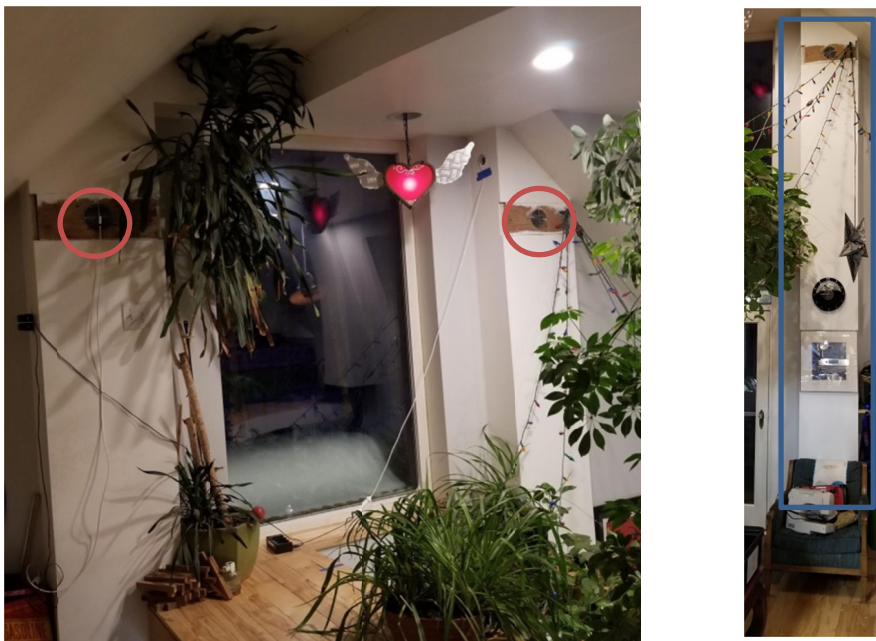
Figure 27. Supply openings. On the left are the two supplies near the ceiling circled in red. The right photo shows the full length of one of the supply ducts (outlined in blue).

This home had an exhaust fan with tempered make-up air vents with recirculating fans in them. The system was designed by Robert Crosby (2001) for prototype homes in Dillingham, Alaska. This whole-house ventilation system relies on an exhaust fan (typically a bath fan). For make-up air, it has in-wall ducts that bring in air from outside and temper it with inside air (Figure 27). The tested system had two make-up air ducts with small fans installed, each blowing 11 CFM of air into the space, however it is uncertain how much was fresh air. The only exhaust is the fan on the pellet stove and the intermittently used kitchen range hood (the range hood backdrafts the pellet stove when in operation).
