Improving Indoor Air Quality for Small Alaska Homes

June 2019

Prepared by the Cold Climate Housing Research Center

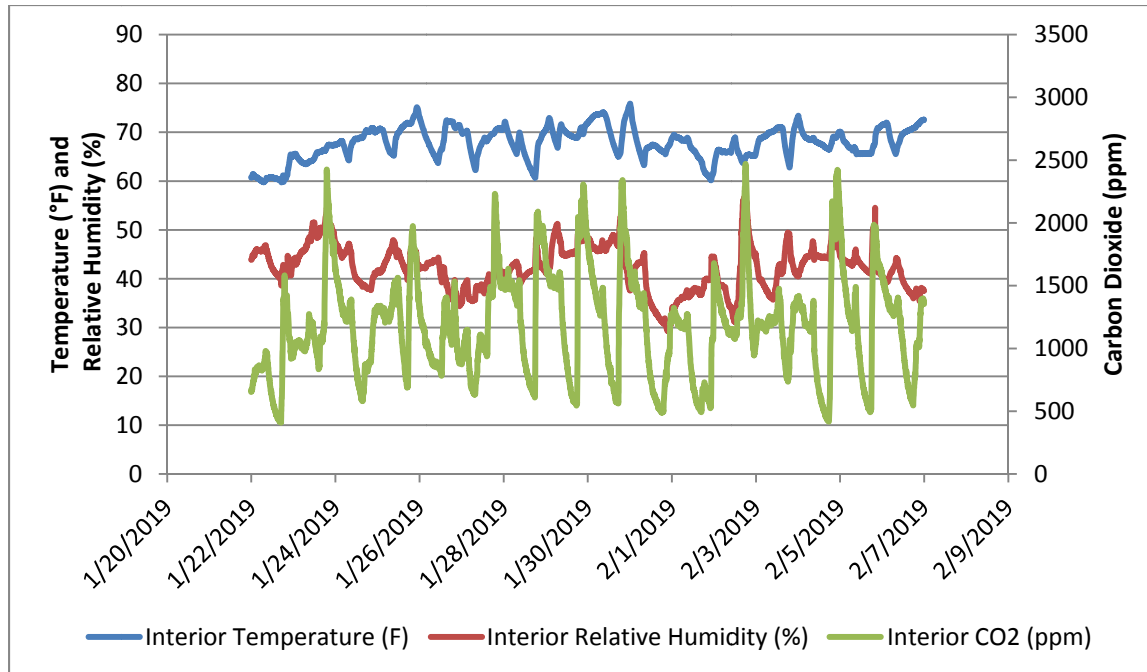
Figure 28. Exhaust system house interior conditions. The high CO₂ indicates a lack of adequate ventilation. The house is humidified.

The current ventilation strategy is not adequate to maintain healthy indoor air. Figure 28 shows indoor air conditions over the course of the study. The CO₂ reached above 2000 ppm when the house was occupied. In order to know if IAQ is healthy, the CO₂ should be below 1200 ppm when occupied. High CO₂ is an indication of high concentrations of other indoor pollutants, not just CO₂. The relative humidity is high for a Fairbanks house with an average of 41%; however, it is within the recommended healthy range (Sterling et al., 1984).

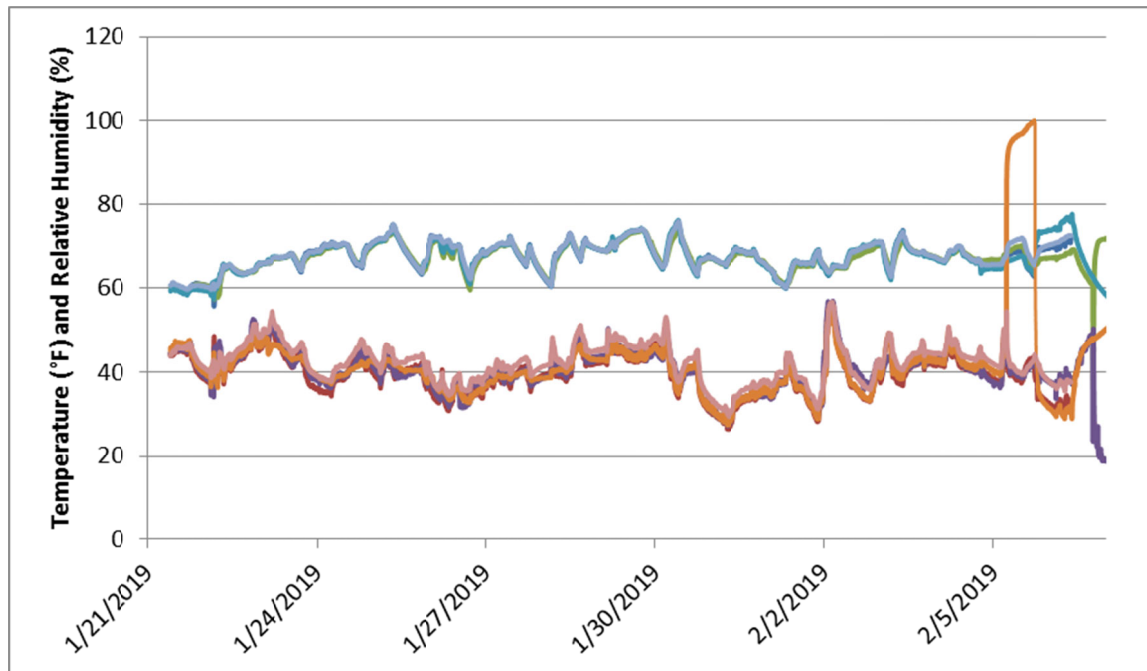
Figure 29. Temperature and RH in the custom exhaust system house. The upper 4 lines are temperature and the bottom 4 lines are relative humidity.

The custom ventilation system does not seem to be bringing in any outside air in its current configuration. Figure 29 shows the data from all four data points in the house; two were at the inlet of the mixing port, one was at the grille for the room supply and the other was in the living space. The temperatures are all identical and the RH is within 5% (the error on the sensor). It looks like the mixing port on the supply is “short-circuiting” any fresh air introduction.

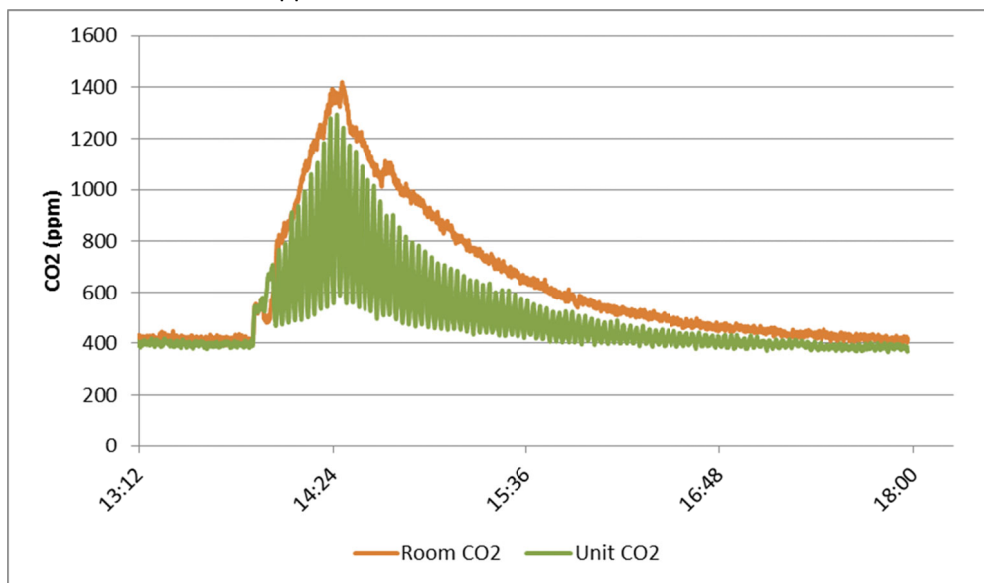
Figure 30. CO₂ in the MTL after a 5-person meeting. The jump in CO₂ around 14:45 is due to the humidifier being restarted.

The airflow in the TwinFresh came close to the maximum specified flow of 29 CFM at 43°F outside, but it was only 11.5 CFM when it was 21°F outside. The two units were within 1 CFM of each other, leading to a slightly more balanced system than the E2. There was a 5-person meeting in the MTL in May to try to create an instance of elevated CO₂. In the 30 minute meeting, the CO₂ only rose to a maximum of 1398 ppm and following the meeting it dropped rapidly back to ambient (Figure 30). For comparison, the CO₂ directly in the incoming and exiting air of the TwinFresh was also recorded. When it was supplying air in the room the CO₂ dropped almost back to ambient and when it was exhausting it was less than 200 ppm difference from the room CO₂. From this data it appears that the TwinFresh is an effective room ventilator.
