COLD CLIMATE HOUSING RESEARCH CENTER
CCHRC

Mobile Test Lab Wall Monitoring Study

*Cold Climate Housing Research Center
February 23, 2007*

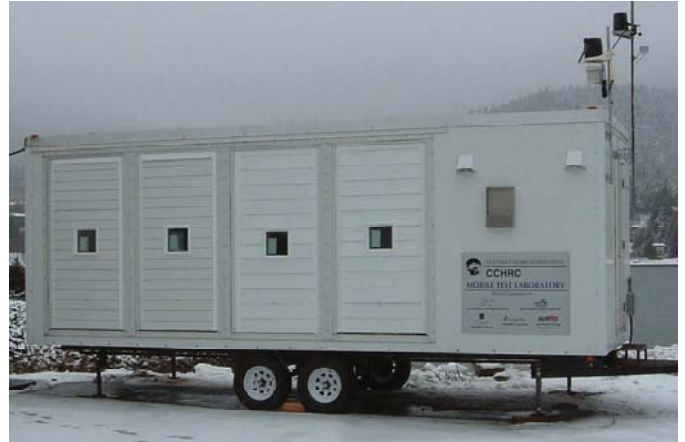
The 8' x 8' x 24' Mobile Test Lab (MTL) has nine bays used for comparable testing of different materials and equipment. Each test wall bay is 45 inches wide by 89 inches high. Temperature for the interior of the lab was controlled with electric resistance heaters to achieve 70°F. A heat recovery ventilator was installed and used to ventilate. Relative humidity was not controlled.

The mobile test lab on location in Juneau, Alaska

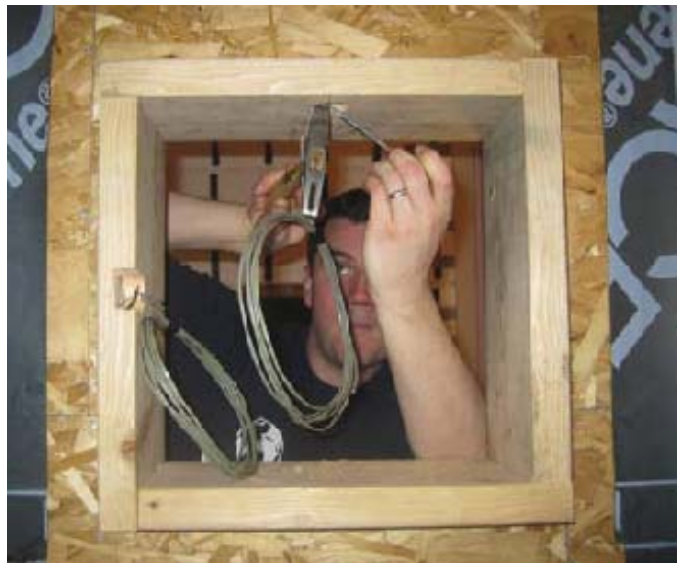
To better understand the temperature gradients and heat flow through the window buck, moisture content pins and a temperature sensor were installed near the exterior surface in all the window bucks.

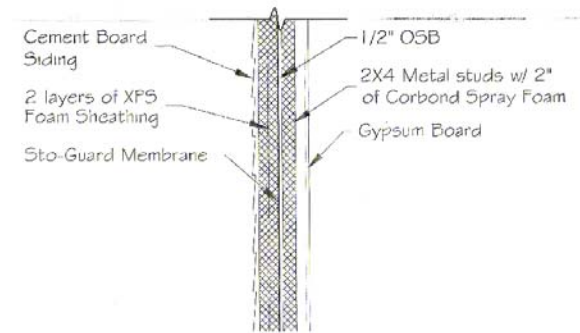
WALL 7
SC: 3/4" = 1'

Wall 7, insulated with spray foam in the stud space also dried very slowly, and held water between the spray foam insulation and the sheathing. This resulted in the highest risk to moisture damage of the test walls.

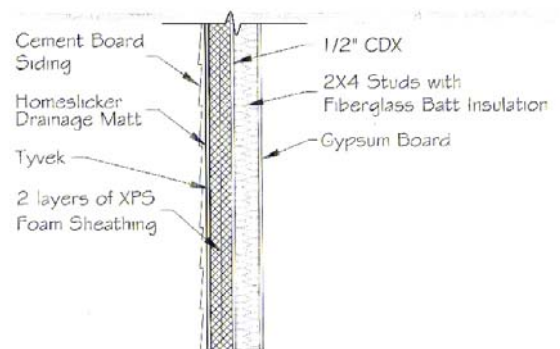
WALL 9
SC: 3/4" = 1'

Wall 9, insulated with batt insulation, dried slower than Walls 1-6. The lower sheathing temperature in combination with vapor open insulation could be a risk for moisture damage. This was shown by the measured elevated moisture content levels of the sheathing.

These results can be compared to a similar wall construction in the CCHRC/UAS test trailer. Wall 9 is constructed with fiber cement plank, drainage matt, Tyvek®, EPS, sheathing, 3.5" batt insulation, and drywall. With the addition of the exterior insulation, the number of condensation hours was decreased to zero because the temperature of the sheathing was increased during the winter months. The graph for CCHRC/UAS Wall 9 is shown to the right. The temperature of the interior surface of the sheathing does not drop below the dew point temperature once during the year of monitoring. All of the CCHRC test walls were analyzed for condensation potential and it was found that none of the test walls had any hours of condensation throughout the period of the testing.
