COLD CLIMATE HOUSING RESEARCH CENTER

# Safe, Effective & Affordable Retrofits for Cold Climates

**November 30, 2019**

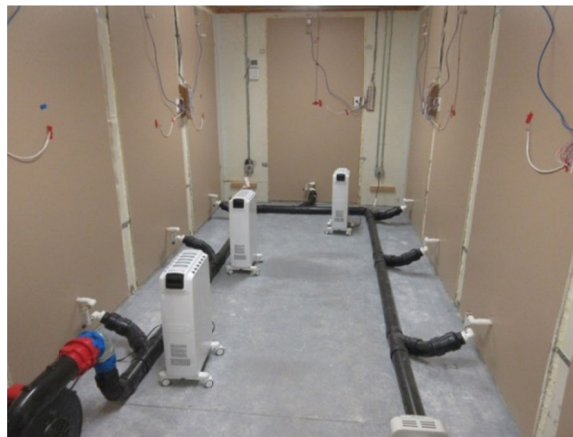
Figure 2. Inside of the completed MTL. The ABS black piping was used to create a constant and controlled air leakage.

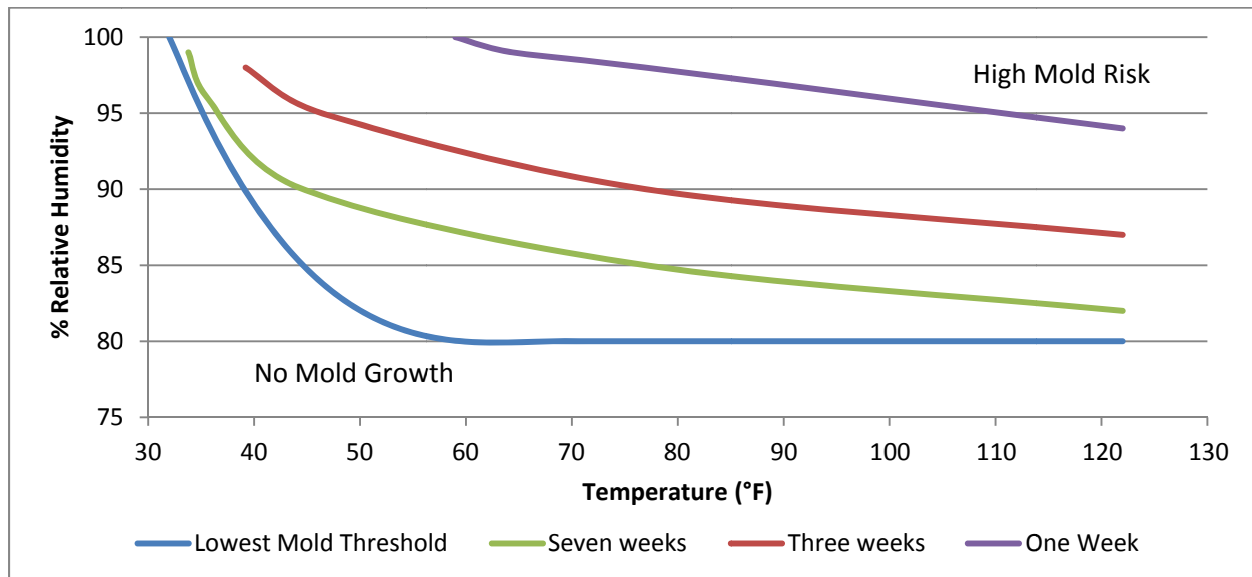
Figure 4. Mold growth conditions for wood. The purple, red, and green lines estimate the conditions that will initiate mold growth within one, three, and seven weeks. Time estimates come from Hukka & Viitanen (1999).

Mold danger was assessed at the inner plywood sheathing surface, which is the most likely component of the envelope to encounter mold growth. Material with MC less than 20% has little mold growth risk, 20 to 28% has the potential for mold growth and rot depending on length of time at these moisture contents, and moisture content greater than 28% will have moisture related problems (Smegal et al., 2013). The relative humidity and temperature were also analyzed. Figure 4 shows the threshold for mold risk based on temperature and humidity that is built in to the hygrothermal model. These results were also compared to the physical investigation of the MTL walls at the end of the 2 year study.

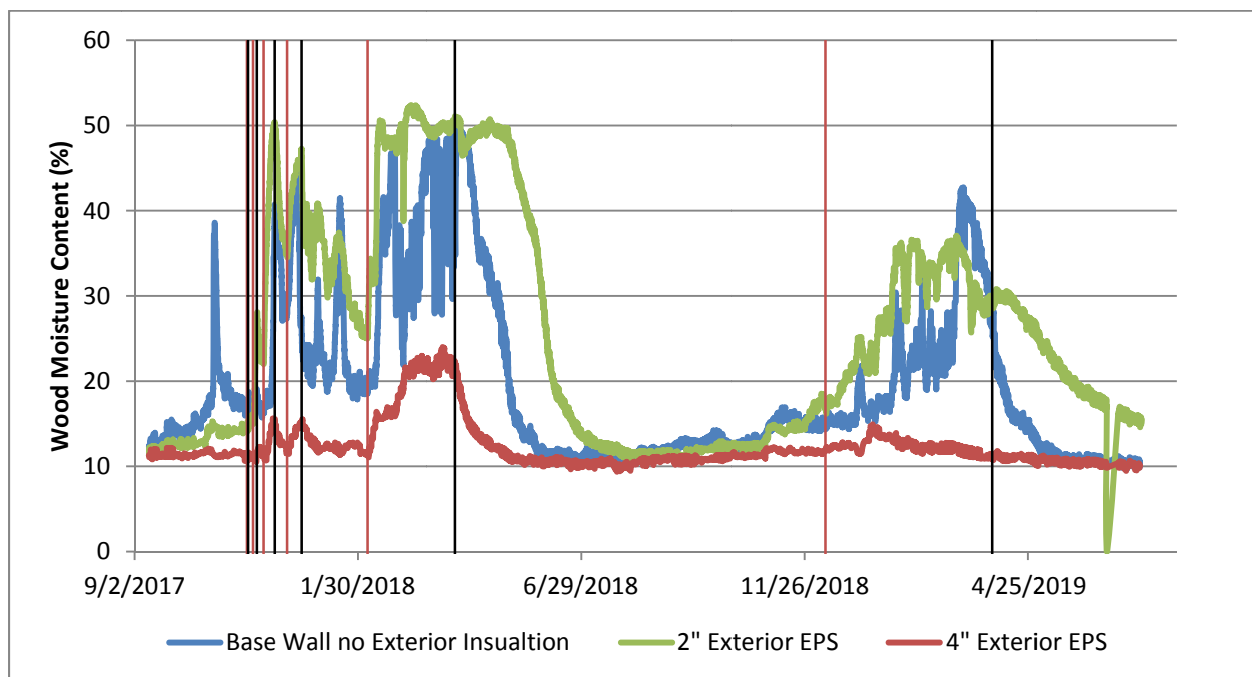
Figure 5. Moisture content of the EPS walls. The wall with two inches of exterior EPS was above the 20% moisture content danger line both winters. The red vertical lines indicate when the air injection system was turned on and the black lines indicate when it was turned off.

Figure 5 shows how too little exterior insulation can allow moisture to build up in the wall and stay there longer into the summer drying season. The 2-inch EPS wall reached 50% moisture content the first year and took two months longer to dry than the control wall with no exterior insulation. In the second winter it reached 35% moisture content and took more than 3 months longer to dry. The stone wool walls performed better in the first winter with the 1.5 inch wall exceeding 30% moisture content for a short period; however the walls dried much quicker in the spring than the EPS or control wall (Figure 6). The higher moisture content in the 1.5-inch stone wool wall during the second year is surprising and could hint at accumulation over time. Figure 7 shows that both the fiberglass and cellulose exterior insulation walls had low moisture content.

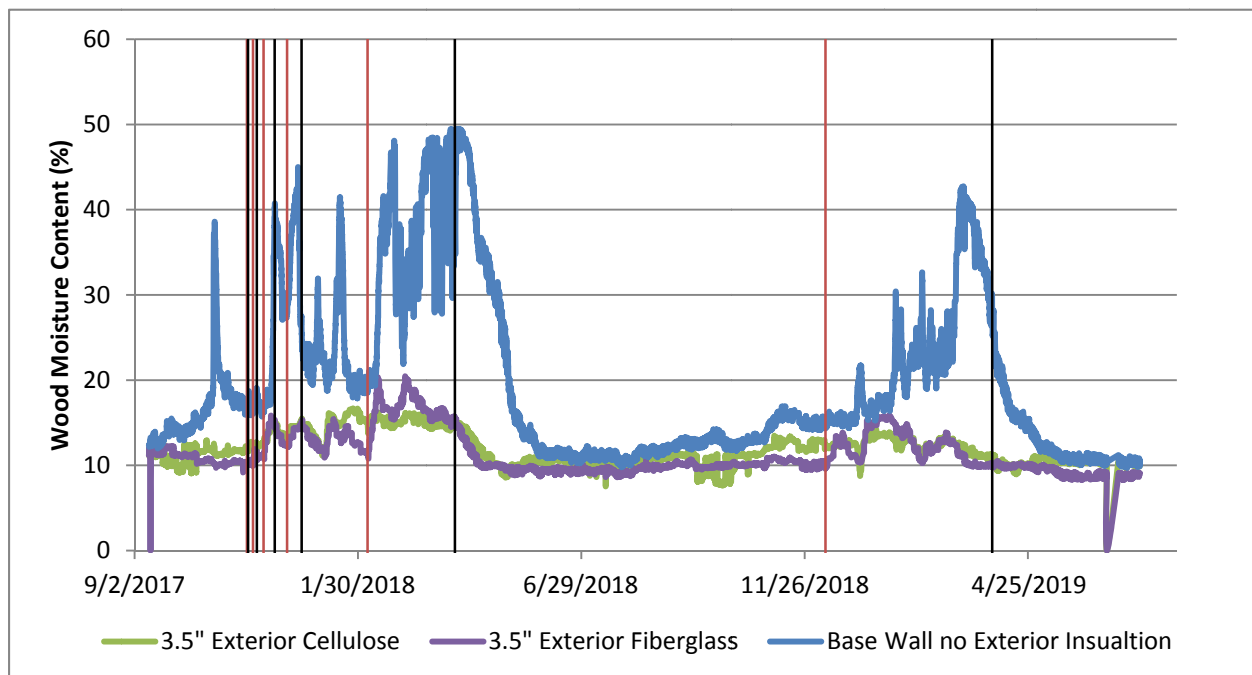
Figure 7. Moisture content of exterior blown-in materials walls. The fiberglass wall did not exceed 20% except for 2 brief periods in the first winter. The cellulose wall never exceeded 20% moisture content. The red vertical lines indicate when the air injection system was turned on and the black lines indicate when it was turned off.

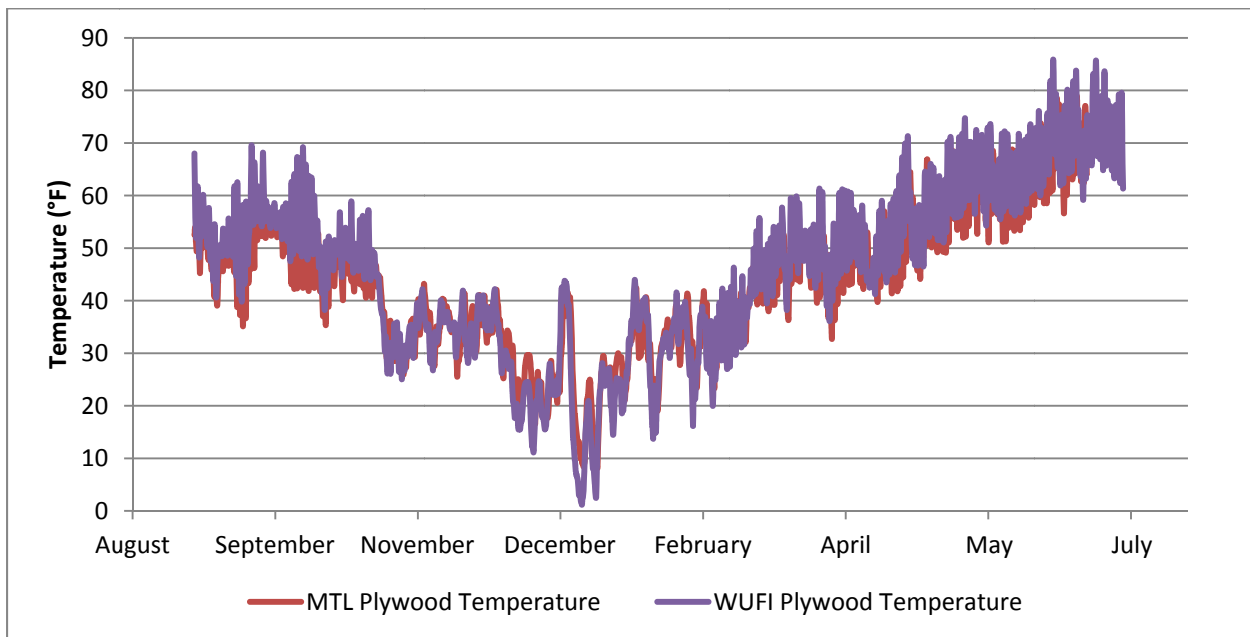
Figure 14. WUFI and MTL temperature correlation for Wall 2. This is a sample graph of the correlation between the MTL and WUFI on temperature. All the walls correlate well with the WUFI model on temperature at the plywood sheathing.

WUFI models were made of each wall and correlations were developed between the MTL walls and the WUFI models (using weather and interior temperature from the 2 year MTL study). Temperature correlations at the inner plywood/fiberglass interface were accurate for all walls (Figure 14).

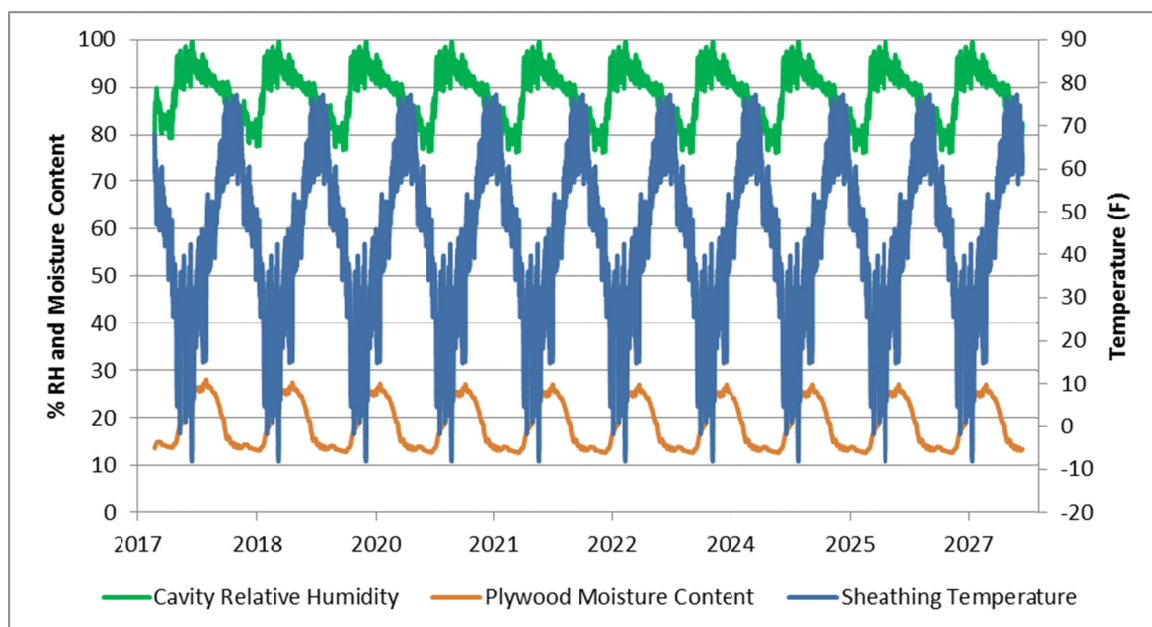
*Figure 18. Fairbanks 10-year WUFI projections for Wall 2 with two inches of EPS. The above freezing temperatures at the sheathing and the high relative humidity lead to mold.*

As Figures 11 and 12 show with measured data, a 2-inch EPS retrofit is not a moisture-safe option for Fairbanks. Deconstruction of MTL Wall 2 showed mold growth on the plywood sheathing after the first winter and more mold after the second winter (see Figure 11). The WUFI model agrees; showing mold growth within the first year post-construction. Figure 18 shows the accumulation of moisture in the wall over a 10-year period. The plywood moisture content exceeds 20% each winter and dries each summer. However, the high moisture content in the winter will lead to rot over time. The high constant relative humidity will result in mold. This wall does not manage moisture safely for the health of the home occupants and the building structure.

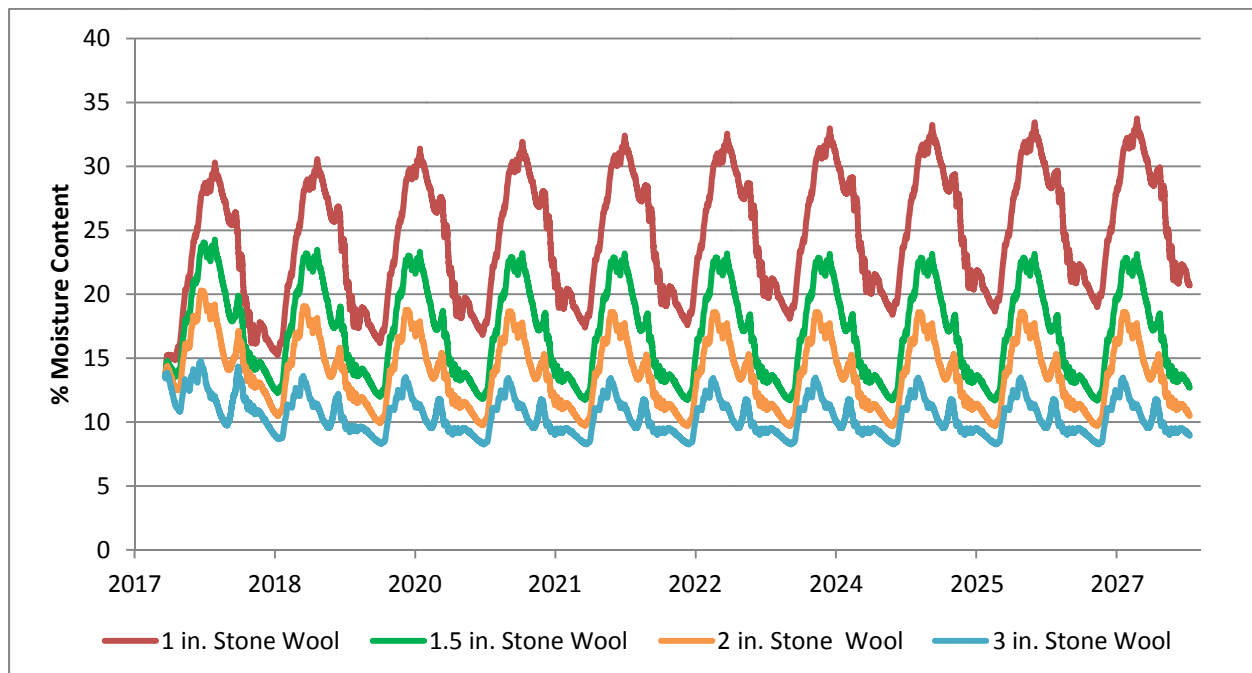
Figure 21. Plywood sheathing moisture content for stone wool exterior insulation in Fairbanks. The 1.5-inch model is the same as Wall 1 from the MTL study. It is in the critical zone enough hours each winter to cause concern.

Stone wool is a highly permeable material. It has a permeability of 107 perm inch versus faced EPS which is only 0.9 perm inch. This high permeability makes the wall more forgiving in high moisture events. The 10-year models of stone wool walls show that having more than R-8 (2 inches) of outer stone wool insulation on a 2x6 wall with an interior vapor retarder makes the wall more robust from moisture damage. Figure 21 shows the moisture content in the plywood based on the amount of exterior stone wool. The model with the least exterior insulation (1 inch) has climbing moisture content over 10 years. The 1.5-inch model doesn't climb but does get above the 20% danger threshold every winter; this is verified by Wall 1 in the MTL, which had 36 consecutive days in the RH critical zone and small patches of visible mold on the sheathing.

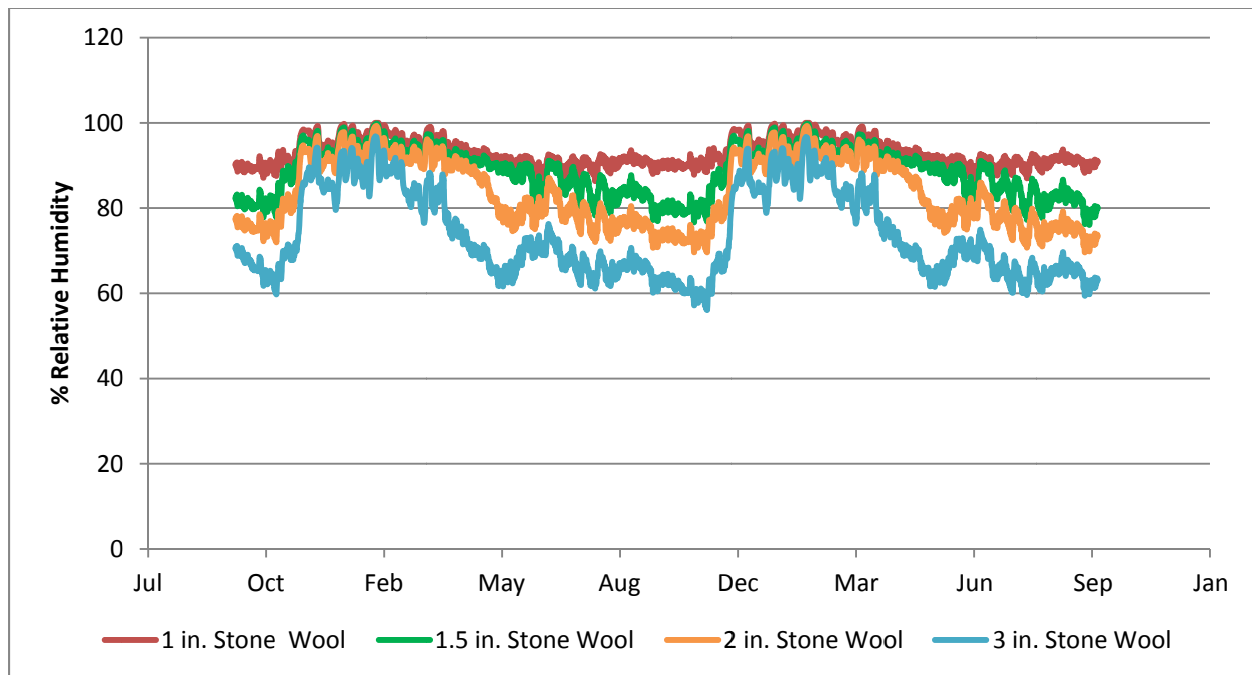
Figure 22. Stud cavity relative humidity for stone wool exterior insulation in Fairbanks. The relative humidity of the thinner stone wool retrofits is much higher than the thicker retrofits.

Figures 22 and 23 show the variation in relative humidity and inner sheathing temperature with varying levels of exterior stone wool. The 1-inch model is always in the mold danger zone while the 1.5-inch model tends to have lower humidity in the summers. This is due to the lower temperature at the plywood sheathing with less exterior insulation; the RH will be higher at lower temperature. The model shows that 1.5 inches of exterior stone wool puts the wall at risk of mold growth; adding more insulation would be a wise choice. The test wall in the MTL showed some visible mold growth in select areas of the plywood sheathing over the 2-year study.

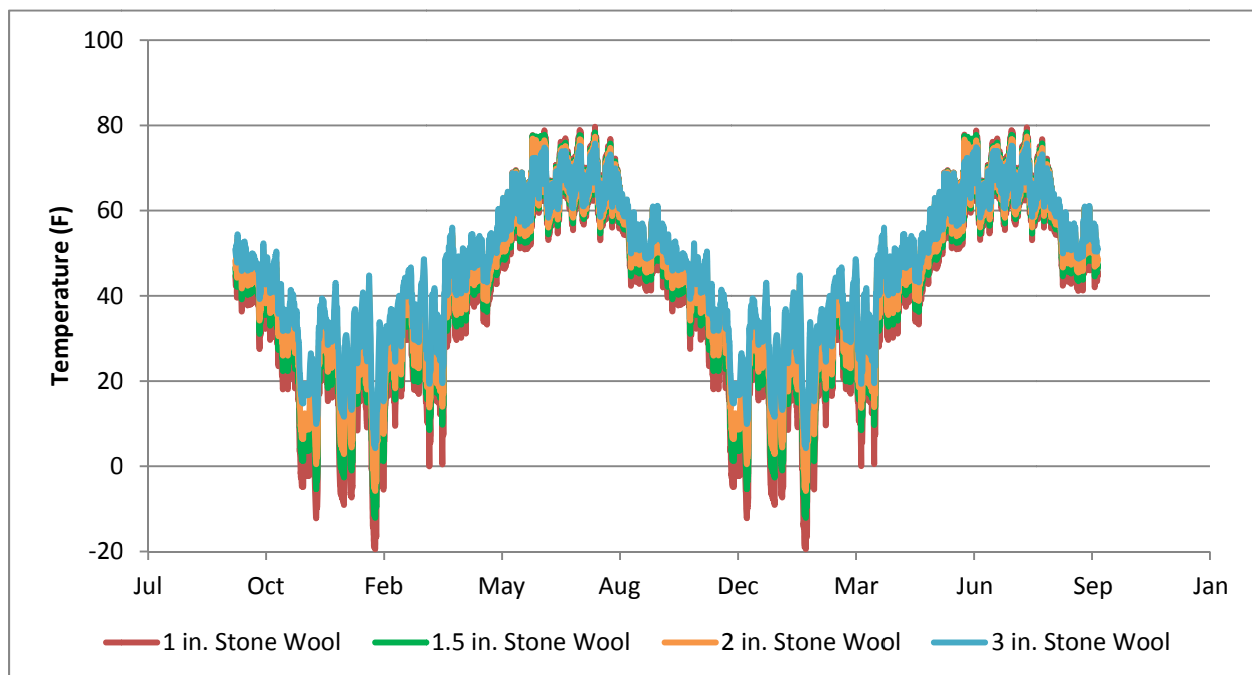
Figure 23. Plywood sheathing temperature for stone wool exterior insulation in Fairbanks. This shows that more exterior insulation keeps the plywood warmer.
