COLD CLIMATE HOUSING RESEARCH CENTER

Vacuum Insulated Panels

Construction techniques and cold climate testing

June 30, 2018

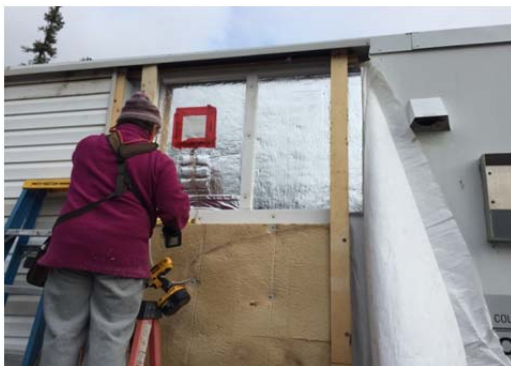
Figure 2. VIPs exterior wall installation on the MTL. Finalizing installation of the VIP and sensors on the MTL. The wall was finished on the outside with vinyl siding

In their current configuration, the VIPs will be the most protected when used as exterior insulation. The exterior insulation method shown in Figures 1, 2, 6, and 7 is the most recommended construction method for working with the Mylar VIPs and traditional residential construction methods. If the building is configured in a way that a self-supporting curtain wall is an option, the exterior insulation method from Figure 19 is an excellent option with less thermal bridging between VIPs.

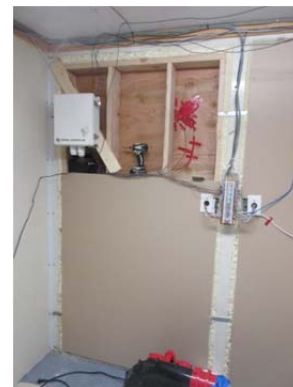
Figure 3. Inside of the VIP wall in the MTL. The sensors are under the red tape on the right.

The VIP section of the MTL is the top half of one small test bay. The interior of the VIP section does not have any insulation or finish so that the cavity is accessible for data collection. Figure 2 shows the wall from the outside and Figure 3 shows the inside of the wall. The final outside wall was covered in vinyl siding. The MTL was completed in October. Temperature data was collected on both sides of the wall and heat flux was monitored over the winter.

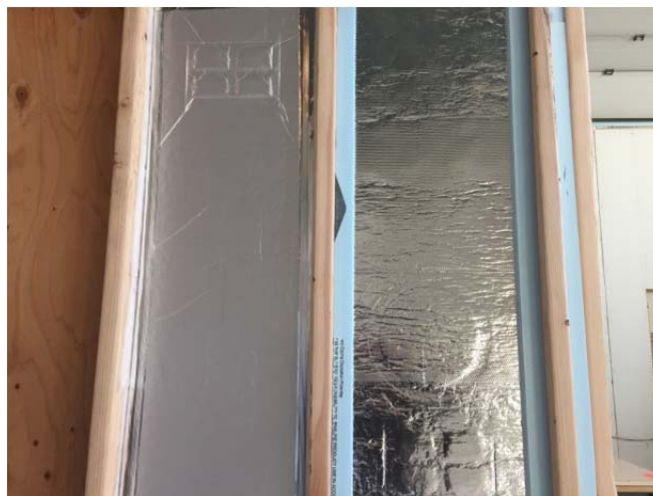
Figure 5. VIPs in-fill. These walls were 2x4 (38X89 mm) on 16 inch (406 mm) center with 14 inch (356 mm) wide VIPs.

Three quick wall designs were constructed in the lab to see if they would be a good fit for testing in the large wall assembly. A 2x4 (38 x 89 mm) wood stud wall with VIP in-fill was developed. Two different in-fill ideas were tried: friction fitting the VIPs with foam sill sealer in order to provide a tight fit and reduce potential puncture from wood splinters, and fitting the VIPs in with table saw milled Extruded Polystyrene (XPS) foam strips (see Figure 4). Figure 5 shows the two in-fill cavities.

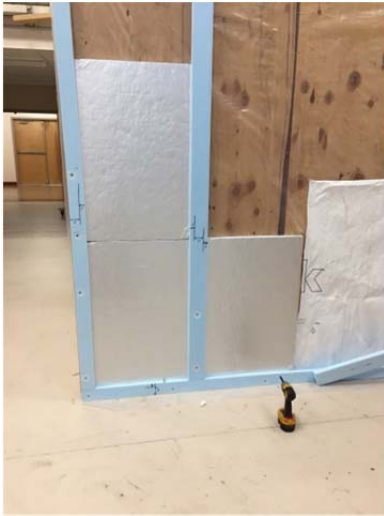
Figure 6. Exterior retrofit VIPs. Two inches (51 mm) between the VIPs and along the edges only have a 2 inch (51 mm) thermal bridge of XPS

A second trial wall was very similar to the MTL wall, only using XPS instead of EPS and covering a full wall with multiple columns of VIPs and XPS strips on all sides of the VIPs. The wall was finished out with 2x4 (38x89 mm) furring strips that could hold siding. Figures 6 and 7 show this wall in various stages.

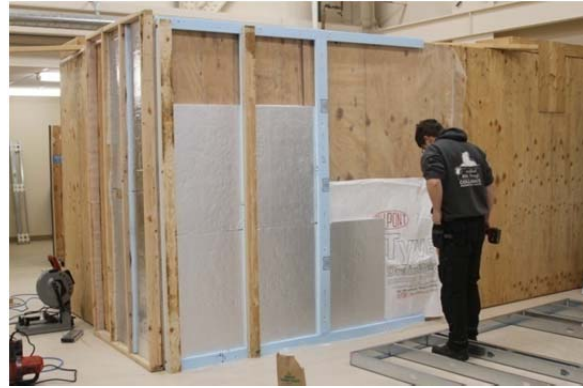
Figure 7. Exterior insulation retrofit method. The exterior 2x4 (38x89 mm) furring strips are shown. The final step in this wall would be adding siding to the furring strips.

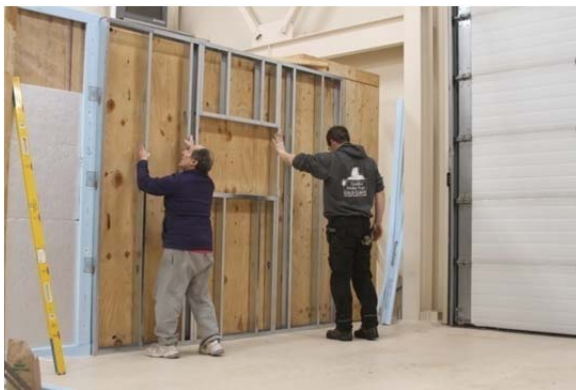
Figure 8. Assembling the exterior portion of a double steel stud trial wall with typical window framing. All the sharp corners were carefully covered.

The third trial wall used double metal stud wall construction to create a cavity to hold VIPs. The metal stud walls were set 1½ inches (38 mm) apart. The outside wall was covered with a weather resistive barrier after all metal joints with cut edges were taped to eliminate sharp edges. The inside wall had ½ x 1½ inch (12 x 38 mm) XPS strips applied to the face of the studs with tape. Once the walls were in place the VIPs were taped together to form large panels with sealed joints and slid into the cavity between the walls. Figures 8 through 13 show the process of building this wall.

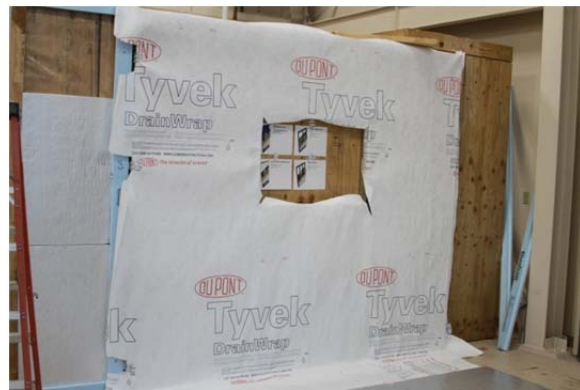
Figure 9. Weather Resistive Barrier (WRB) applied to framing. This was added to keep the VIPs away from sharp metal.

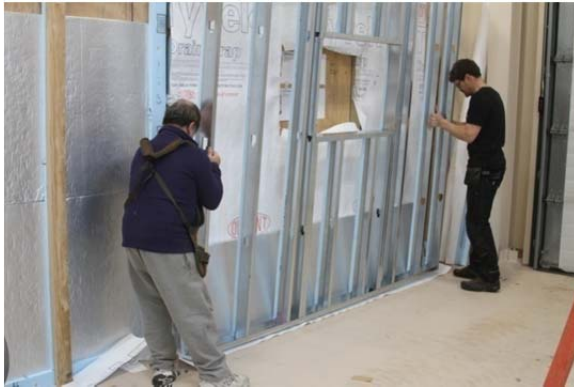
Figure 10. Assembling the interior portion of a double steel stud trial wall with typical window framing. Rigid foam used as a thermal break/gasket material for the VIPs in conjunction with the steel studs.

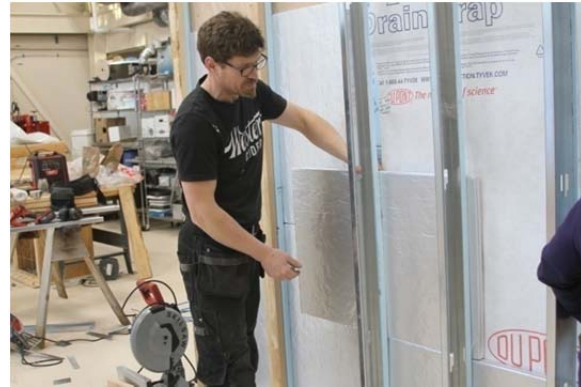
Figure 11. Friction fitting VIPs with the rigid foam gaskets into stud bays of trial wall. These VIPs were slid in individually.

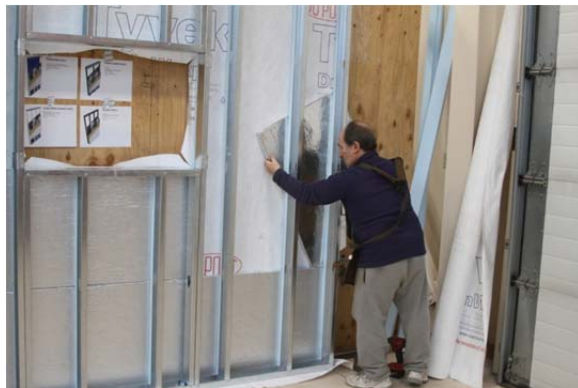
Figure 12. Inserting VIPs into protected cavity of the trial wall. There was some consideration of being able to replace broken panels at a later date. This is possible with this design but it would not be easy.

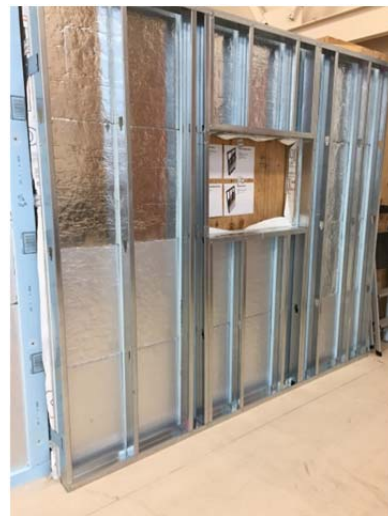
Figure 13. Final metal stud wall. This side of the wall would be the interior of the wall covered in gypsum board.

The metal stud wall took a great deal of preparation to make sure there were not sharp edges that might puncture the VIPs. Even using extreme care to protect the VIPs a few were still punctured. The fine metal shavings that come off metal studs when they are cut or shards from screws were found to be highly problematic. Figure 14 shows a VIP that was compromised by a metal shaving. The next iterations of wall designs did not use metal studs.

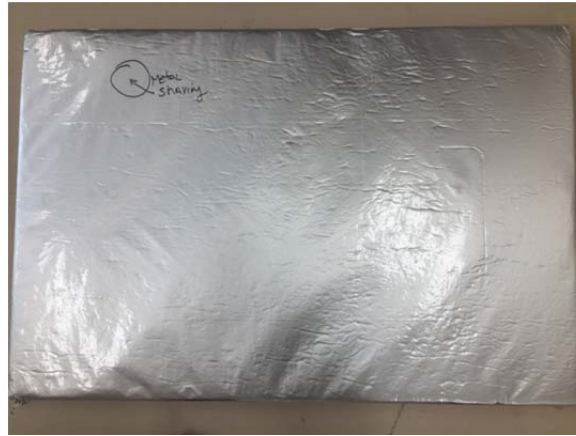
Figure 14. VIP with lost vacuum. The large wall was built using wood studs rather than metal studs to avoid any potential sharp metal shavings that might compromise the panels.

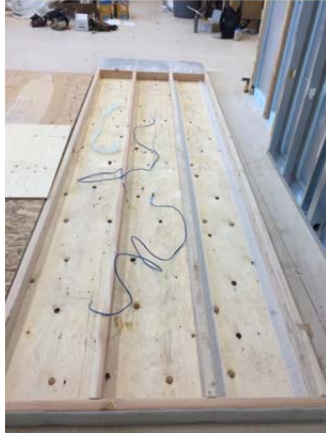
Figure 15. Large test wall section framing. Relative humidity sensors were embedded in the center cavity.

The stud in-fill techniques are shown in Figures 15-18. The panels were ordered to fit in the 16 inch (406 mm) on center stud bays. Each VIP was 14 inches (356 mm) wide and 4 feet (1.2 m) long. Two stud bays tested friction fit ideas and one stud bay tested bi-axial reinforced double sided mounting tape. Stud bay one used sill sealer around the edges with small XPS stop blocks around the perimeter to hold the VIPs against the sheeting without air sealed joints between the VIPs or around the perimeter. Stud bay two had milled XPS channels to hold the VIPs (shown in Figure 16) with air sealed joints between the VIPs. In stud bay three the VIPs were held in place with double sided tape and air sealed on all joints and perimeters with polyurethane spray foam.

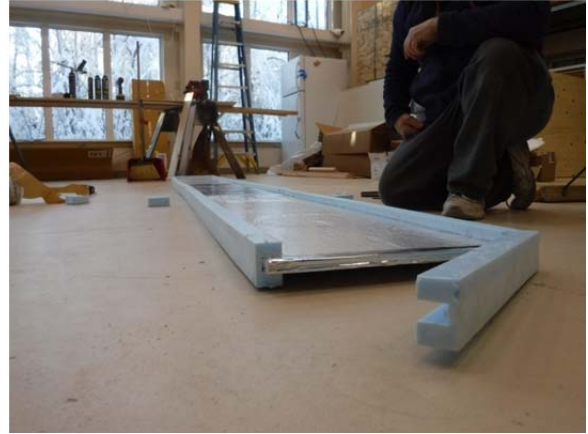
Figure 16. Friction fit cavity assembly technique. Mortised rigid foam was developed to accommodate the VIPs.

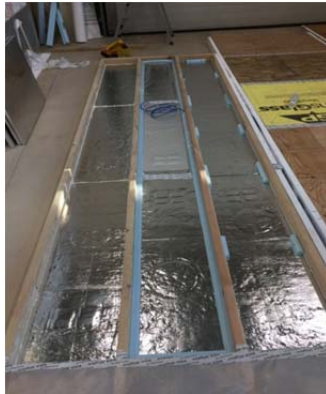
Figure 17. Completed large test wall sections. This shows all 3 in-fill techniques.

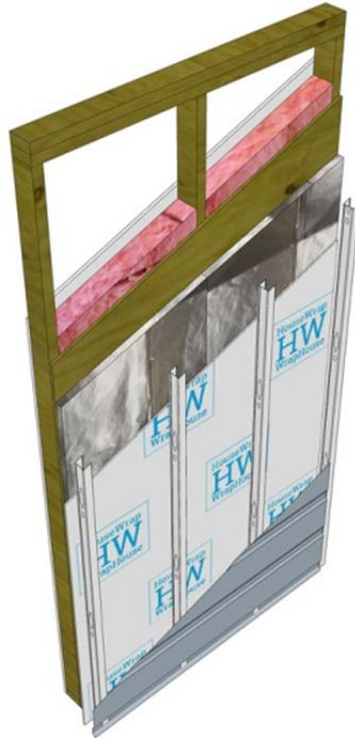
Materials from Inside to out:

- 1/2" (12 mm) Gypsum Wall Board
- 2x4 (38 mm x 89 mm) wood studs 16" (406 mm) O.C.
- Fiberglass Insulation
- 1/2" (12 mm) Plywood Sheathing
- 1" (25 mm) Vacuum Insulated Panels taped together
- Air Barrier
- 1/2" (12 mm) Air Space
- Curtain Wall
- Exterior Cladding

Figure 19. Continuous exterior insulation with a curtain wall. The VIPs were glued directly to the plywood.

The central part of the large wall had an exterior continuous insulation design. VIPs were glued to the sheathing outside the 2x4 (38x89 mm) framed wall using a variety of adhesives. A variety of sheathing materials were also used in order to test adhesion on a variety of substrates. Once the wall was in place an external curtain wall constructed of 2 inch (51 mm) metal studs with painted plywood siding was installed to protect the VIPs from the outside, representative of a rain screen curtain wall design. Figure 19 shows the final wall construction.

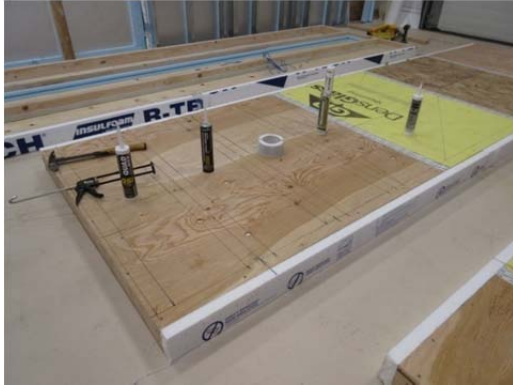
Figure 20. VIPs were applied to the exterior of this wall. Different sheathing materials were evaluated.

The VIPs were adhered to the sheathing with the adhesives shown in Figures 20 and 21. The joints between the VIPs were taped in some cases and sealed with spray foam in others (see Figure 21). A weather resistive barrier was laid over the VIPs and taped in place.

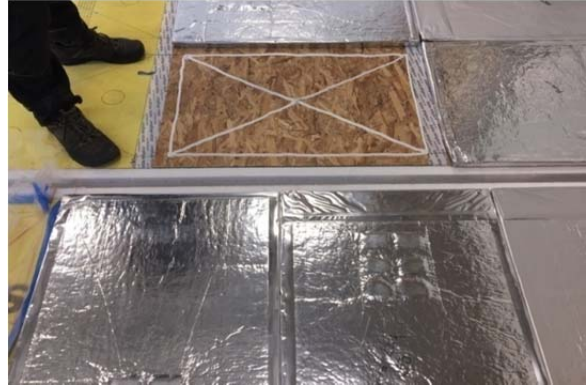
Figure 21. Applying adhesives to exterior side of wall. All adhesives were applied in the same pattern.

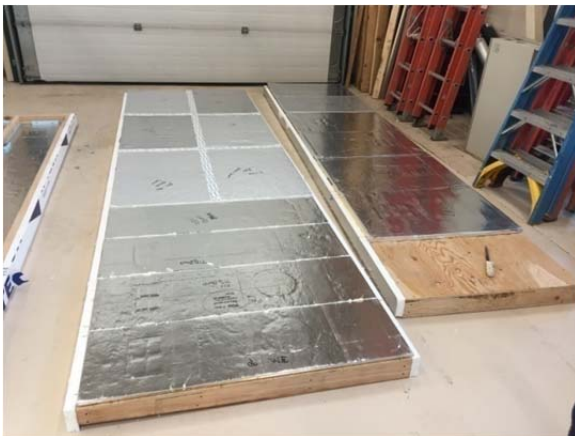
Figure 22. Completed exterior insulation test section. This section of the large wall has both $\frac{1}{2}$ and 1 inch (12 and 25 mm) VIPs.

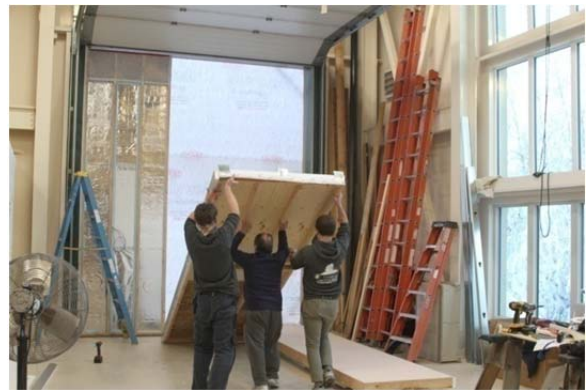
Figure 23. Standing up the large test wall. The three sections were stood up independently and attached together in place.

Once the walls were completed in the lab they were stood up in the test space. They were not built in place because construction took place in January, which was too cold to keep the test space open for as long as the build took. In addition, the adhesives that were tested with the exception of the spray contact adhesive and double sided tape required cure time to set; requiring the walls be constructed flat. Figure 23 shows how the wall sections were tipped into place.

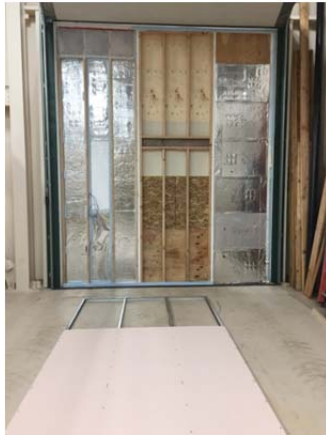
Figure 24. Completed installation of large test wall. The partial curtain wall is laying on the floor

Figures 24 through 26 show the final touches to the large wall both inside and outside. The wall was completed in mid-February and data collection started the first week in March. Figure 27 shows the inside wall with some of the interior finish wall boards installed, these boards were installed the last week of March.

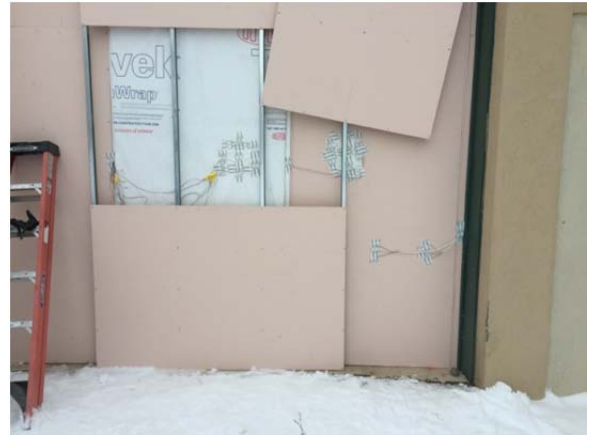
Figure 25. Installation of exterior sensors. Part of the curtain wall siding is swung to the side.

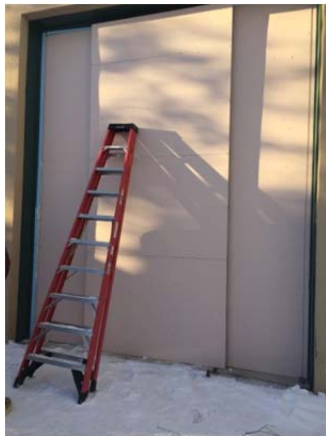
Figure 26. Completed installation of large test wall. The center is the curtain wall.

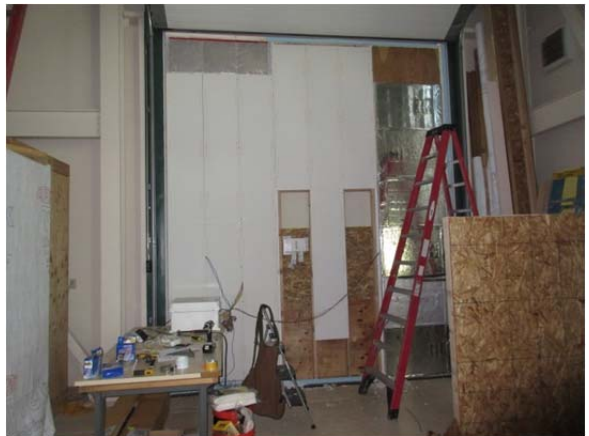
Figure 27. Installing the new finish wall boards on the inside of the large wall. The boards have nailing edges where they can be affixed. There are non-VIP finish wall boards in use in places that needed cutting.

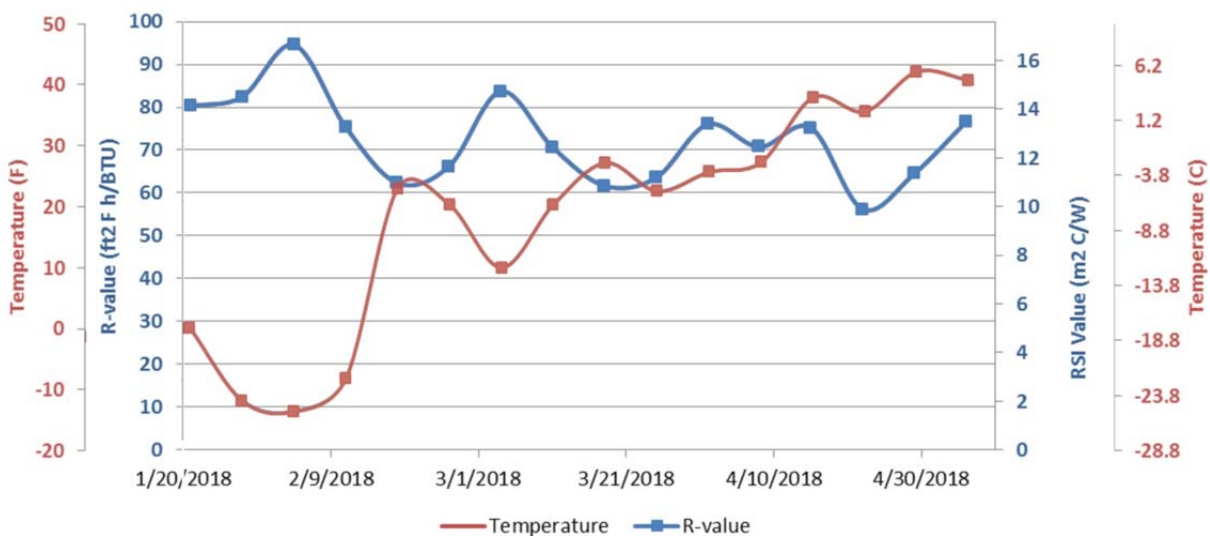
Figure 33. Weekly averages of the MTL VIP wall. The R-value improved with dropping outside temperature. This is because radiation is the dominant form of heat transfer in a vacuum and the colder outside temperature slows heat transfer by radiation.

The MTL had 1 inch (25 mm) VIPs outside of the stud wall with no insulation inside the studs. The VIP and sheathing R-value was calculated over 5 months. Figure 33 shows the R-value in the MTL over time. The average R-value was 72 (13 RSI). The R-value was higher than the expected R-60 (10.5 RSI); the higher numbers tended to coincide with lower temperatures.
