Final Report to The Denali Commission

Combined Residential Wind and Solar Energy Project at the Anaktuvuk Pass Prototype House

March 31, 2012

Cold Climate Housing Research Center

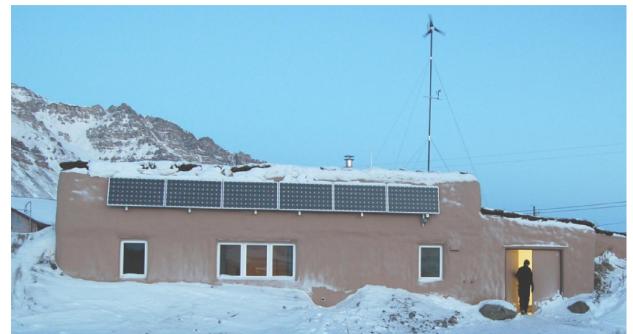
Figure 1. The Anaktuvuk Pass prototype house. The house built in 2009 has both solar and wind power generation systems installed.

The Anaktuvuk Pass prototype home includes a combined solar photovoltaic (PV) power and wind power generation system. Both the PV panels and the wind turbine are visible in the photo in Figure 1.

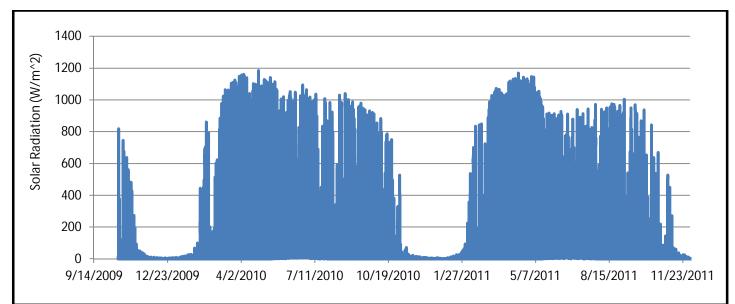
Figure 2. Solar radiation at the Anaktuvuk Pass prototype house. The south facing pyranometer is mounted beside the PV panels. This shows the solar radiation incident on the panels on the prototype house since they were installed.

From early December to early January the sun does not rise above the horizon in Anaktuvuk Pass; for several weeks on either side of this period, the sun is obscured by mountains. The extremely short days from late November to February also diminish the potential solar radiation. However, from late May until early July the sun does not dip below the horizon. The on-site measured yearly solar radiation shows these extremes (Figure 2). The solar radiation in Figure 2 only accounts for the direct radiation on the fixed-azimuth (south-facing) solar radiation sensor. According to PVWatts, a National Renewable Energy Lab (NREL) analysis tool for the performance of solar PV systems, Anaktuvuk Pass averages 3.4 kWh/m²/day (sun-hours per day) compared to 6.57 kWh/m²/day for Phoenix, AZ (PVWatts, 2012).

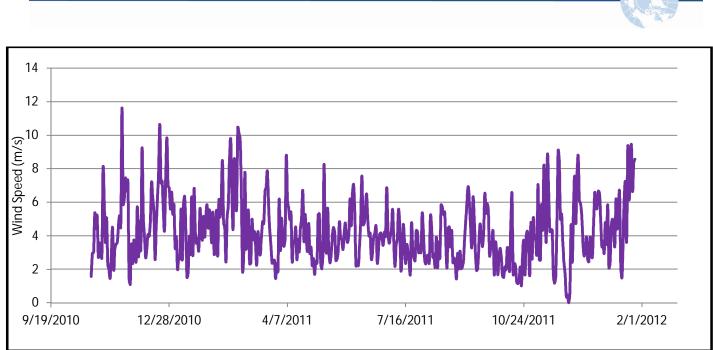
Figure 3. Wind speed at the Anaktuvuk Pass prototype house. This shows daily average wind speed, which remains fairly steady; the maximum gust was 23.1 m/s on February 25, 2011 around 11:00 pm.

At the prototype house an anemometer was installed on the wind turbine tower 15 m (49 ft) above the ground to measure the wind speed. Figure 3 shows the average wind speed for a one-year period on the tower behind the prototype house. The average measured wind speed from October 2010 through February 2012 was 4.2 m/s (9.4 mph). This is considerably less than the wind speed on the research tower that was double in height; this highlights the necessity of accessing the wind speed as close to the final turbine installation location as possible.

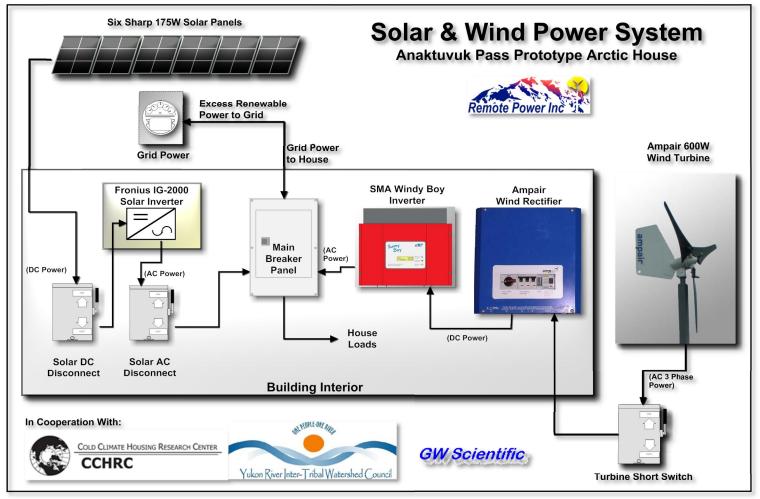
Figure 4. Schematic of the renewable energy systems installed in the Anaktuvuk Pass prototype home. The two systems were designed to work together to supply power to supplement the electrical demand from the house.

The solar PV and wind power generation systems provide alternating current (AC) power to the grid-connected main breaker panel. Figure 4 is a simple schematic that depicts the PV and wind electrical systems and their integration with the house and grid power. A technical wiring schematic of the integrated HMEP systems is shown in Figure 5. Electrical demand by the home's electrical systems is supplied by the renewable energy systems before power is supplied from the grid. As a result, the power demand from the grid is offset by the power produced by the renewable energy systems. When the renewable energy systems produce more electrical power than the house electrical systems demand, then power is supplied to the grid. The homeowner and the electrical utility signed a utility connection agreement that allows the homeowner to be given credit for any surplus power fed onto the grid.

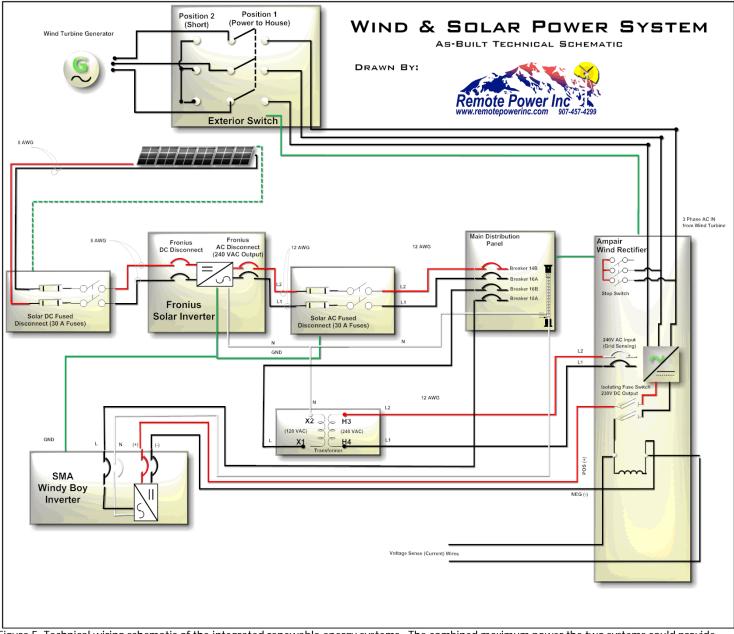
Figure 5. Technical wiring schematic of the integrated renewable energy systems. The combined maximum power the two systems could provide is 1,650 W. The schematic provides an as-built diagram of the system, produced approximately one year after the system installation.

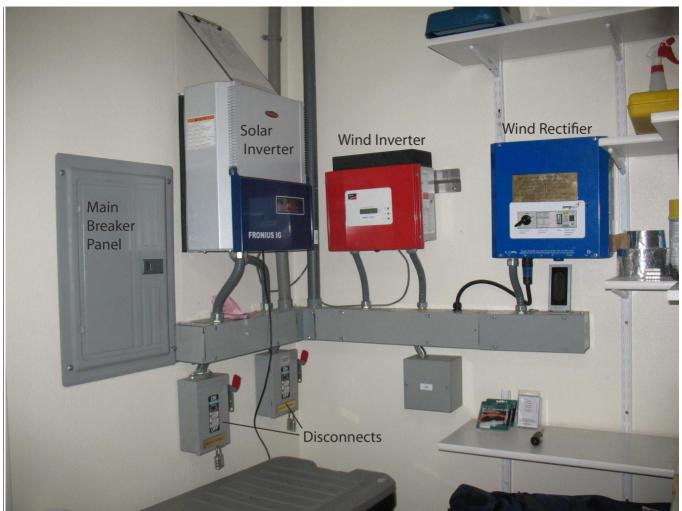
Figure 6. Interior components of the renewable energy system. These components are located in the arctic entryway, which is outside of the living space but still warmer than outside of the house.

The battery-less grid-tied solar PV system consists of six 175-watt solar panels that are wired to a 2,000-watt inverter. The inverter, an electrical device that converts direct current (DC) from the PV panels to alternating current (AC), subsequently supplies power to the main breaker panel of the house. The panels installed for the system are Sharp NT-175U1 monocrystalline panels. Each panel is 62 inches by 32.5 inches. They are mounted across the top of the wall on the south side of the house. The combined six-panel array is capable of supplying 1,050 W of power. The inverter, a Fronius IG 2000, is located in the arctic entryway of the house (Figure 6).

The inverter (shown in Figure 6) interfaces with the user via a display and various LED lights. A quick look at the display indicates how much power, if any, is currently being generated. A sequence of push buttons enables the user to manage inverter settings and access power generation history.

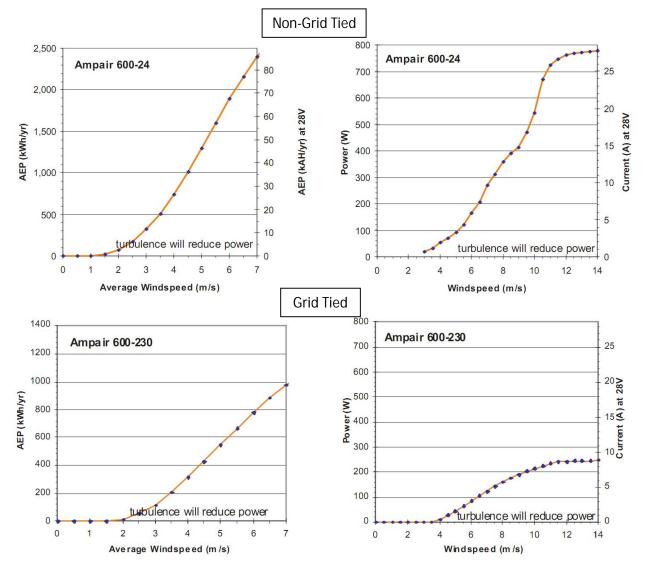
Figure 7. Power curves for two Ampair[®] 600 series wind turbines. The top power curves depict the non-grid-tied wind turbine performance. The lower power curves depict the grid-tied wind turbine performance. Adapted from Ampair[®] wind and water power 2011 catalogue, issue 6.

installed. Troubleshooting and further discussions with the manufacturer revealed that the specific grid-tied model was not capable of producing the same power output as similar non-grid-tied models. Figure 7 shows the power curves of two of the three Ampair[®] 600 series turbines that depict the difference in performance between the grid-tied and non-grid-tied wind turbines.

The average wind speed during this window of operation was 3.8 m/s (8.5 mph) (Figure 15). At 3.8 m/s the turbine should be producing about 275 kWh per year; its amp output does not even register at this wind speed (Figure 7 bottom graphs).

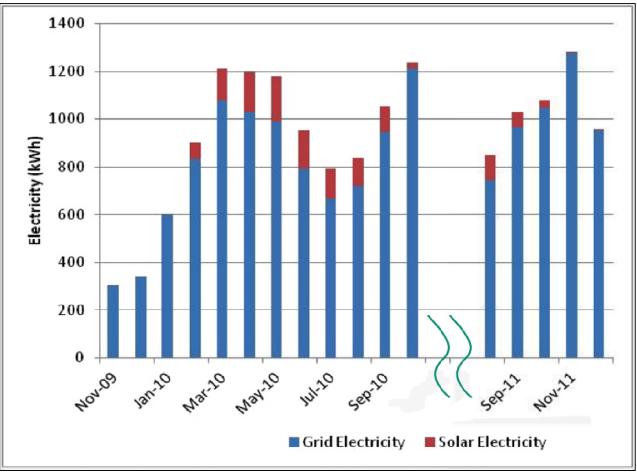
Figure 8. Electrical use for the Anaktuvuk Pass prototype house. The solar energy is included as part of the total monthly use, as it is also consumed by the house. The gap in the data is due to the switch to a new data monitoring system, which took from November 2010 until June 2011 to complete.

Home electrical usage is strongly a function of occupant behavior. The electrical usage in the house is shown in Figure 8. Prior to the family occupying the home in February 2010, the total use for the house averaged 367 kWh a month, a good metric of the baseline load of the house and the STP. Since the house has been occupied it has averaged 1,100 kWh per month. This average is well above the Alaskan monthly household average of 661 kWh/month (U.S. Energy Information Administration, 2009).

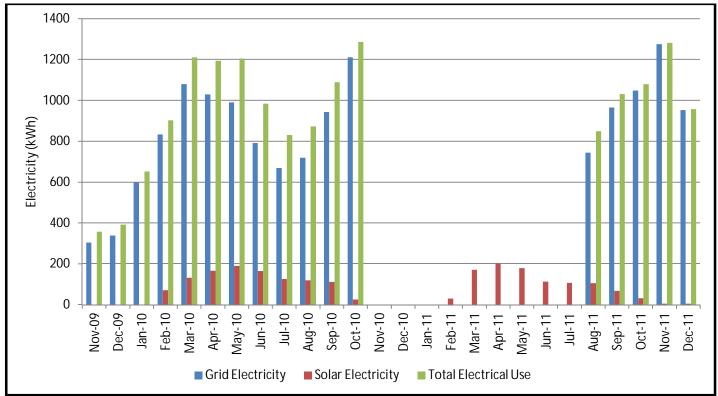
Figure 9. Electrical usage and source. The green bars represent the total amount of electricity used by the family living in the home. The blue bars are the amount of that electricity that came from the grid. The gap in grid use (Nov-10 to Aug-11) is due to a loss of data during transition to a new data monitoring system. The red bars represent the electricity from the PV panels. The accuracy of solar data prior to May 2010 is questionable due to the use of a less accurate monitoring system, which was replaced in May 2010.

The electricity from the electrical utility (grid) and from the PV panels has been monitored by three different systems since October 2009. Monthly electrical demand and generation comparisons are summarized in Figure 9. As the chart shows, the electricity from the panels is a relatively small percentage of the electrical usage during the winter months, which corresponds to the time of highest usage. The photovoltaic panels offset the grid power by about 6% of demand on a yearly average. In the summer that percentage approaches 20% and the solar array can produce more electricity than the house consumes at certain times during the day (which is sent back to the grid).

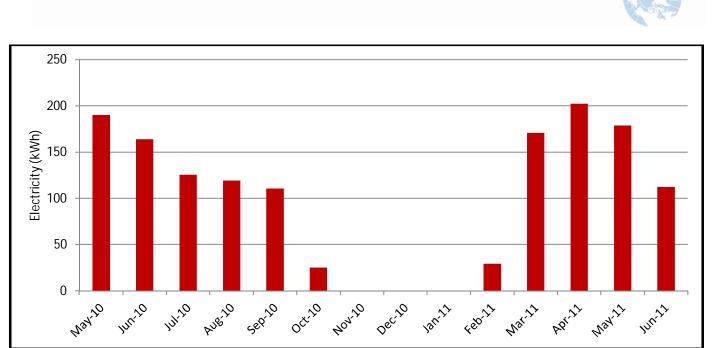
Figure 10. Solar electricity produced. The Fronius inverter also logs data on the electricity produced by the panels. This data is only available when someone is able to physically visit the site and retrieve the data.

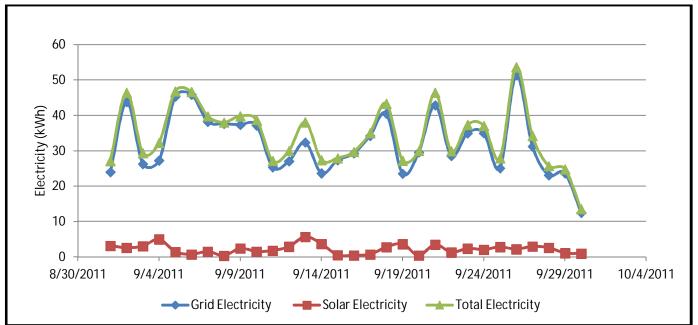
Figure 11. Daily electrical demand and production for September 2011. The red line represents the amount of electricity produced by the PV panels each day. The blue line is the electricity from the grid (that the family paid for), and the green line is the total electricity used by the family.

September is the month of the fall equinox when the sun is between its maximum and minimum yearly values. In 2011, the equinox fell on September 22, meaning that the length of day and the night were approximately equal in length in Anaktuvuk Pass. Figure 11 shows the amount of electricity that was used and produced each day in September. The solar contribution during September averages 2.2 kWh per day, and the total for this month is 66.8 kWh. The solar electricity offsets the family usage slightly in September.

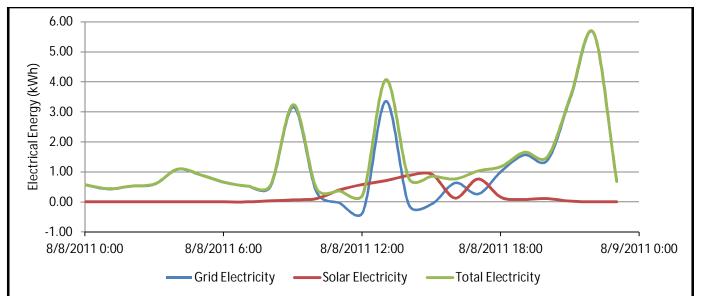
Figure 12. Electrical usage for August 8, 2011. The electricity from the PV panels (red line) rose above the total amount of electricity used by the family (green line). The blue line drops below zero because electricity is flowing into the grid from the house, instead of from the grid to the house.

Looking at the hourly average electrical usage and production each day provides examples of times when the PV panels put electricity back into the grid. For example, on August 8, 2011 electricity flows from the house back into the electrical grid at approximately 12:00 and 2:00 pm. Figure 12 shows the electricity from the PV panels (red line) rising above the amount of electricity used by the family (green line).

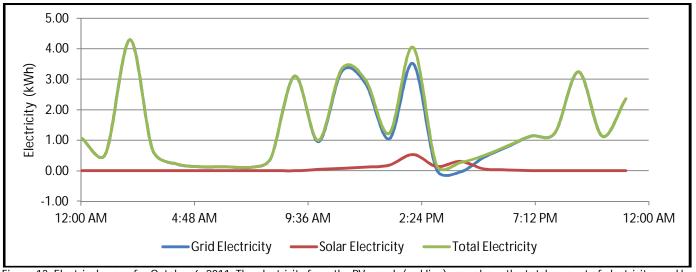
Figure 13. Electrical usage for October 6, 2011. The electricity from the PV panels (red line) rose above the total amount of electricity used by the family (green line). The blue line drops below zero because electricity is flowing into the grid from the house, instead of from the grid to the house.

Two months later, the same situation occurs, although less sunlight is available. Figure 13 shows the hourly average electricity production and usage totals for October 6, 2011. Even though this day is after the equinox, Figure 13 demonstrates that surplus solar electricity is produced during mid-day. In fact, the extra solar electricity does flow back into the grid because the family is not using that much electricity at that time.

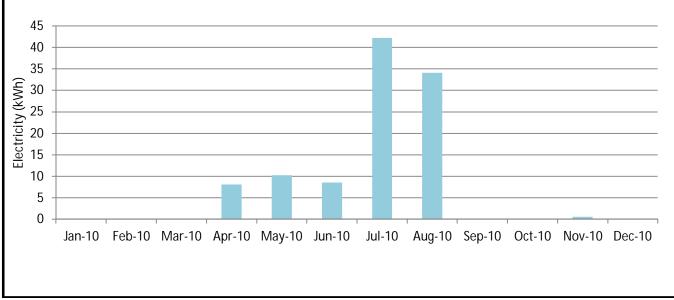
Figure 14. Electricity produced by the wind generator system. Prior to April 2010 and after August 2010 the system was not functioning due to a variety of problems (see Table 3).

The wind turbine only worked for a brief time. At the height of its operation it produced 42.2 kWh in July 2010. Figure 14 shows the monthly averages for electricity from the wind turbine. It was not functioning prior to April 2010 and stopped working in August 2010.

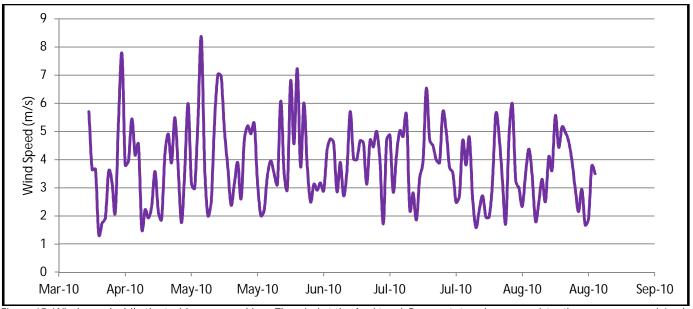
Figure 15. Wind speed while the turbine was working. The wind at the Anaktuvuk Pass prototype house consistently averages around 4 m/s, which is a marginal wind resource.

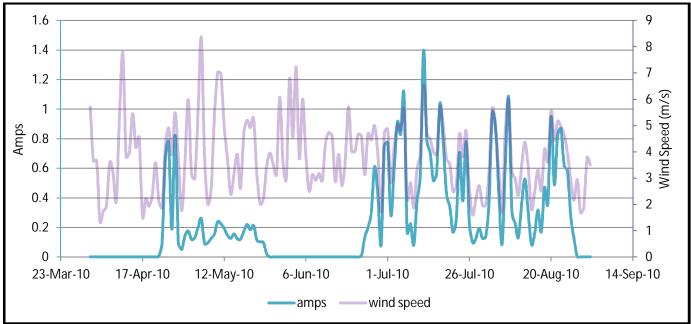
Figure 16. Wind speed and amperage for the wind generator. From March to mid-April 2010, no power was being produced by the turbine. In April 2010, the turbine started functioning following work on the operating parameters. In July and August the wind speed and amperage produced correlate well to each other and to the manufacturer specifications (Figure 7). Turbine stopped working at the end of August.

Figure 16 shows the correlation between wind speed and amperage produced from April to August 2010. The system started working on April 22, 2010, when YRITWC discovered an error in the set-up for the inverter. Judging from the data, the system was not up to full power until July and August 2010. From July 2010 to the end of August 2010 the turbine was producing the amperage that meets the specifications for this turbine at those wind speeds (see Figure 7 bottom graphs). The system abruptly stopped working in August 2010, when a circuit board in the power rectifier shorted out during a maintenance visit.

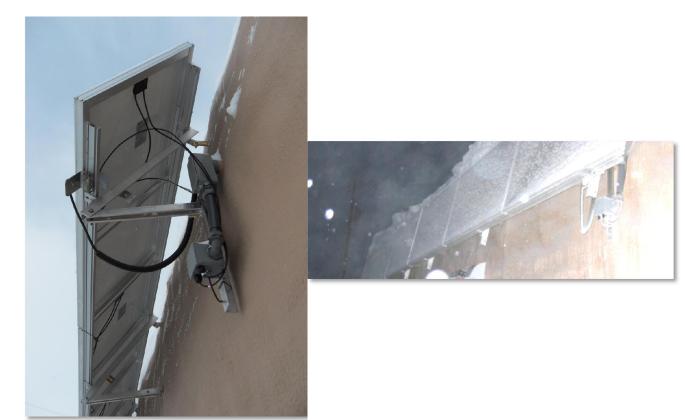
Figure 17. Solar array adjustable positions. The array can be tilted to 53 degrees from horizontal (as shown on left) to maximize solar radiation during the months without snow. The array can be tilted to 90 degrees from horizontal (as shown on right) to reduce snow cover on the panels and to maximize solar radiation during the months with snowfall.

The PV panels are mounted on adjustable aluminum racking that enables the user to vary the tilt of the panels between approximately 53 and 90 degrees from horizontal. The racking is composed of Unirac SolarMount rails, 2"x2"x3/16" aluminum angle, and 1-7/8" Unistrut metal framing. The racking is easily adjusted by removing six sets of bolts from the Unistrut standoffs. Figure 17 shows the tilting positions of the solar array. Seasonally adjusting the arrays enables the homeowner to maximize solar radiation and PV power production. If the panels are tilted to 53 degrees (tilt based on latitude) from horizontal from April through September, the amount of solar radiation absorbed by the panels can be maximized. If the panels are not adjusted from this position in the winter, any snowfall would shade the panels, rendering them unable to produce power.

If the panels are tilted to 90 degrees from horizontal during the winter, they can maximize the solar radiation from the low sun angle from October to April. Additionally, they can generate significant power by capturing the sun reflection off the snow in early spring months (Colgan, Wiltse, Lilly, LaRue & Egan, 2010). Snow accumulation on the panels is minimized in this position; however, accumulation must be removed manually using a long-handled brush or broom. The panels should be adjusted back to 53° in April in order to maximize the power generation in the summer.

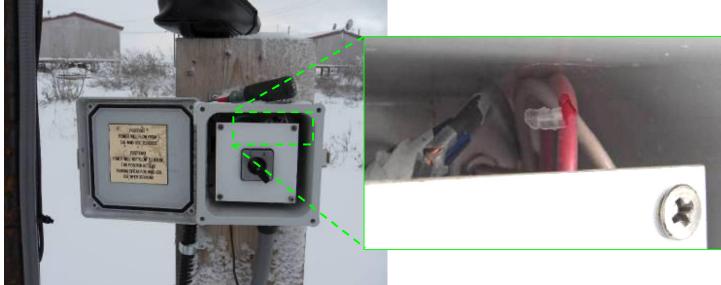
Figure 18. Cracked electrical insulation on the wiring within the turbine short/stop switch. After discovering this hazard the renewable energy professional shut down the wind turbine until the wiring and any potential short in the system could be repaired.

Remote Power Inc., a Fairbanks renewable energy systems company, inspected the installation of the wind turbine in November 2010 and suspected an electrical short somewhere in the system between the wind turbine and the short switch, most likely at the top of the tower (refer to the "Exterior Switch" in Figure 5). Additionally, they found that the electrical insulation on the wiring within the electrical short switch has cracked or fallen completely away from the

wiring. A photograph of this cracked wiring is shown in Figure 18. This condition provides an electrical hazard to those working on the system and could contribute to the detriment of the turbine power output. For safety reasons, the electrical stop switch was engaged and the turbine has been inactive ever since. Currently, the system is disabled and YRITWC has no plan in place for correcting the known problems.

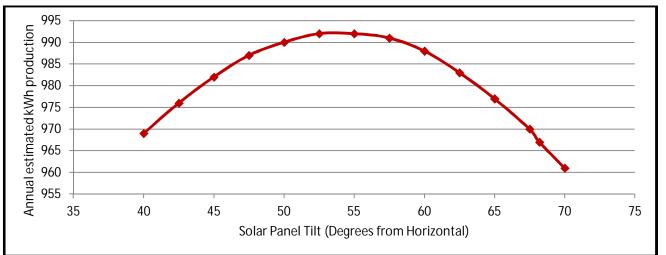
Figure 19. Estimated kWh production based on PV panel tilt. The optimum production of 992 kWh occurs when the PV panels are tilted between 52° to 55° from the horizontal.

direct sunlight for about 8 weeks. The homeowners have not performed the suggested semi-annual task of adjusting the tilt of the panels. It seems that the process of moving the panels is more difficult than desired - an additional person on an extra ladder is required to safely adjust the panels. Since the effort is not required for the functionality of the PV panels, it is considered to be a low-priority task on their maintenance list. As of November 2011, the PV panels were fixed to 90 degrees from horizontal year-round. In order to get the most electricity out of their PV panels in a fixed location the homeowners should move them to the fixed 53 degree position (see Figure 19). With the exception of occasional snow removal from the panels, minimal interaction is required of the homeowners for the operation of the system.

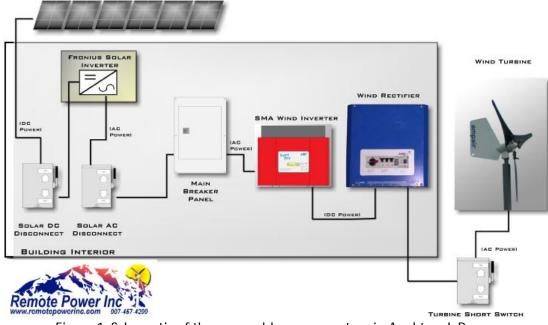
Figure 1. Schematic of the renewable power system in Anaktuvuk Pass

- Solar photovoltaic (PV) panel array: The solar array consists of six panels mounted on the south-facing side of the house. Each panel is 62 inches by 32.5 inches and is capable of producing 175 Watts in standard test conditions.
- 2) Wind turbine: The wind turbine is located on the north side of the house. It has 3 blades and a swept diameter of 5.5 feet.
- 3) Inverters: Inverters for the solar array and wind turbine convert the direct current (DC) electricity from the solar panels and wind turbine to alternating current (AC) to be used by the house or sent to the Anaktuvuk Pass electrical grid.
- 4) System wiring: Wires are used to connect the PV panels and wind turbine to the inverters, and to connect the inverters to the house electrical system and the grid.

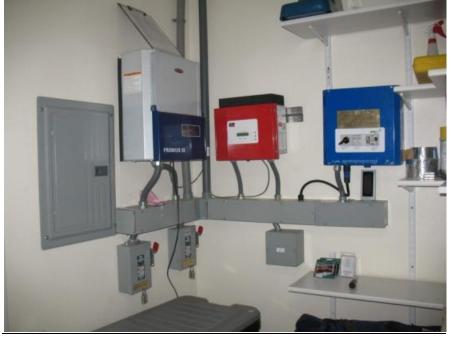
Figure 4. Inverters should be kept clean and dry.

The inverters do not require much maintenance but they should still be checked when maintenance is performed on other parts of the system. They should be installed in a clean, dry and ventilated area out of direct sunlight. Inverters can make a small noise when operating, so usually they are not installed in a living area.

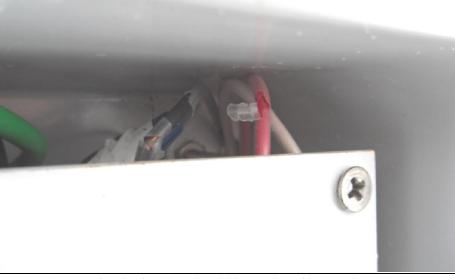
Figure 5. Cracked wiring should be replaced by an electrician.

<u>Safety</u>: The wiring connections and any disconnected wires should only be handled by an electrician. Residents should not touch wires that become disconnected as they can cause electric shock. If wires have signs of corrosion or burning upon inspection, contact an electrician to identify and fix the problem.
