COLD CLIMATE HOUSING RESEARCH CENTER

Designs for Rural Alaska Walls

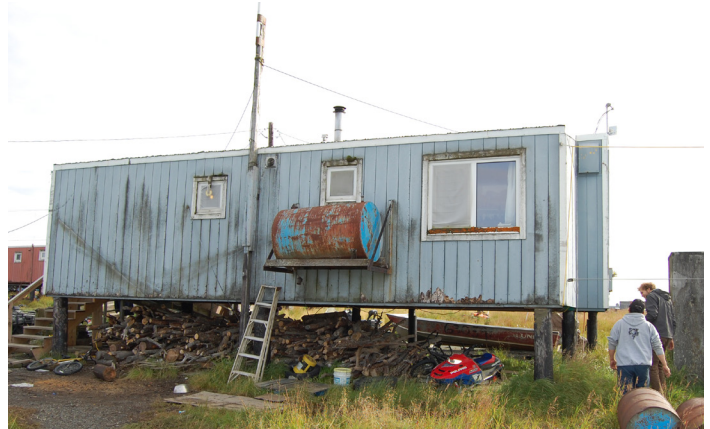
Durable housing is critical in a climate like southwest Alaska, where homes face driving rain and snow throughout the year. This home in Quinhagak has been so compromised by moisture that it is structurally unsound.

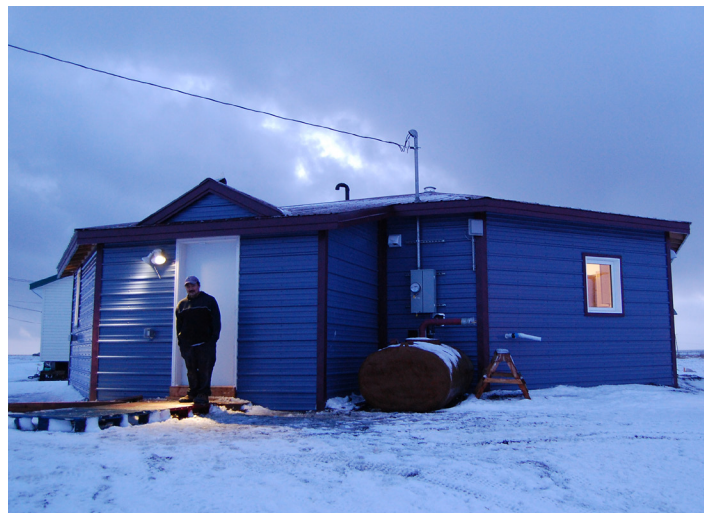
CCHRC worked with the community of Quinhagak to build a super-efficient home in 2010 that was tailored to the southwest climate. This study looked at alternative wall designs that don't rely on spray foam insulation.
