Using Vapor-Open Exterior Insulations in Wall Retrofits

Safe, Effective, and Affordable
Retrofits for Cold Climates

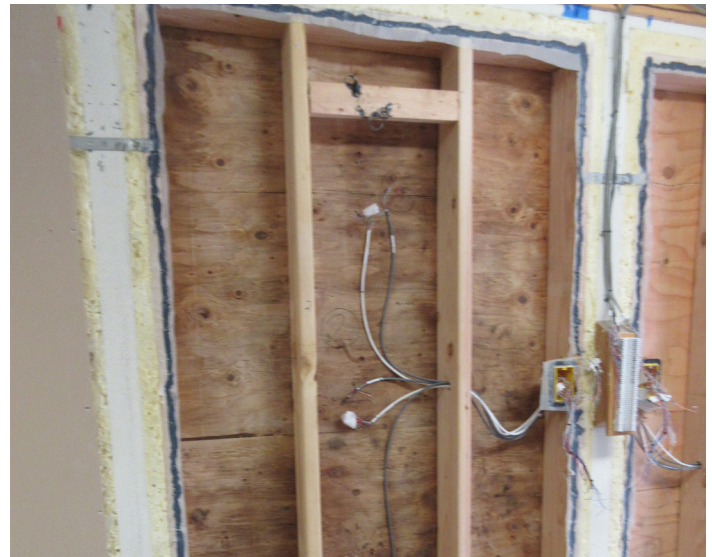
Figure 2. Unsurprisingly, the wall with 2 inches of exterior EPS grew mold after 2 years. This is a common retrofit technique in Fairbanks and occurred in more than 60% of wall retrofits between 1996-2015.

Moisture performance was measured by how long the temperature and relative humidity (RH) at the plywood sheathing were conducive to mold growth, which requires RH above 80% and temperatures above freezing. We refer to this as the “danger zone.” If those conditions persist for 4-8 weeks, the wall has a strong likelihood of developing mold. Table 1 depicts how long each wall was in the danger zone. The longer a wall is in the danger zone, the greater the likelihood of growing mold, as seen in Figure 2.

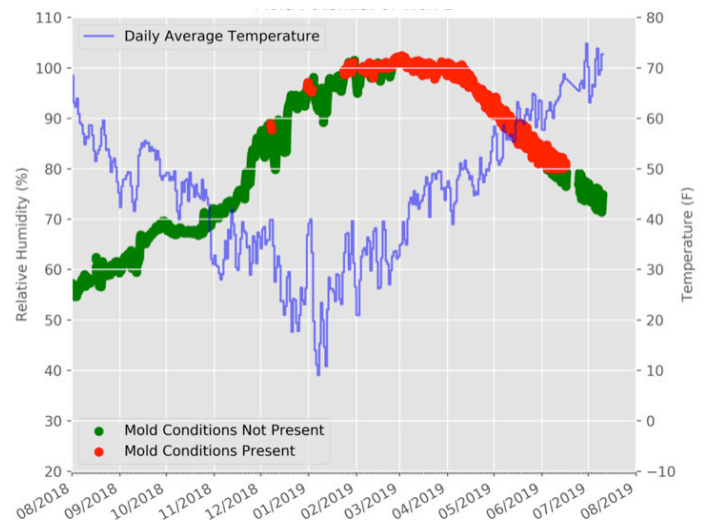
Figure 3. Data from the wall pictured above. With conditions of 80% RH and temperature above freezing, the wall was the danger zone for 17 consecutive weeks.
